Lower Wise River Assessment Survey and Prioritization

April 23, 2010

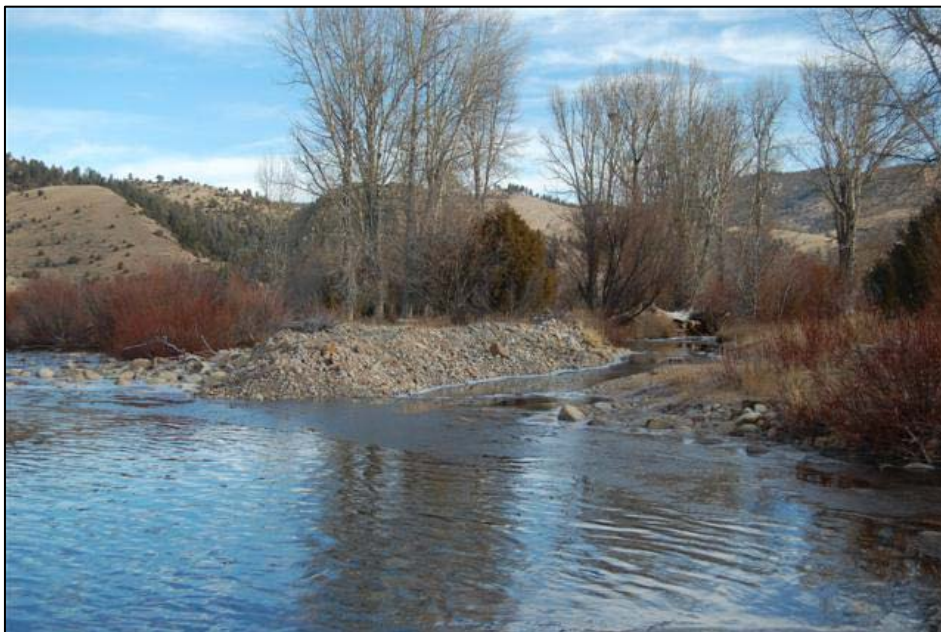
The first observed point of diversion on the Wise River is located on the right bank at River Mile (RM) 0.25, Map 1. The lowermost diversion within the project reach belongs to the Kampershroer Ranch, hereafter referred to as (PKR). No structural control is present; an alluvial gravel berm on the right bank is used to divert flows down the ditch. The ditch runs to the north through a series of holding ponds, head gates, timber frame diversion boxes, and beaver dams. Lateral ditches branch from the main ditch to irrigate hay fields farther north adjacent to the south terraces of the Big Hole River valley.

Photo 1. Lower Kampershroer, Wise River, RM 0.25, right bank (RB) no structural control.

Install a permanent head gate and grade control structure similar to the boulder weirs that have been effective at other head gates and a flume to measure flows in the ditch. Pre-fabricated cast iron gate frames and assemblies are available from regional manufacturers.

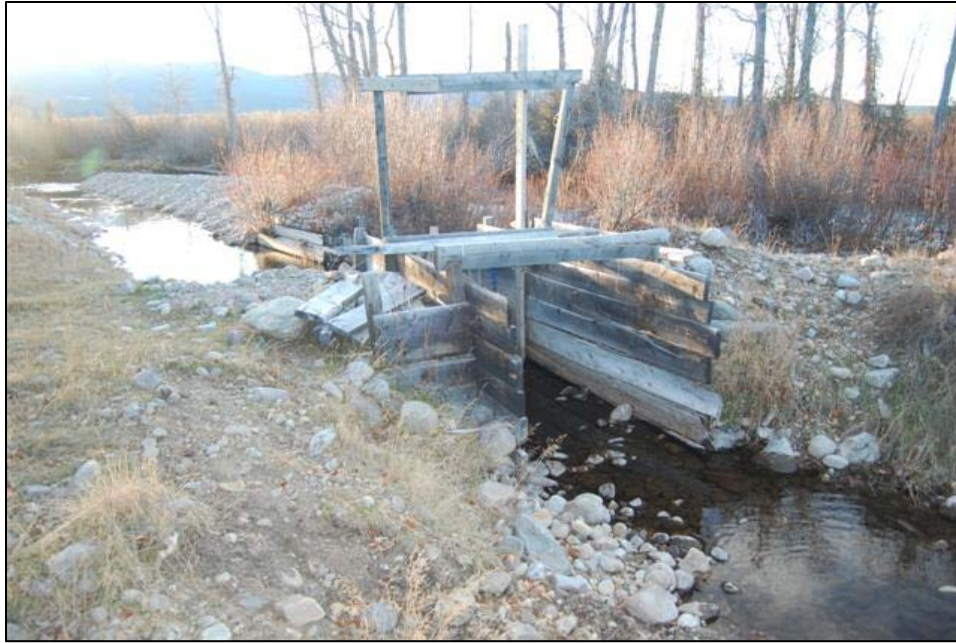
The next major point of diversion upstream is located on the right bank at RM 1.55, Map 2. Town Ditch is in poor condition and includes annual back hoe and heavy equipment work in the active channel to maintain an alluvial ‘push-up’ berm on the right bank to divert flows to the head gate. The head gate is composed of old timbers and a slot board frame which is nearly defunct and relies on temporary measures (tarps) to divert and control flows into the ditch as shown. The head gate is located approximately 100 feet downstream from the point of diversion, a narrow alluvial berm with sparse willows near the old timbers (Photos 2 and 3).

Photo 2. Town Ditch head gate structure, looking upstream, right bank, at RM 1.55 (Map 2).

Discontinue use of the Town Ditch. See Section 4.3.5.

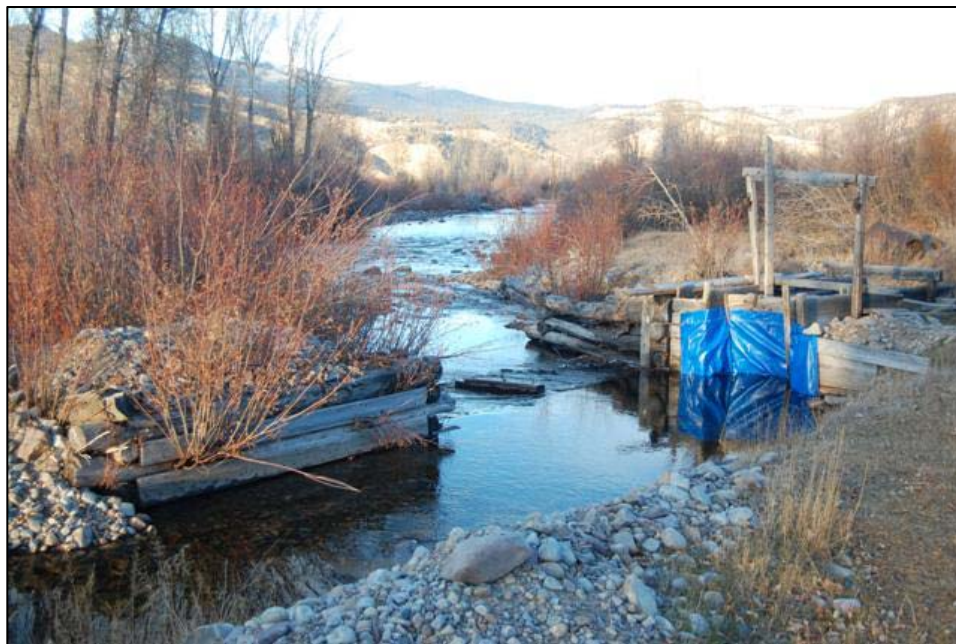
Photo 3. Town Ditch, looking downstream.

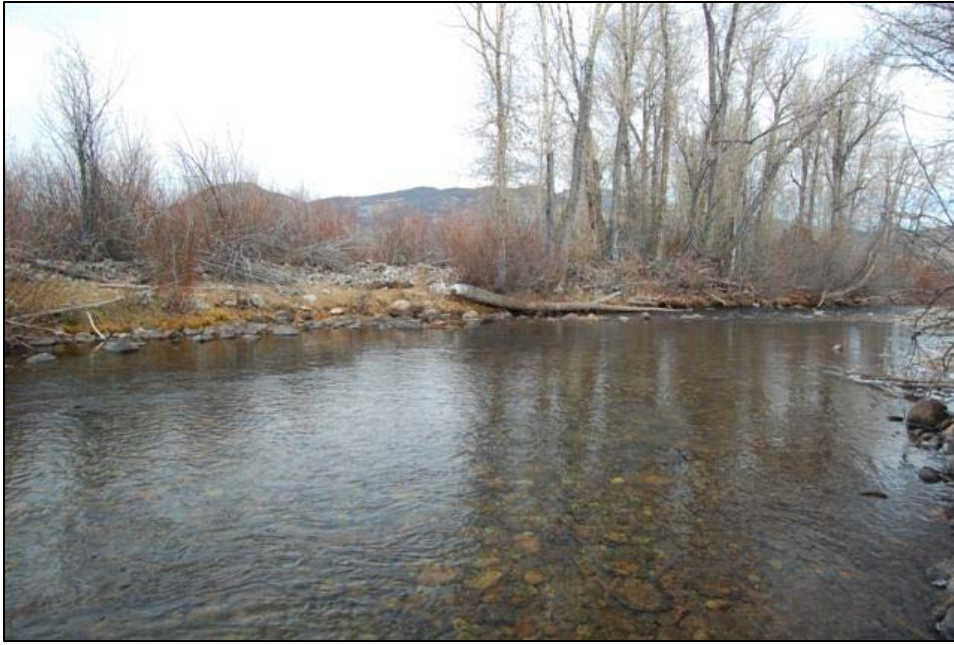
On the opposite (left bank) of the Wise River adjacent Town Ditch, approximately 300 feet of an historic levee is present and parallels the left bank and floodplain margin (Photo 4). The levee consists of native alluvial cobbles piled on the edge of the left bank to an approximate height of four feet above the floodplain. The rock levee does not appear to serve any direct function or

purpose at this time, but perhaps the structure was constructed for downstream flood control alleviation and/or means to confine flows towards the historic Town Ditch head gate. Further analysis is necessary to determine if removal of the levee is warranted to provide greater floodplain connectivity to the lower reach above town.

Photo 4. Opposite Town Ditch point of diversion, approximately 300 feet of historic cobble levee piles parallel the left bank in willows, photo background.

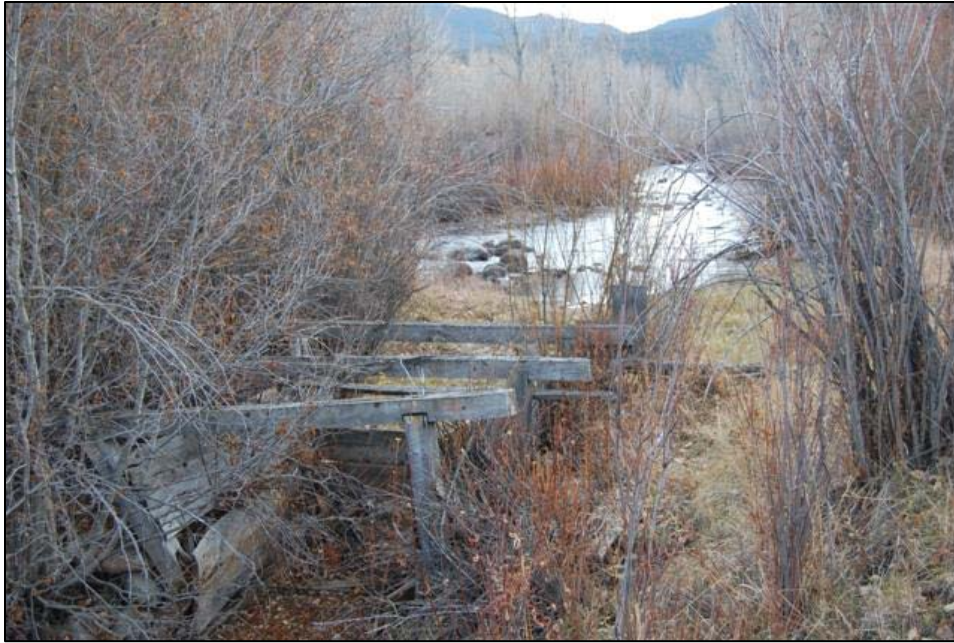
The Jolly Ditch point of diversion (POD) and remnant head gate structure is located on the left floodplain margin of the Wise River at RM 2.08 (Photo 5). As shown, the ditch no longer has a functional head gate and the ditch conveys flows only during high water. In fact, the existing ditch slope is adverse for some distance from the POD, conveying return wastewater flows derived from the upper bench (Mosley Ditch) back to the Wise River. While the Jolly Ditch remains in disrepair, its surface-groundwater contribution to Smart Creek, if any, is not fully known.

Photo 5. Remnant Jolly Ditch head gate looking upstream, Map 2, RM 2.08.

Install a permanent head gate and grade control structure similar to the boulder weirs that have been effective at other head gates and a flume to measure flows in the ditch. Pre-fabricated cast iron gate frames and assemblies are available from regional manufacturers.

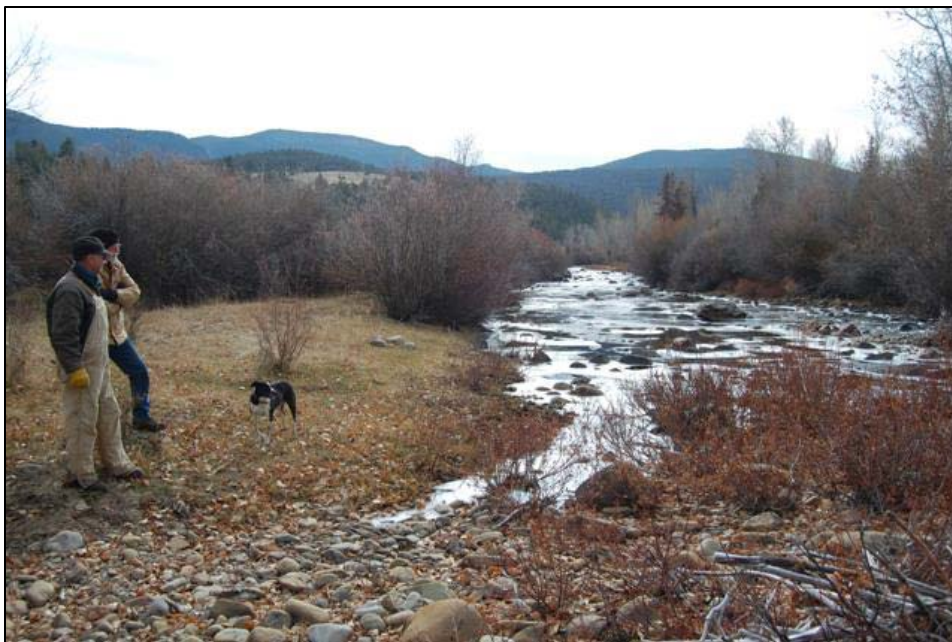
The next major point of diversion is located at RM 2.29, labeled as Kampershroer Ditch 2, Map 2. This POD has no structural control and appears to carry only high water flow to the Town Ditch.

Photo 6. Point of diversion with no structural control or head gate looking upstream, Wise River, RM 2.29, Map 2

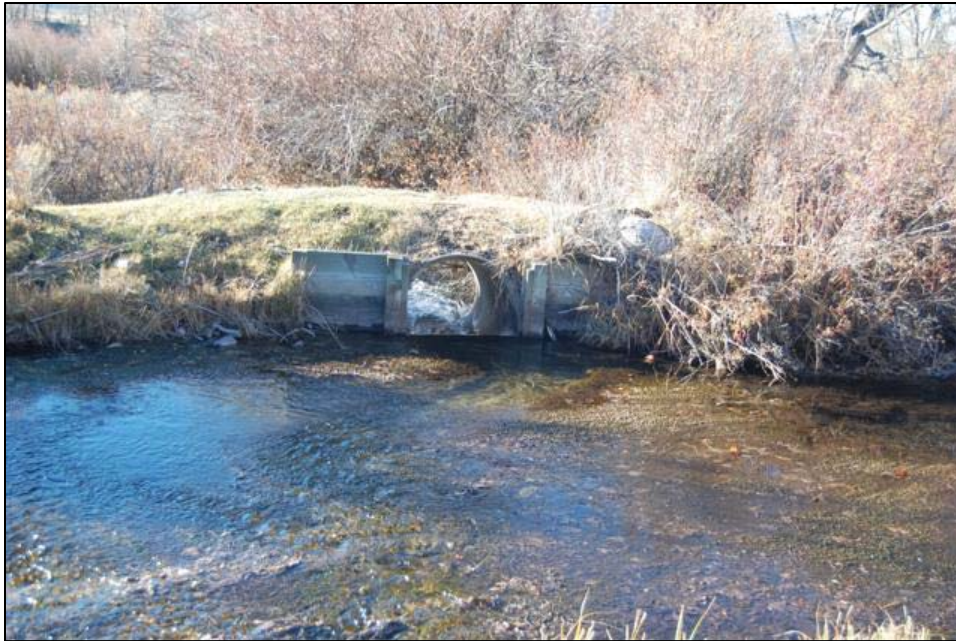
Photo 7. Swamp Creek flows directly into the PKR Ditch.

The lower reach of Swamp Creek is captured by and/or flows directly into the PKR Ditch. Westslope cutthroat trout, *Oncorhynchus clarki lewisi*, a Montana Species of Special Concern (M FWP) are known to be present in upper Swamp Creek (J. Olsen, personal comm.). At present, non-native fish could physically access upper Swamp Creek through the main PKR Ditch. Therefore, a siphon or pipe system that provides a physical fish barrier and separates native Swamp Creek flow from Wise River ditch flow is recommended on Swamp Creek proper. The purpose of improved infrastructure and source control is to 1) restore Swamp Creek flow to the Wise River and 2) prevent hybridization and loss of a fragmented pure Westslope cutthroat population. The lowermost segment of Swamp Creek is ditched and denuded with a century of stock use and manipulation of the drainage and ditch system. Restoration efforts of the last 500 +/- feet of Swamp Creek and better irrigation control structures would provide resource improvements for multiple stakeholders including the general public.

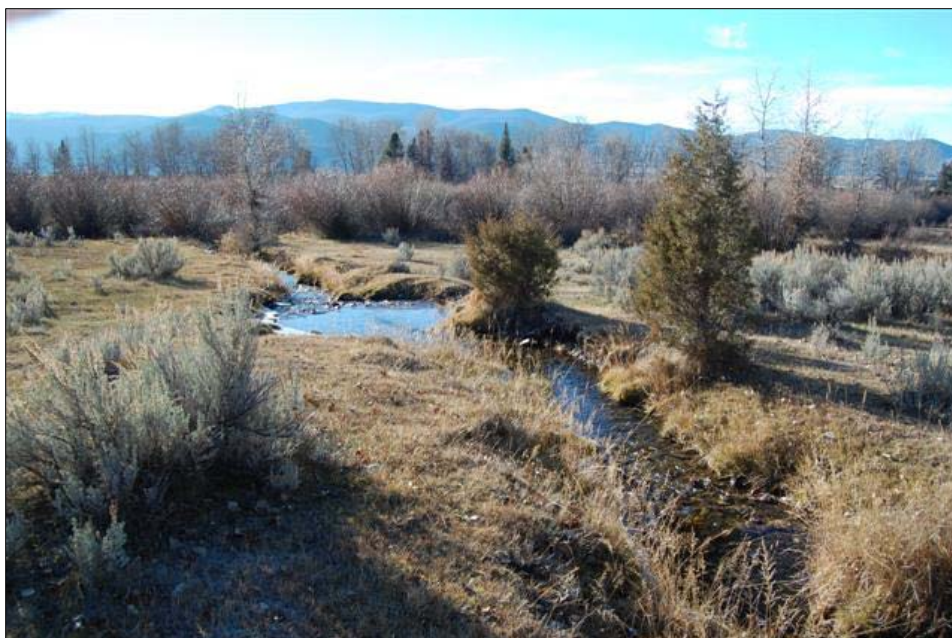
Photo 8. Swamp Creek outflow from PKR Ditch shows channelized creek corridor.

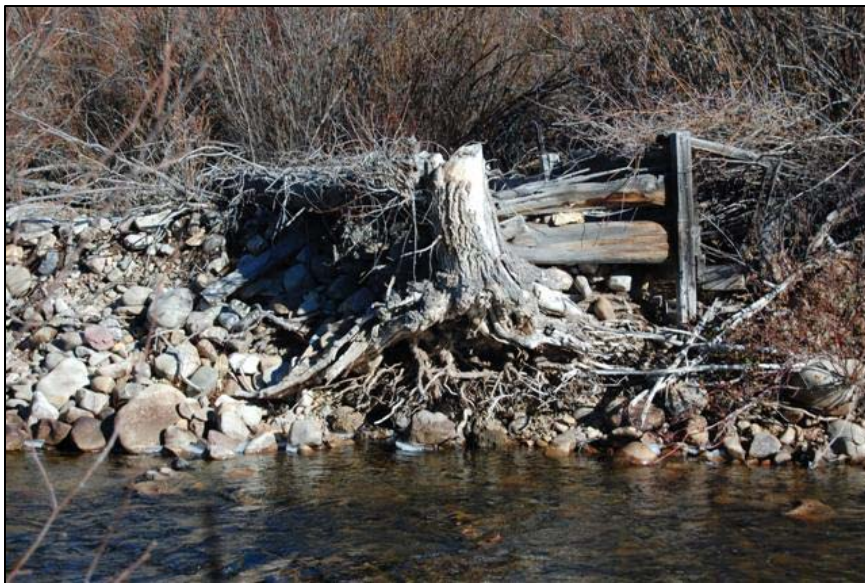
Photo 9. Remnant diversion structure; PKR, RM 2.63, Map 2.

Consolidate five (5) separate points of diversions into one shared head gate and major source ditch. Discontinued use of the Town Ditch at RM 1.55, PKR Ditch 2 (RM 2.29), remnant PKR Ditch (RM 2.63), and Allen-Lovell Ditch at RM 2.69; and partner all remaining water rights through a single point of diversion and head gate assemblage and flume near the PKR-Allen-Lovell POD (RM 2.69). Two, 2- ft diameter round metal culverts (CMPs) on a ditch / road crossing approximately 3,600 feet north of the POD are undersized and would require resizing and replacement.

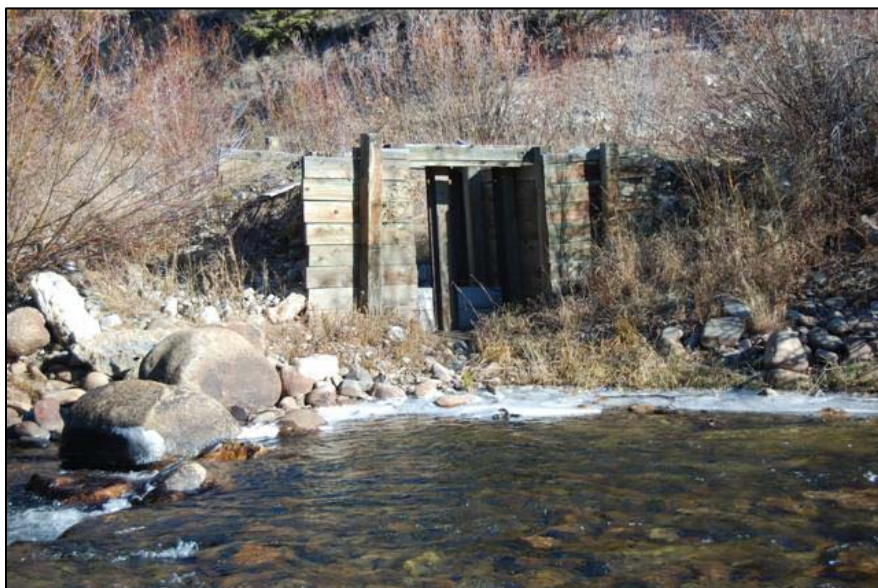
Photo 10. Lovell-Allen head gate diversion structure at RM 2.69, timber-slot board only functions during high water.

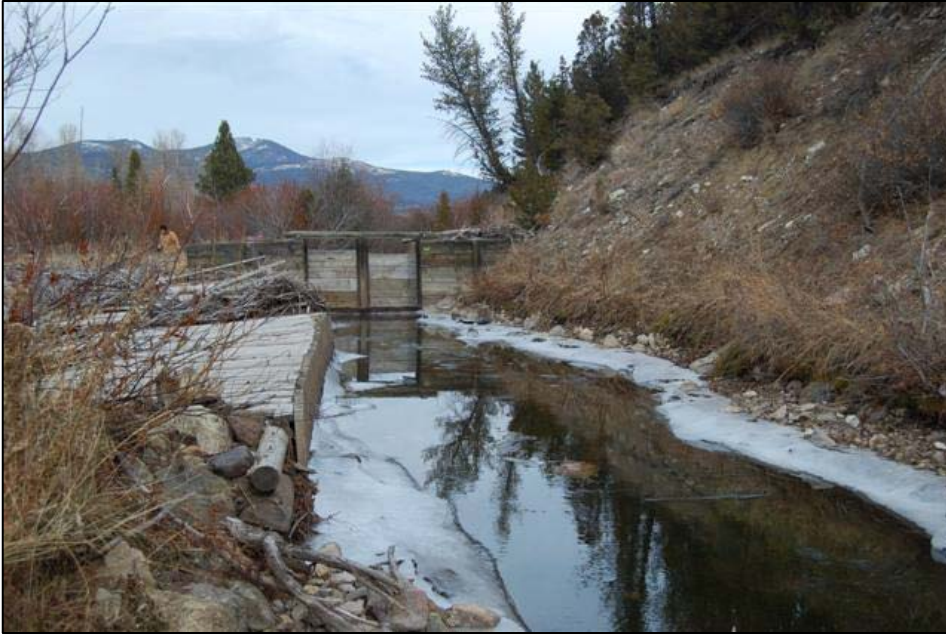
Photo 11. Looking down valley at PKR head gate structure on right bank, RM 2.7, Map 2.

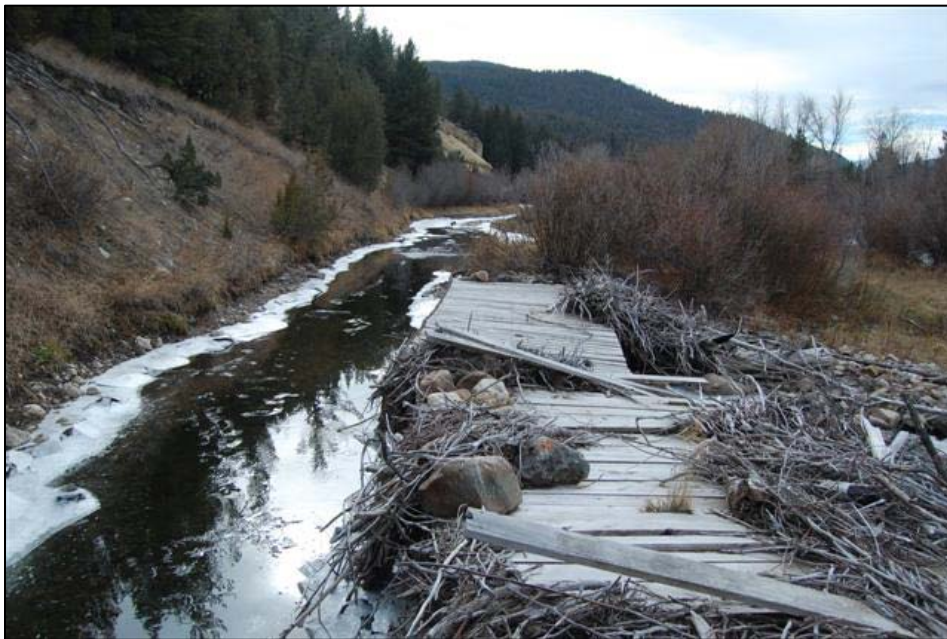
Photo 12. Looking up valley at PKR head gate structure on right bank, RM 2.7, Map 2. Note poor access, temporary boardwalk and debris to access POD approximately 200 feet upstream.

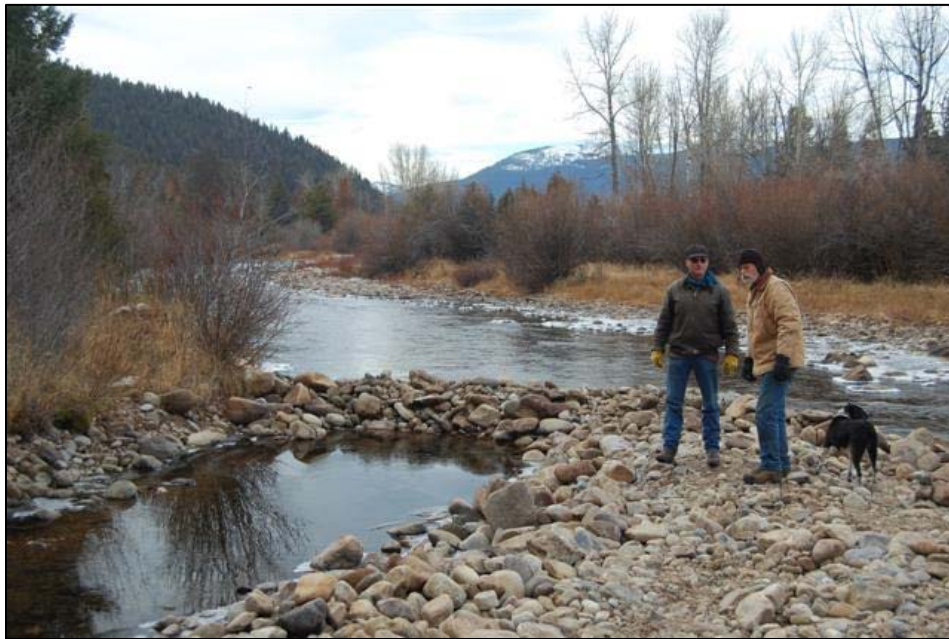
Between RM 2.63 and 2.71, three head gates (PODs) are located on the right bank of the Wise River (Table 1, Map 2). The lowermost head gate has been completely abandoned and remains perched well above the active channel (Photo 9). Water right owners in the area include PKR, Lovell, and Allen, who cooperatively share the uppermost and most active ditch at RM 2.71. The middle ditch belongs to Lovell-Allen and remains functional only at high water (Photo 10). These two upper marginal head gate structures are constructed from old timbers and rely on slot boards to divert irrigation flows. The uppermost ditch POD consists of a 200 foot +/- alluvial cobble berm that requires annual maintenance and cleaning. The constricted nature of the corridor and dense riparian zone makes maintenance access a high impact, cumbersome, and dangerous (Photos 11-13).

Photo 13. Point of diversion on right bank to PKR Ditch at RM 2.71 requires annual maintenance and work in the active channel to control quantity of water inflow.

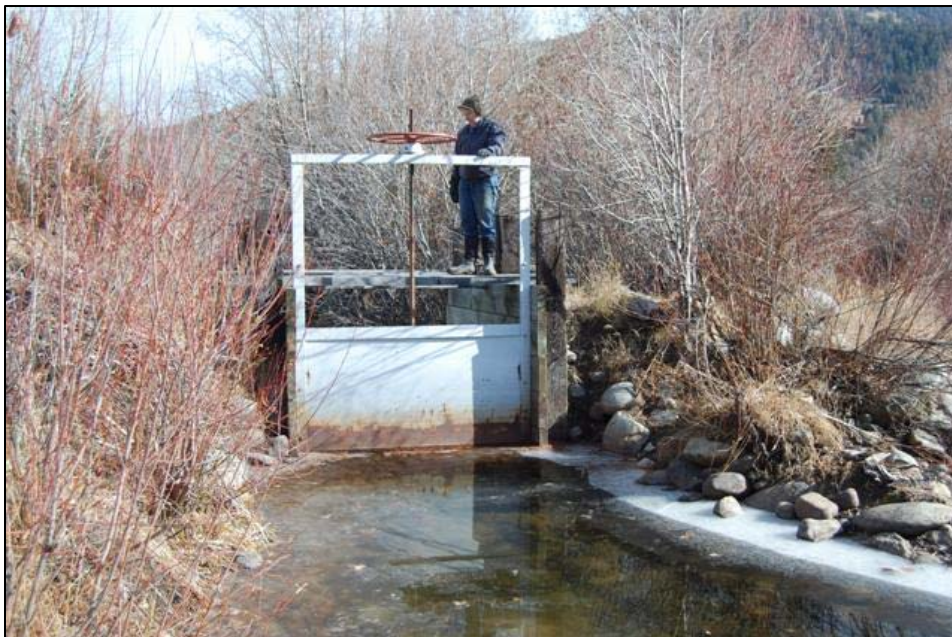
The next head gate and POD is located at RM 5.10, the Truman Ditch, which services the Rafter Ranch. The head gate configuration includes a timber frame and steel gate assembly. Several years ago, a grade control structure comprised of native boulders was constructed on the main Wise River channel to help maintain channel grade and divert flows to the Truman head gate. The grade control has started to lose some of its “footer” boulders on the far right bank, but overall, the head gate and diversion appear to function adequately. Additional efforts to improve and re-stabilize the grade structure across the main channel are warranted.

Photo 14. Truman Ditch head gate comprised of treated timber and steel gate assembly.

Improve and maintain boulder grade control structure. Install a flume to measure flows on ditch near POD.

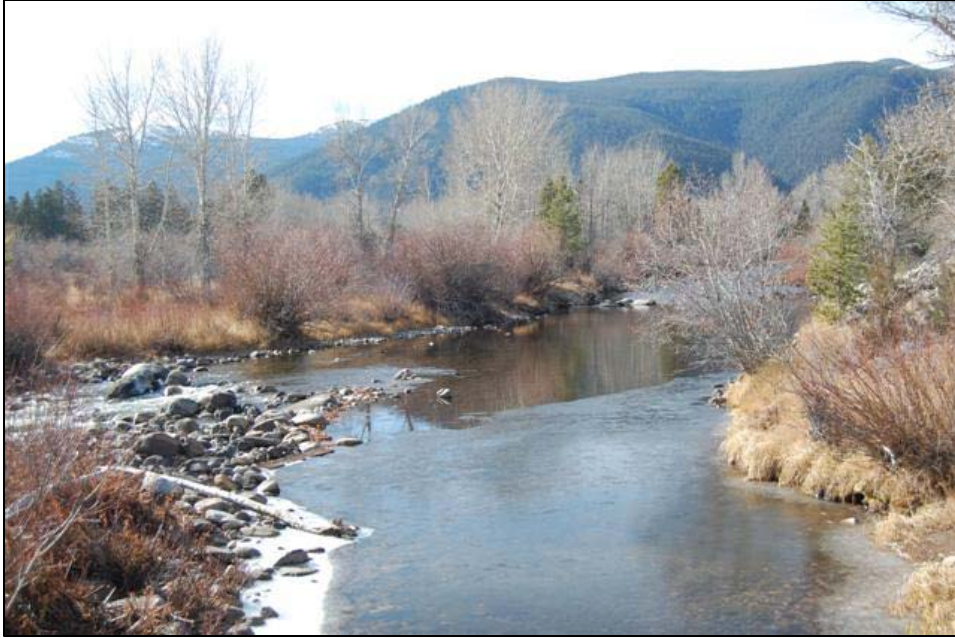
Photo 15. Looking upstream at Truman Ditch boulder grade control structure.

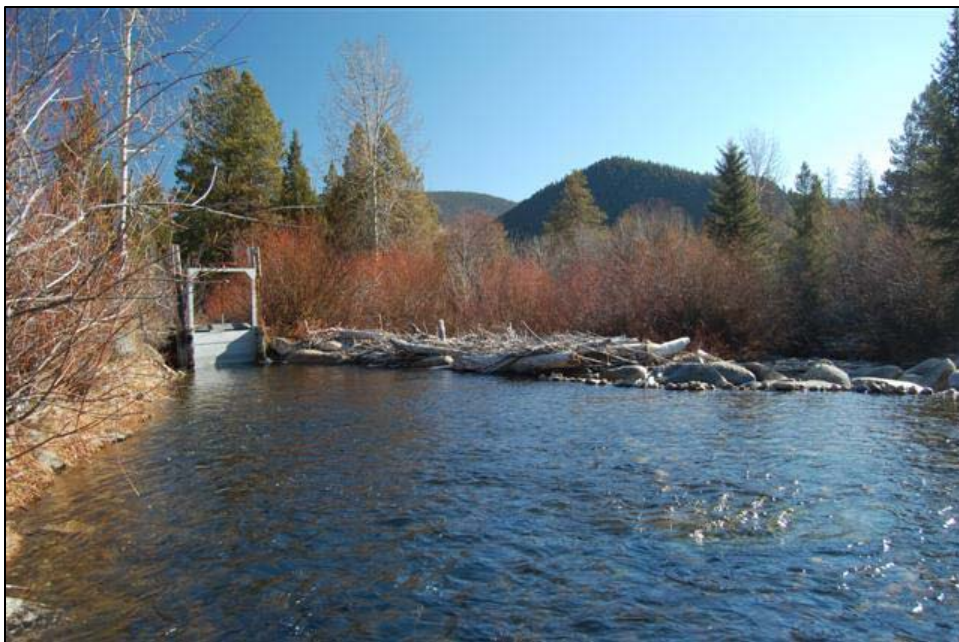
The next major POD and head gate is called the Company Ditch, located at RM 5.88, Map 4 and is responsible for conveying irrigation water rights to the Jones, Stanchfield, and Zuckers ranches. Similar to the Truman Ditch, a grade control structure was constructed several years ago immediately upstream from the head gate. While the steel head gate and wheel stem assembly was also replaced at this time (circa 2004), the timber framing remains off kilter and needs repair or replacement. The point of diversion from the main Wise River is located over 600 feet farther upstream from the head gate.

Photo 16. Looking downstream at the Company Ditch head gate, RM 5.88, left bank.

Improve and maintain grade control structure, replace old timber frame head gate with either treated timber or a custom formed concrete headwall assembly.

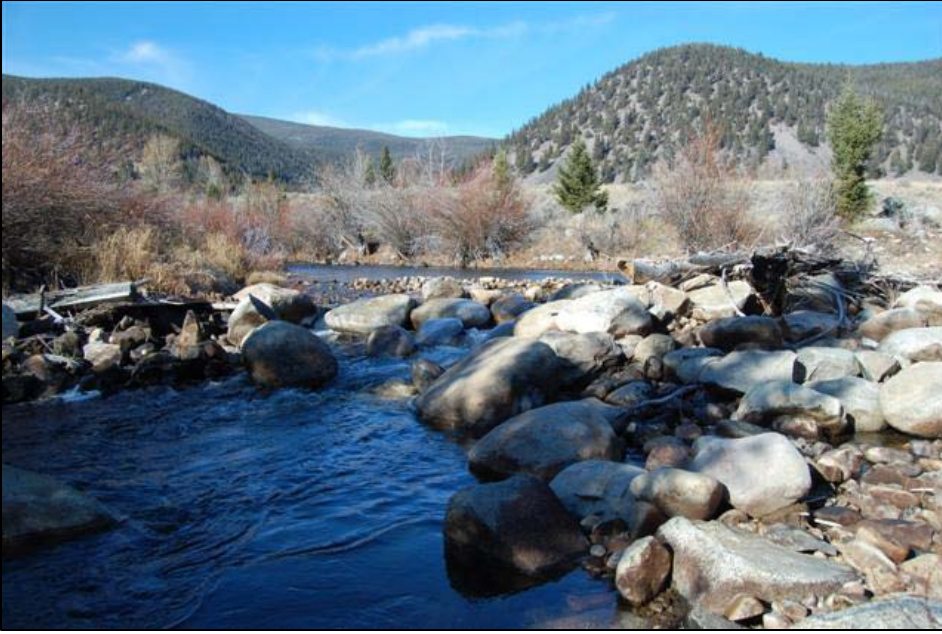
Photo 17. Looking upstream at steep grade control structure at Company Ditch.

The boulder grade control structure appears to function well for water delivery, but the steepness of the structure is not ideal from a structural or fish passage standpoint. Instead of taking up the entire grade in one major drop, the structure could be improved with several less severe step-plunge pools with at least two major sills to accommodate the steep gradient at this site.

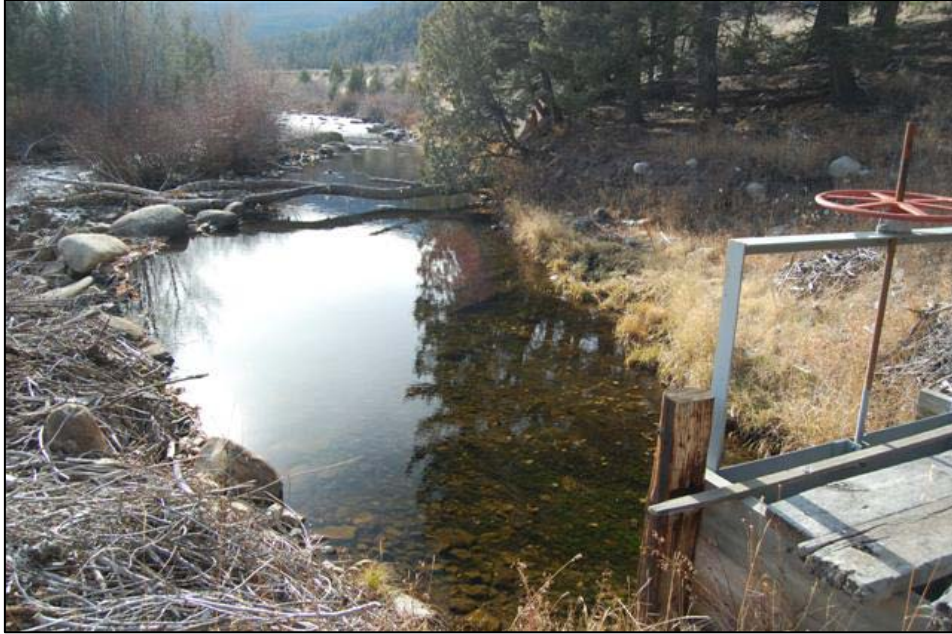
The Vineyard Ditch is located on the left bank, RM 6.73, Map 4 and serves the Rafter Ranch water rights as well as the Vineyard Acres subdivision (Table 1). The Vineyard head gate is comprised of a steel gate and timber frame, same as Company and Truman head gates. The POD is located approximately 300 feet upstream from the head gate; a well vegetated willow-boulder berm and grade control structure across the main channel appear stable and functional. No other issues were identified with this infrastructure except, like all diversions in the project reach, Vineyard lacks a water measuring device, staff gage, and/or flume to quantify a flow rate.

Photo 18. Looking upstream at the POD grade control above the Vineyard head gate, RM 6.73.

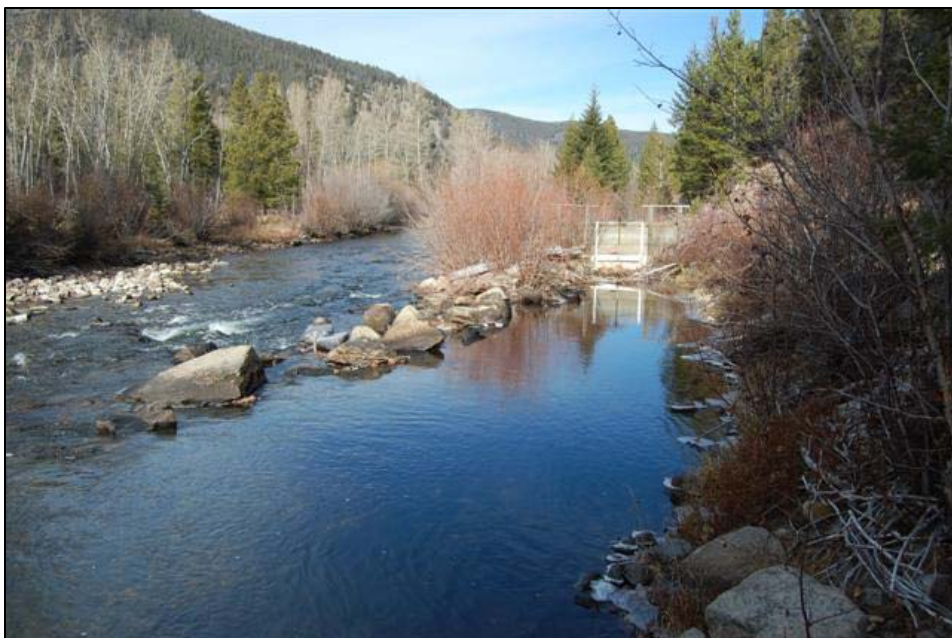
The Connolly Ditch (Photo 19) is located on the right bank of the Wise River, RM 7.53, Map 5. The head gate and rock vane grade control structure, which extends approximately 50 feet upstream was installed the mid to late 1990s by R.E. Miller and Sons. The head gate and diversion structure function well and does not require annual maintenance in the main channel. The structure consists of a slide gate and timber frame connected to a 3- ft diameter arch pipe outlet. No other issues were identified at this site, with the exception of no flume or measuring device present.

Photo 19. Looking downstream at the Connolly head gate and rock vane structure, RM 7.53.

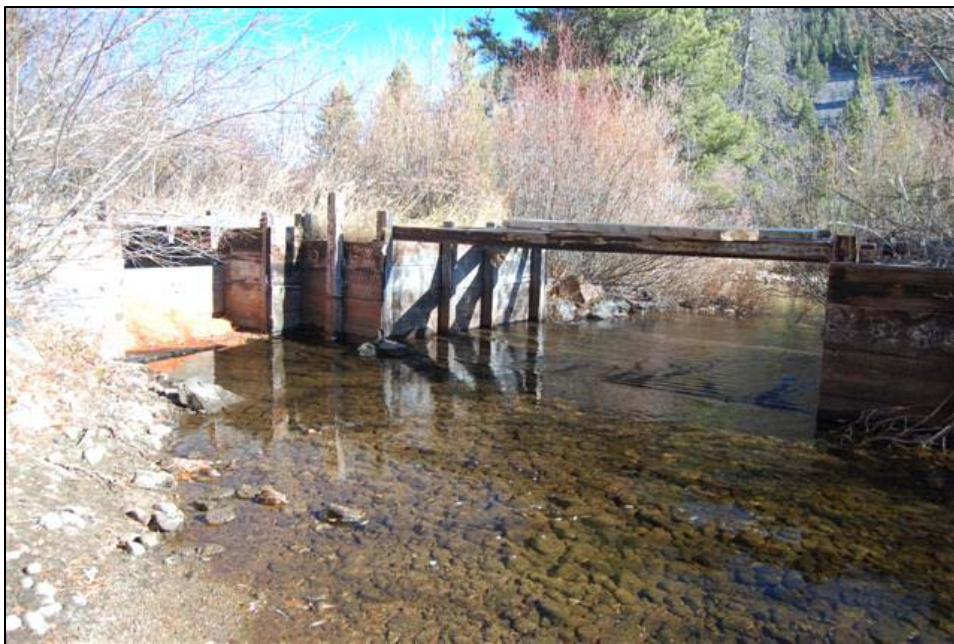
The most upstream point of diversion within the Lower Wise River project reach services Buckner's Split Diamond Ranch, located at RM 10.10 on the left bank and floodplain. Unfortunately, the POD and the place of use are on opposite sides of the river. The ditch takes off approximately 245 feet upstream from the head gate and return channel, a timber slot board structure as shown in Photo 20 below. The head gate structure appears functional. Remnant irrigation tarps in multiple channel threads were observed upstream, including the main channel, to help deliver adequate water to the head gate during summer base flow conditions. Downstream at RM 9.65, an open metal bottom flume elevated about 15 feet above the channel, supported by log crib piers and abutments is used to convey irrigation water across the Wise River to the Split Diamond hay fields or pasture (Photos 21-22). While not seen in operation, the flume is aged and leaks with dime sized holes visible in its bottom. Upstream from the flume crossing, the right bank margin of the Wise River is stabilized with riprap sourced from angular local bed rock that appears to protect the flume crossing as well as a road or historic railroad embankment.

Photo 20. Split Diamond head gate and return channel at RM, 10.10, Map 6. Timber and slot board assembly.

At existing POD (RM 10.1), recommendations include 1) design and installation of a fish passable grade control native boulder structure, 2) design and installation of a measuring flume on ditch, and 3) repair existing flume at crossing (RM 9.65).

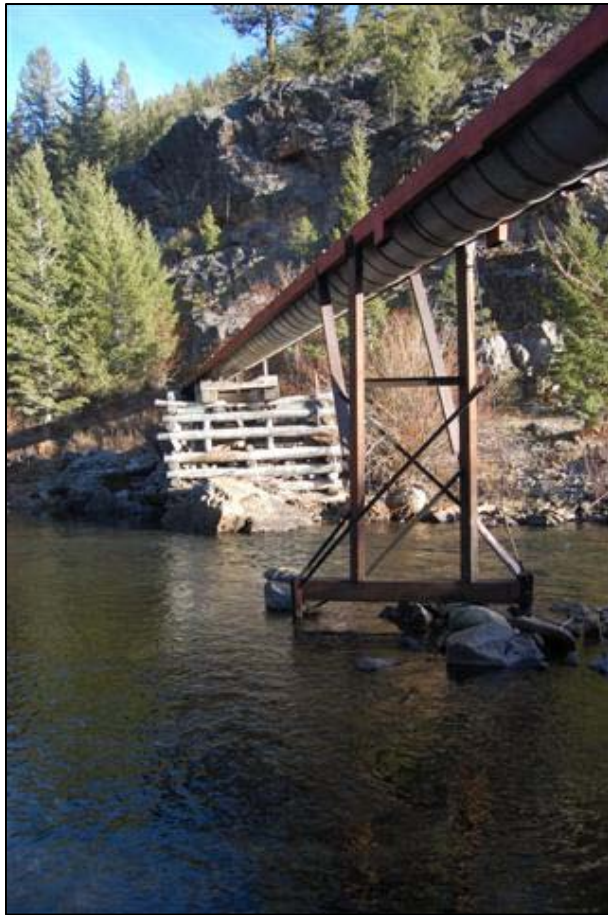
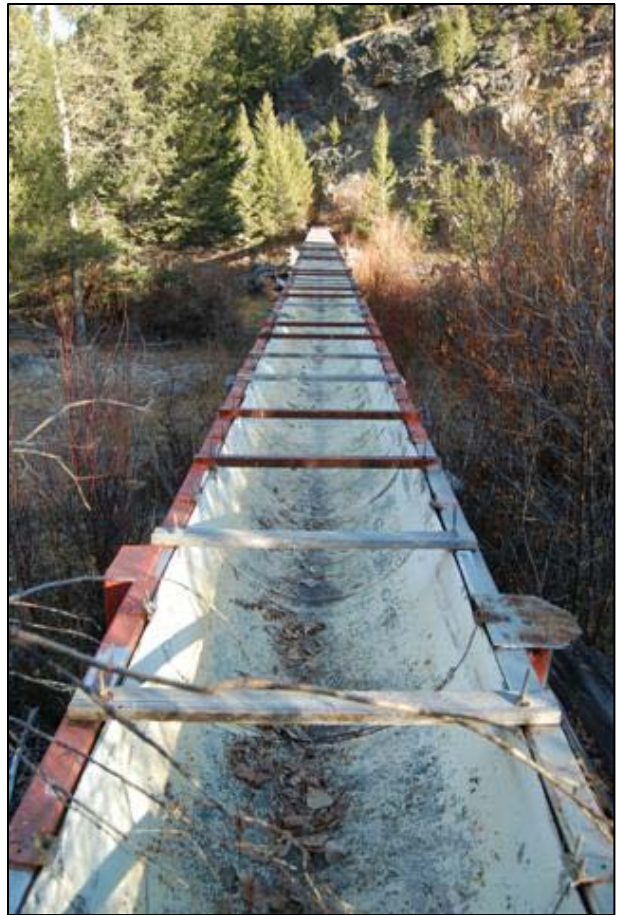
Photos 21 and 22. Split Diamond flume crossing on the Wise River, RM 9.65, Map 6.

As a conceptual idea to eliminate use of the existing flume crossing on the Wise River, further stakeholder inquiry and detailed topographic survey data are necessary to determine if Split Diamond Ranch could feasibly change its POD to the right (east) bank. In addition, it is unknown at this time whether or not the Flying Cloud Ranch and USFS would consider a ditch or pipe easement across respective properties.

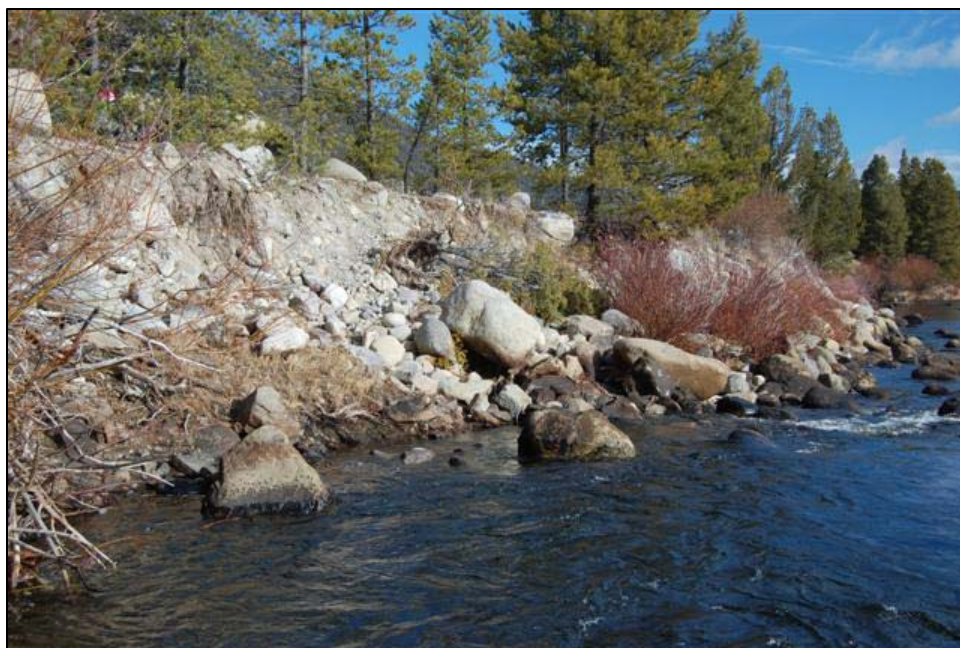
A short, 50- ft segment of the Wise River's left bank immediately below the confluence with Pattengail Creek is eroding in vicinity of the NF 73 Scenic byway pull off, RM 11.38, Map 7. While the upper terrace is not in imminent danger of collapse, the asphalt covered shoulder of the road could potentially fail if undermining of the bank continues.

Photo 29. Bank erosion on the left bank margin, Wise River, RM 11.38. Note close proximity of parked vehicle on road pull-off, upper left corner.

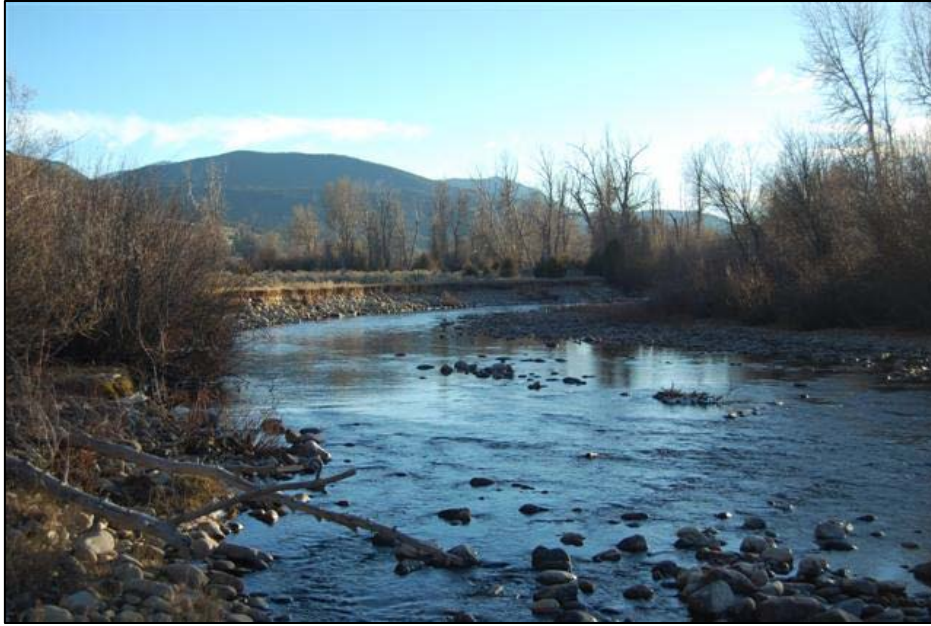
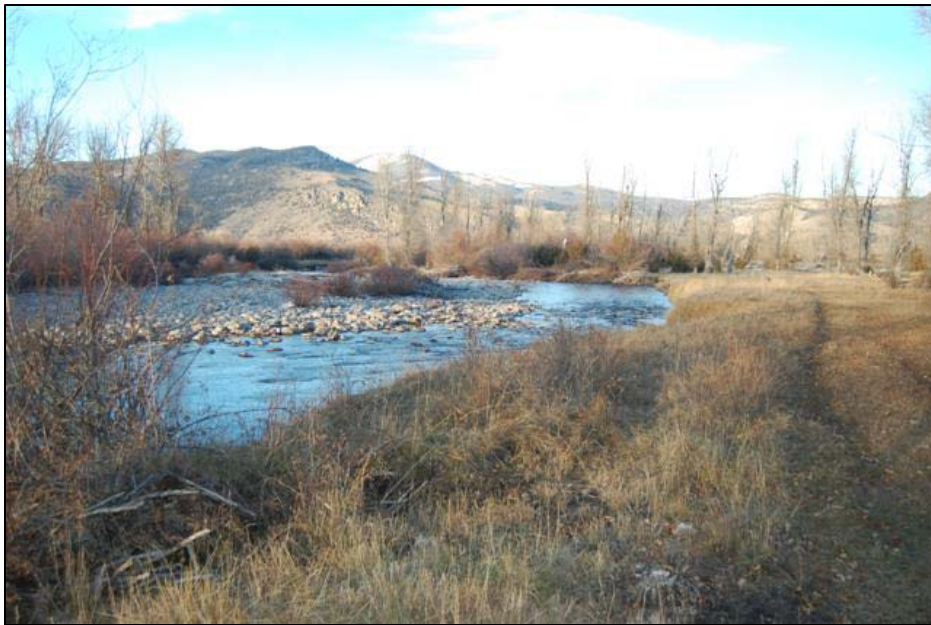
Photos 30-31 provide uncommon examples of active bank erosion in the lower Wise River, RM 1.20- 1.35. Both banks lack a woody riparian buffer zone and provide candidate sites for bank stabilization, revegetation, and fish habitat enhancement.

Bank stabilization and revegetation and fencing on two, 200- foot long eroding right (east) bank segments located below Town Ditch, between RM 1.20 and 1.35, Map 2 (photos 32-33). These 5-7 ft high floodplain-terrace banks appear susceptible to further bank retreat with no riparian buffer as the channel continues to laterally migrate into a coarse gravelly unconsolidated alluvium overlain with a thin veneer of soil and sparse sagebrush and upland grasses. Water users expressed concern that if the channel avulses and changes course here, the main channel will capture the Town Ditch and bypass the Hwy 43 Bridge downstream. This segment of the lower Wise River offers potential to initiate pro-active, bioengineered bank stabilization and revegetation measures while also recognizing natural geomorphic processes, channel adjustment, and an increase in the meander belt width (sinuosity) and decrease in channel slope occurring over time.
