UPPER FRENCH GULCH FISH PASSAGE AND RESTORATION PROJECT

FINAL REPORT

December 2022

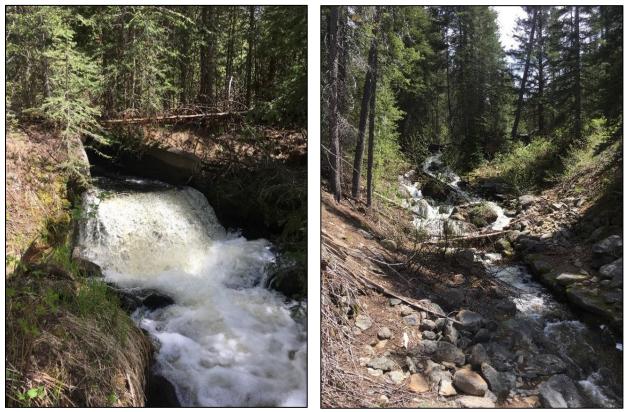
Figure 2. Fish barriers in the project area prior to restoration. This is the location where major mining activities stopped in French Gulch, creating the 30-foot-high, unnaturally steep cascade that plunged from the original valley height down to the current elevation. At the head of the cascade sat a perched culvert where an old road crossed the stream.

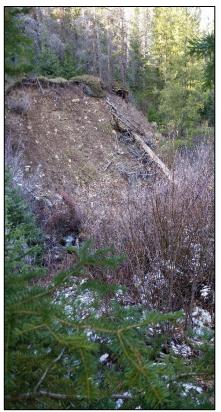
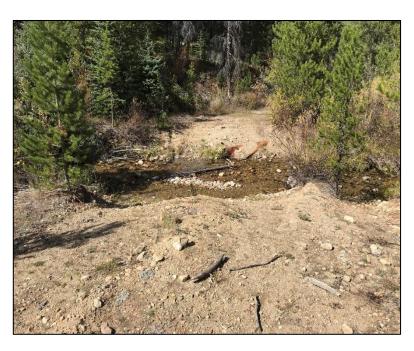
Figure 2. High eroding bank (left) and bare eroding bank (right) below the cascade.

The second goal of this project is to improve water quality, by reducing fine sediment loading to the stream. Two large, bare, eroding stream banks exist below the cascade and Chinese Wall. These degraded banks exist due to past anthropogenic mining activities and are contributing excess sediment into French Gulch.

Restoration of eroding bank 1 (upper) and 2 (lower) are complete. A Montana Conservation Crew (MCC) performed the work on the upper bank from October 10-12, 2022. The work was focused on restoring/stabilizing the eroding streambank downstream of the cascade (now, the new fish passage step pools). The unnaturally steep and high eroding bank was caused by past mining and resource extraction. The bank was contributing to excessive sedimentation of the system, resulting in poor quality fish and spawning habitat. We used low-tech restoration and erosion control techniques, mainly wattle fences (Figure 5), to revegetate and spot-treat the eroding bank, reducing stream bank erosion and chronic sedimentation. Wattle fences are short retaining walls built out of live cuttings or logs. The walls take up the vertical component of the slope, reducing the effective slope angle and allowing vegetation to become established (Polster, 2015). After the wattle fences were installed, we seeded the bank to grow vegetation and establish roots.

The lower eroding bank was stabilized and revegetated using an excavator. This was the location of the second stream-crossing/culvert. During demobilization and pulling of the culvert, Watershed Consulting narrowed the over widened section of the channel, added large woody debris/root wads, and planted live willow clumps into the bank. MCC crews then came in and planted willow stakes near the water's edge and seeded with a native seed mix.

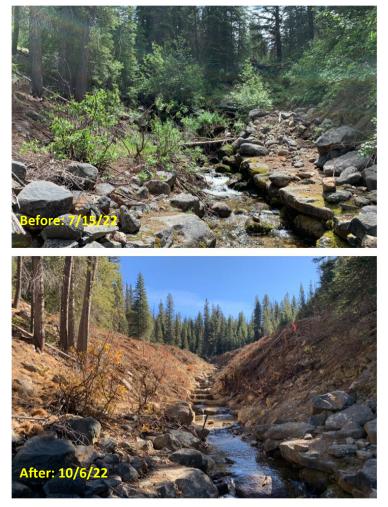
Figure 4. Before and after photo of the completed project, looking upstream.

Watershed Consulting started project implementation on July 28, 2022, and completed construction on October 6, 2022. Figure 4 shows the before and after photos looking upstream. The stream crossing and access routes were established first. Then, the project site was cleared of trees to make room for work. All slash and forest by-product material was stockpiled and set aside for later use. Next, the diversion ditch was constructed and activated to remove water from the active project site. Once the diversion ditch was activated, the main digging and construction began. On August 30, 2022, Watershed Consulting hit an unexpected impenetrable bedrock layer in the project alignment that halted operations until the arrival of a hydraulic jackhammer attachment. The hydraulic jackhammer attachment arrived on September 15, 2022, and was used on-site for seven days. Watershed Consulting broke through the hard rock vein and proceeded with normal construction operations once through the hard rock layer. Water was activated into the new channel on September 28, 2022. Watershed Consulting then decommissioned the diversion ditch, slashed the side slopes, and completed demobilization. In total, 31 step-pools were built to restore fish passage. All disturbed areas have been seeded using a native upland mix.

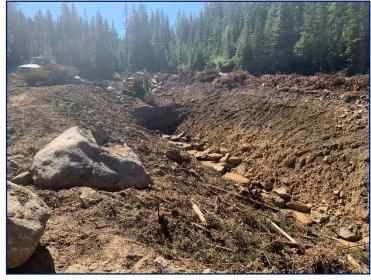
Roughly halfway through construction, before encountering the hard rock layer

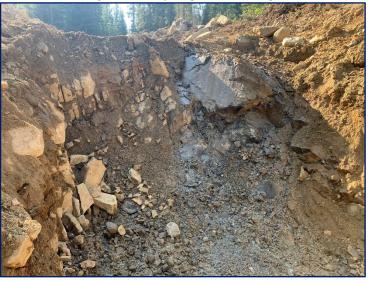
Unexpected impenetrable bedrock layer in the project alignment.

Watershed Consulting, our contractor, hit a very hard rock layer about halfway through construction. This was an unforeseen obstacle that shifted the logistics of the project, budgeting, and contracting. The chosen alternative required the use of a hydraulic jackhammer attached to the excavator to punch through the bedrock. This was not part of the original bid and required a significant change order. Change Order 2 was signed on September 19, 2022, which put the remaining time of the project into a daily burn rate.

Bedrock was encountered beneath the existing stream channel at station 1+80. Watershed Consulting reported that the bedrock layer was impossible to penetrate using the excavator bucket and obtained a hydraulic jackhammer attachment to break through the bedrock layer. These unexpected subsurface conditions lead to an approximately two-week delay in construction progress.

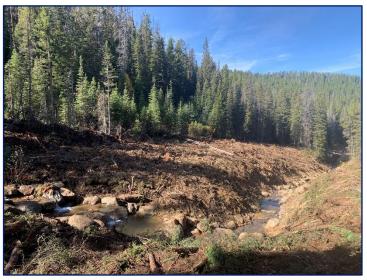
Final and completed project after stream activation.

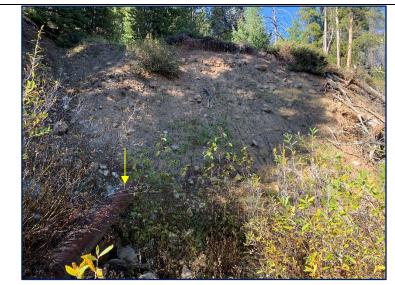
"Before" photo of the first high and eroding bank. Looking west.

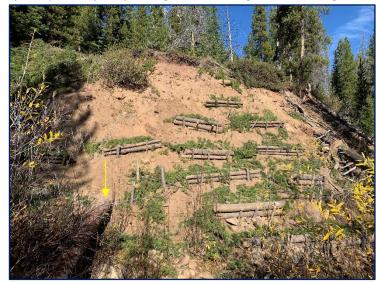
"After" photo of first high and eroding bank post low-tech wattle fence installation. Looking west.

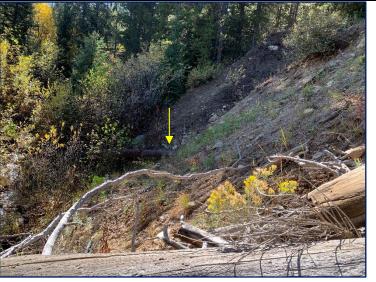
"Before" photo of first high and eroding bank. Looking south.

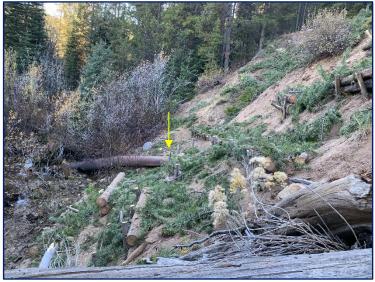
"After" photo of first high and eroding bank post low-tech wattle fence installation. Looking south.

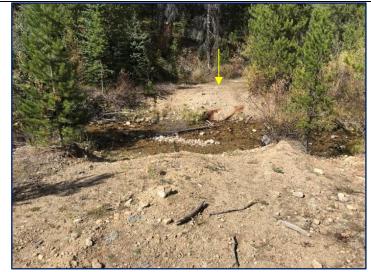
"Before" photo of second eroding bank/stream crossing. Looking west

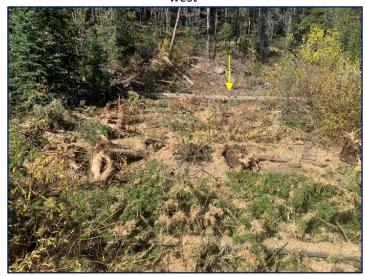
"After" photo of second eroding bank/stream crossing postrestoration. Looking west

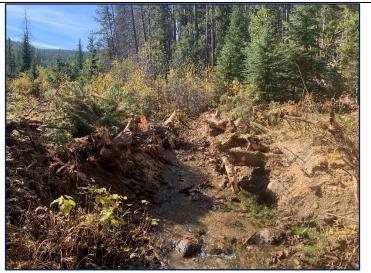
Looking upstream at second eroding bank/stream crossing postrestoration. Note the large root wads anchored in to both sides.

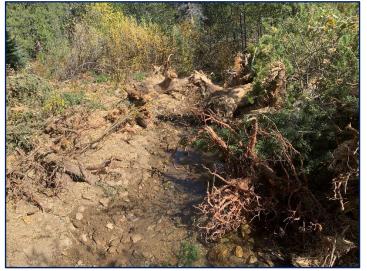
Looking downstream second eroding bank/stream crossing postrestoration. Note the large root wads anchored into both sides.
