French Gulch and Moose Creek Restoration Project Final Report

February 2018

BIG HOLE
WATERSHED COMMITTEE
Conservation Through Consensus.

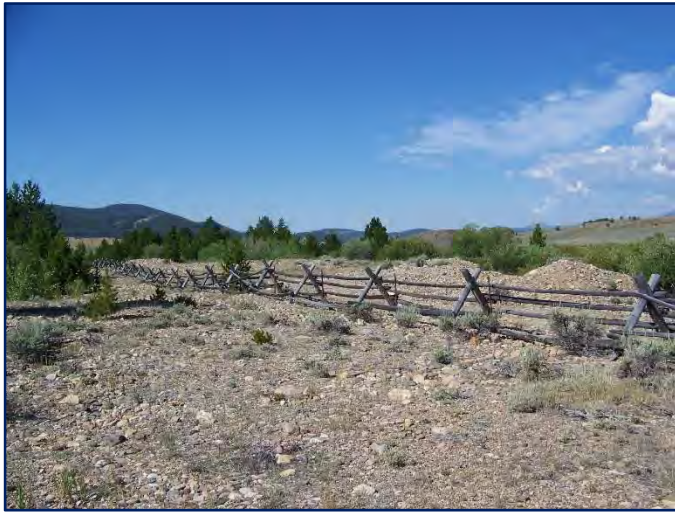
Placer piles in reach 1 and stream channel

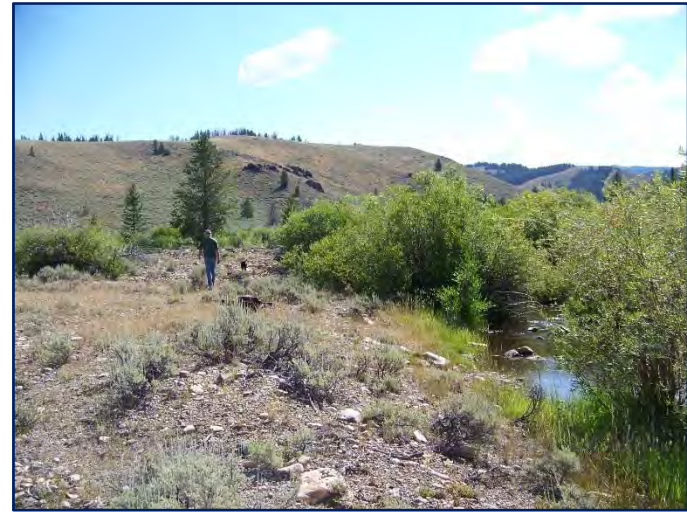
Existing channel and width of riparian corridor in reach 1. Nearly 6-feet of artificially elevated floodplain clearly shown

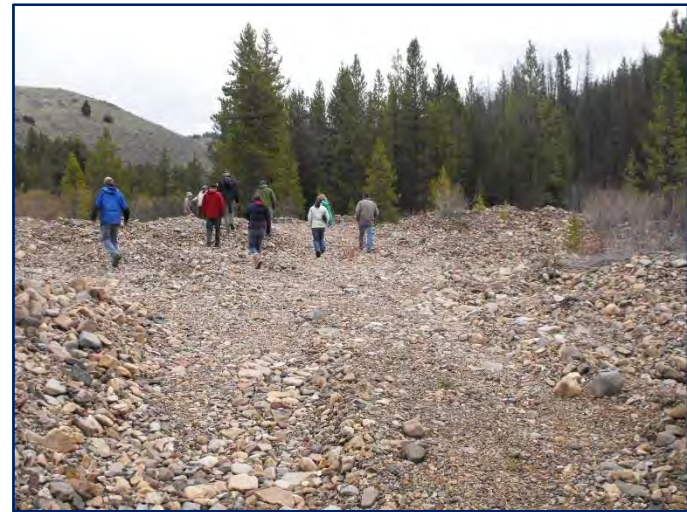
Extensive placer pilings in upper part of reach 1

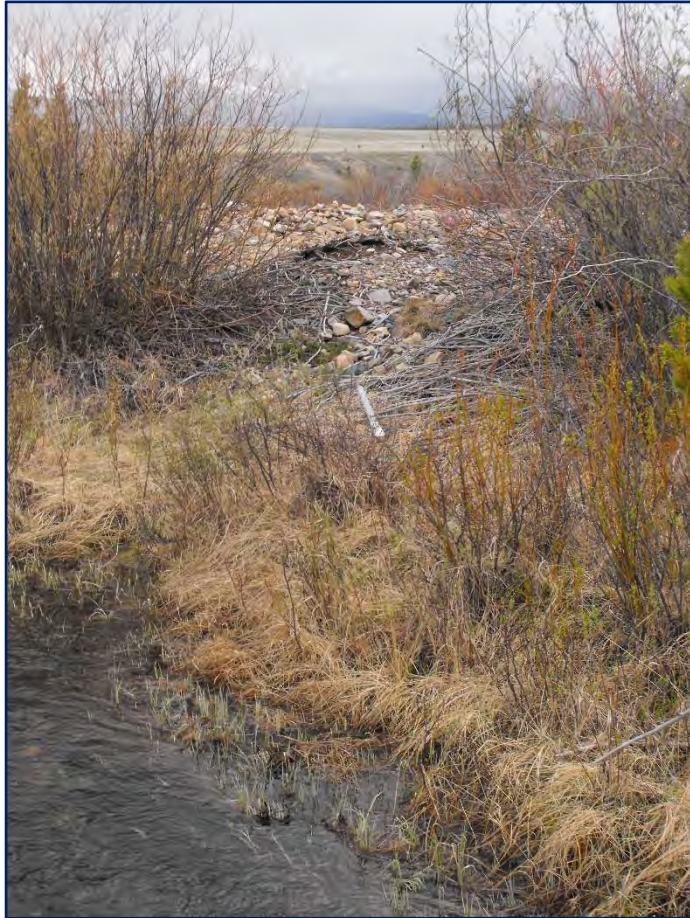
Large placer piles in reach 1 limit extent of riparian area

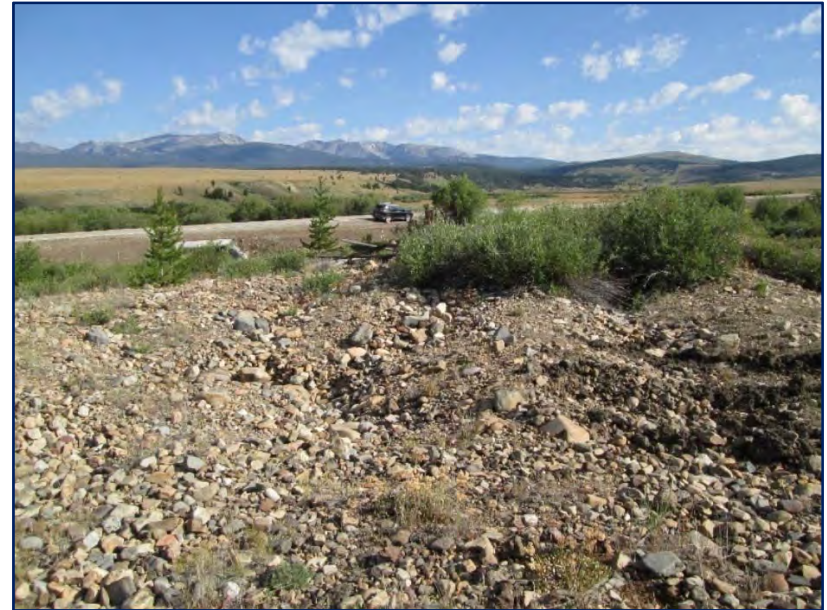
Reach 1 prior to channel construction with box culvert marking location of future channel

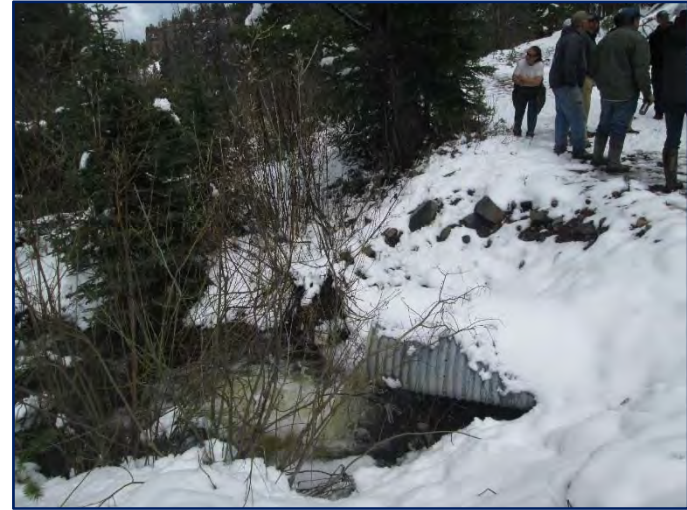
Perched culvert at the top of reach 5 shown in 2014 (left) and during pre-construction walk-through in the spring of 2016 (right)

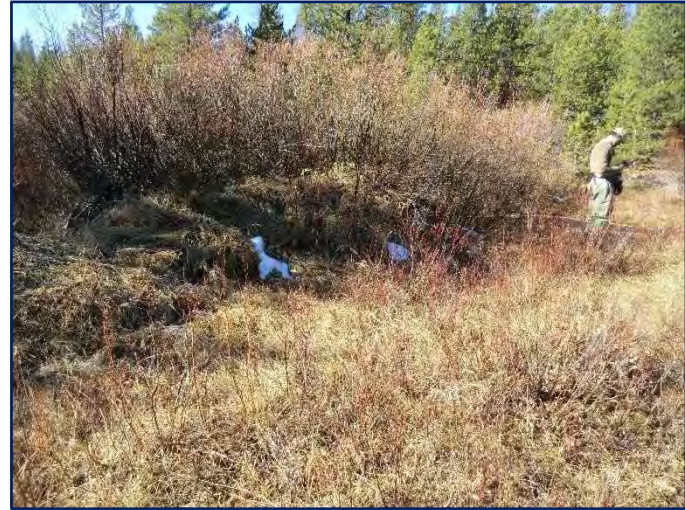
Old beaver dam and pond in Reach 2

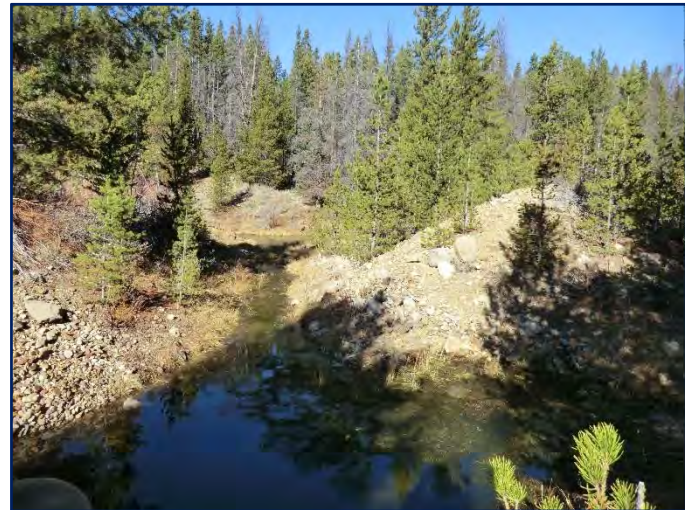
Location in Reach 2 where stream channel and wetlands connect through two large placer piles

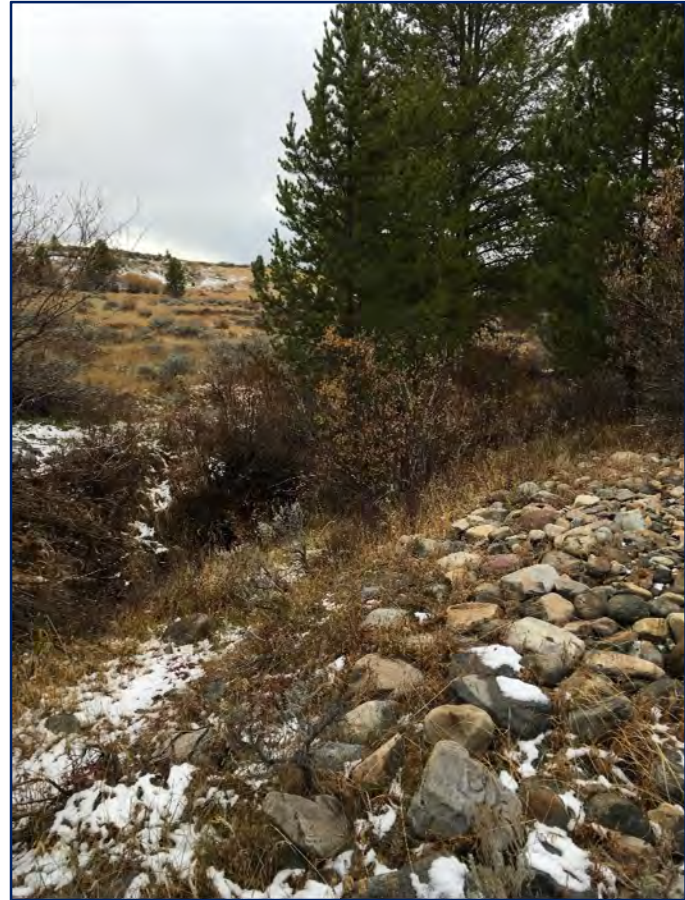
Moose creek in project reach. Narrow riparian corridor, sagebrush and placer piles with conifer growing in floodplain

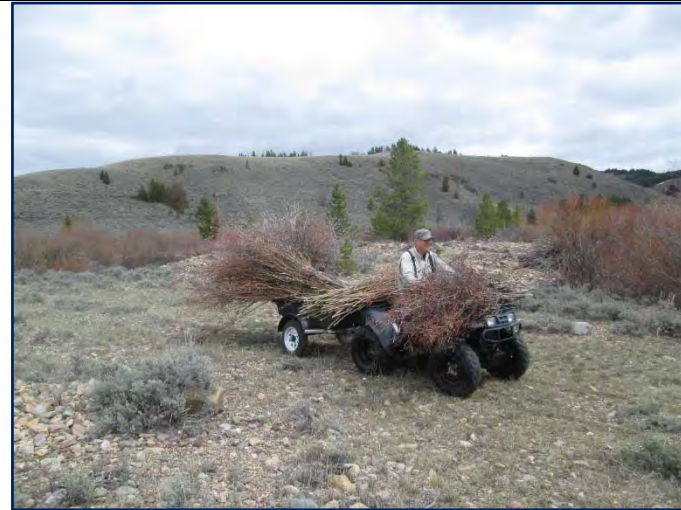
Construction equipment clearing placer piles in Reach 1. Newly created floodplain and mechanically transplanted willows in foreground

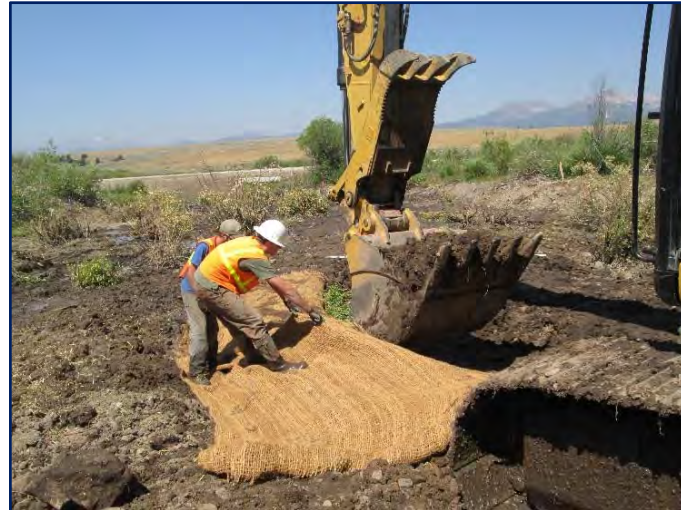
Crews install a bioengineered streambank in Reach 1

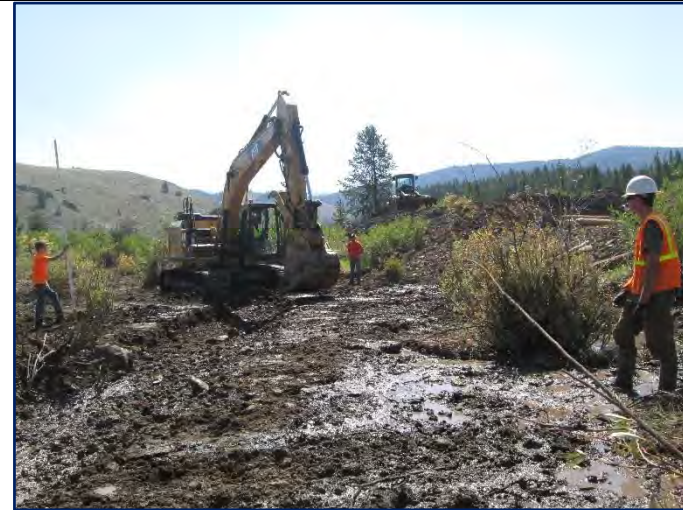
Reach 1 channel construction, showing drier floodplain areas higher in the reach (left) and where groundwater was captured (right).

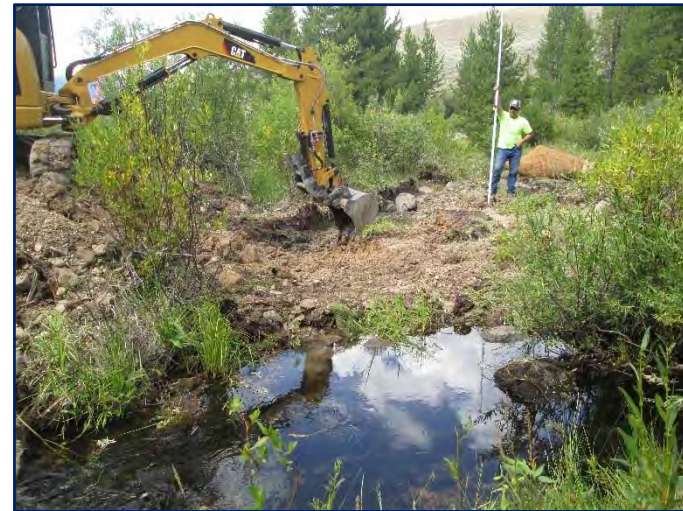
Channel construction at the top of Reach 1 (left) where new channel was tied into existing stream (right).

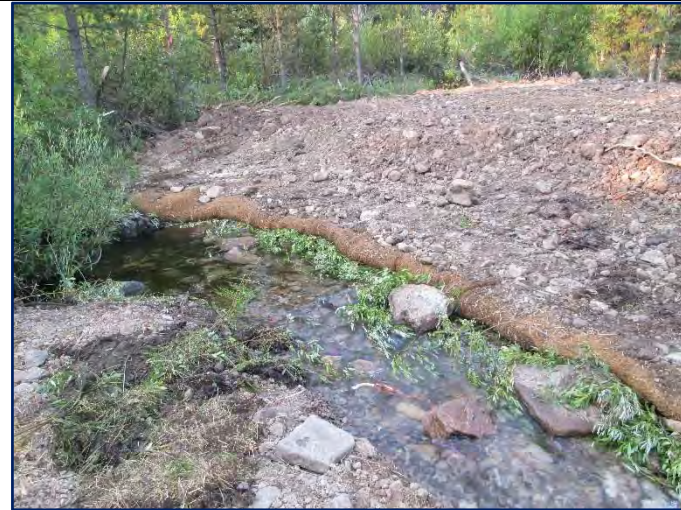
Same location where new channel was tied into existing stream. Earthen plug installed to prevent stream from returning to old channel

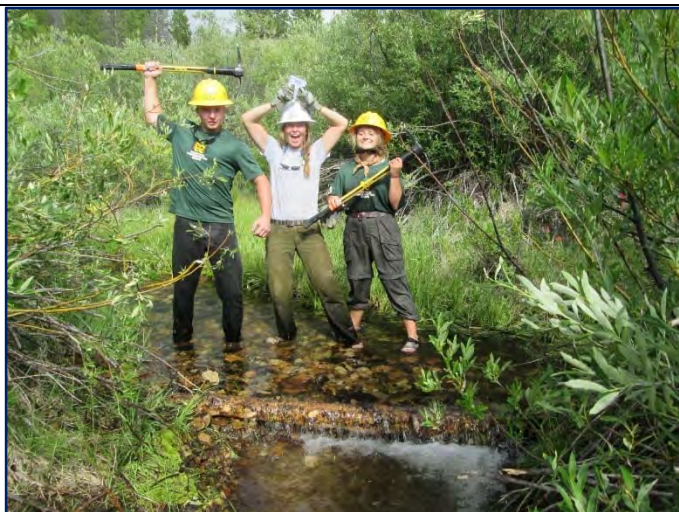
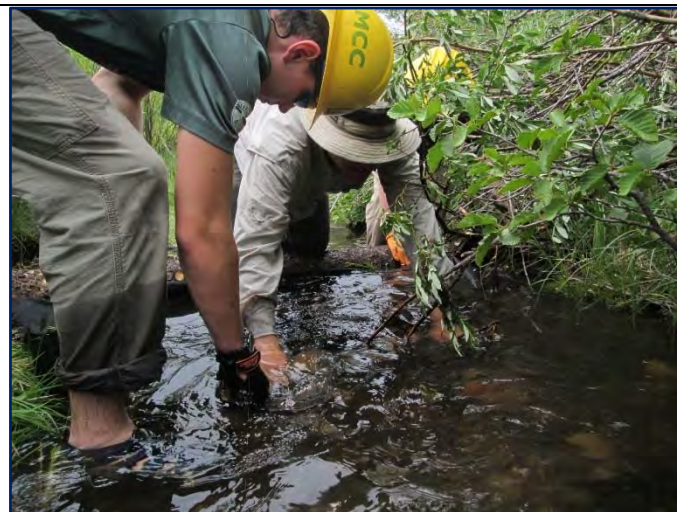
MFWP and Montana Conservation Corps constructed 48 fish habitat structures in June, 2016 in less impaired reaches where no mechanization was present. Structures were constructed with logs harvested on site

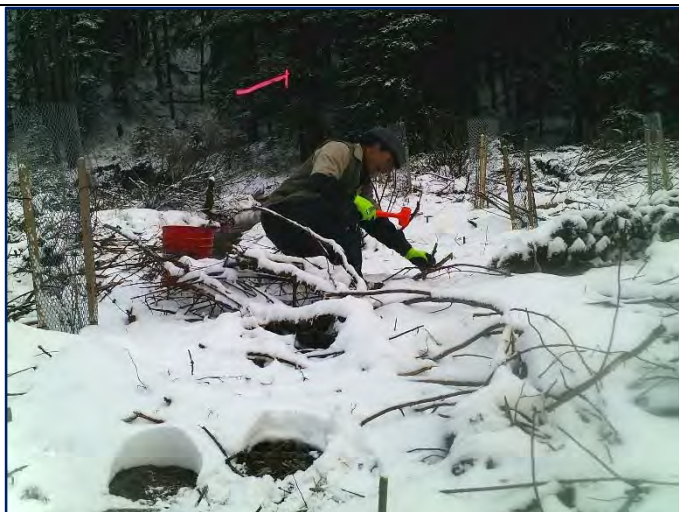
Contractors install willow stakes along riparian area of new channel- October, 2016

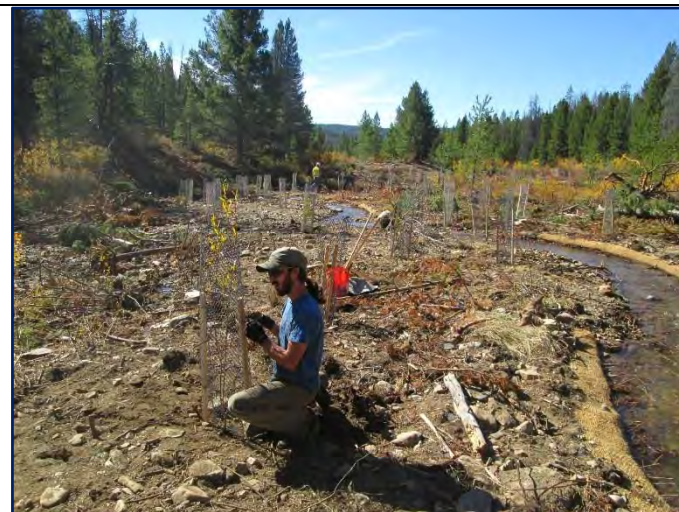
Planted container stock being protected from browse in Reach 2- September, 2016

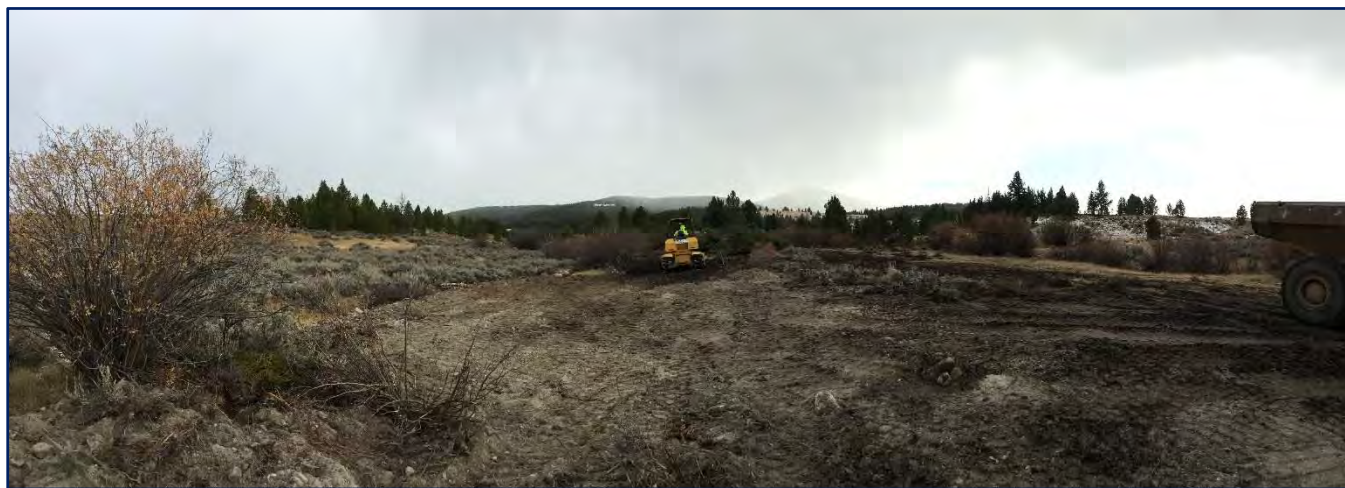
Channel construction in Moose Creek in progress, October, 2016

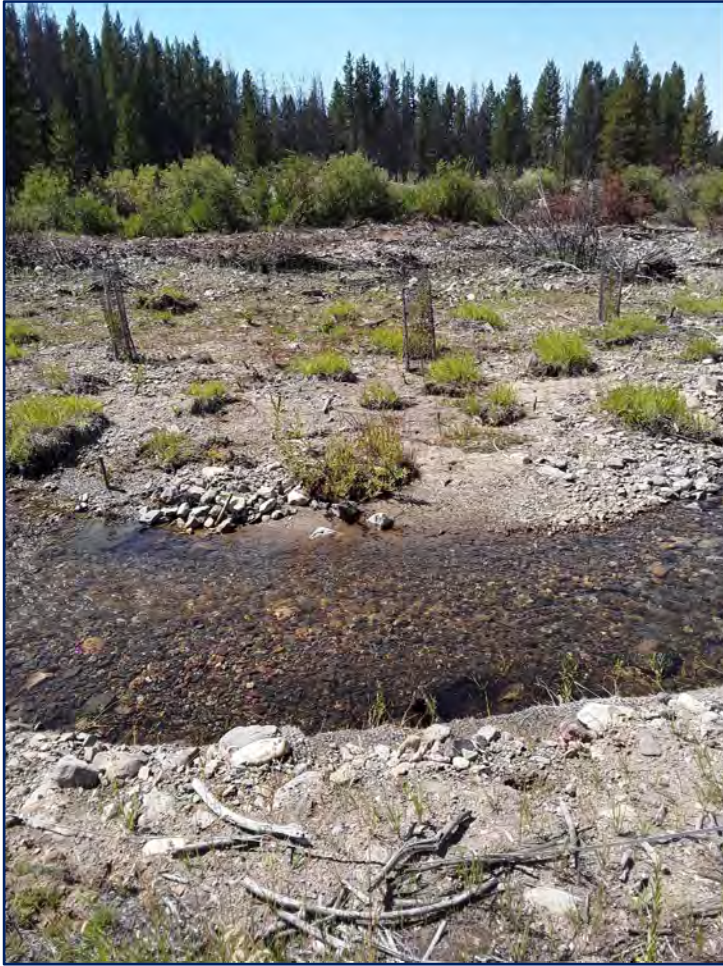
Point bar and floodplain inundation area clearly developing by mid-August, 2017

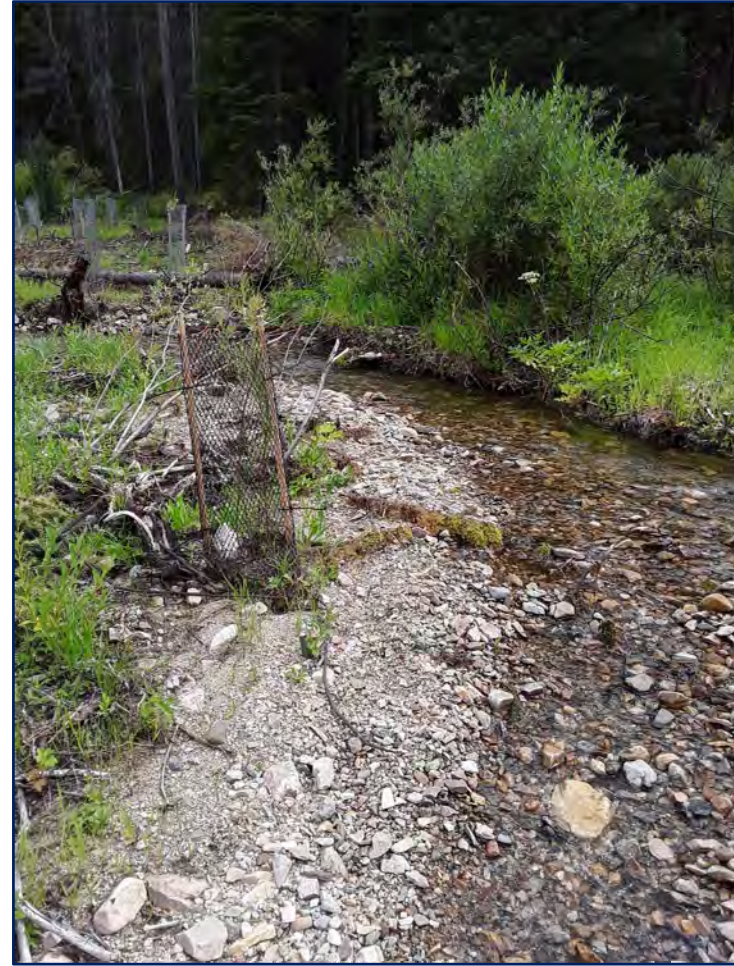
Point bar formation in mid-August, 2017 on constructed channel in Reach 2

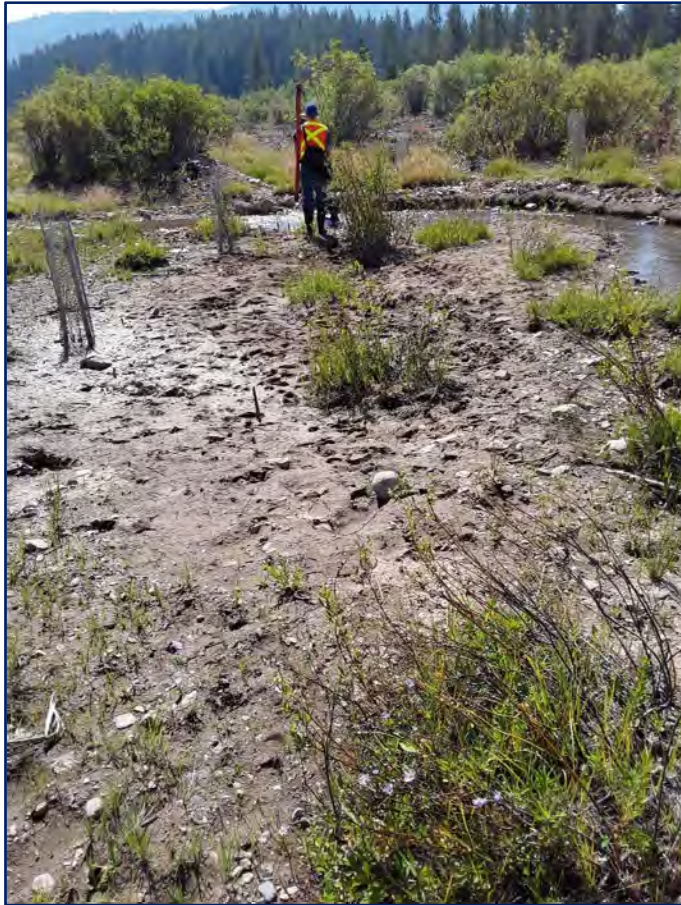
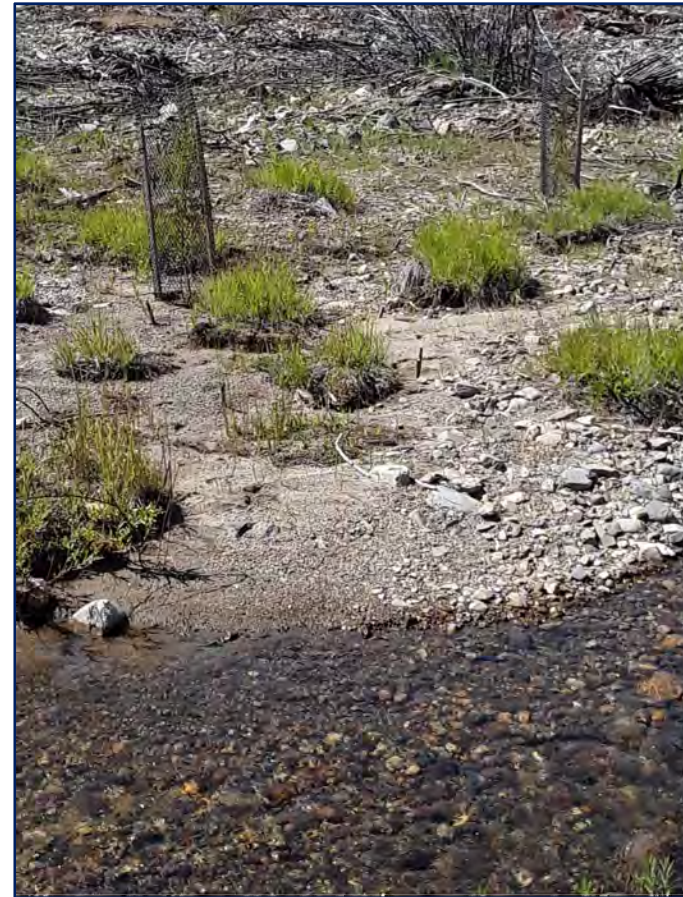
New sediment deposition on inside meander bend, August, 2017 in Reach 1 demonstrate connection between floodplain and stream channel, point bar formation and positive vegetation response. Also noteworthy is decreasing substrate size as channel loses energy

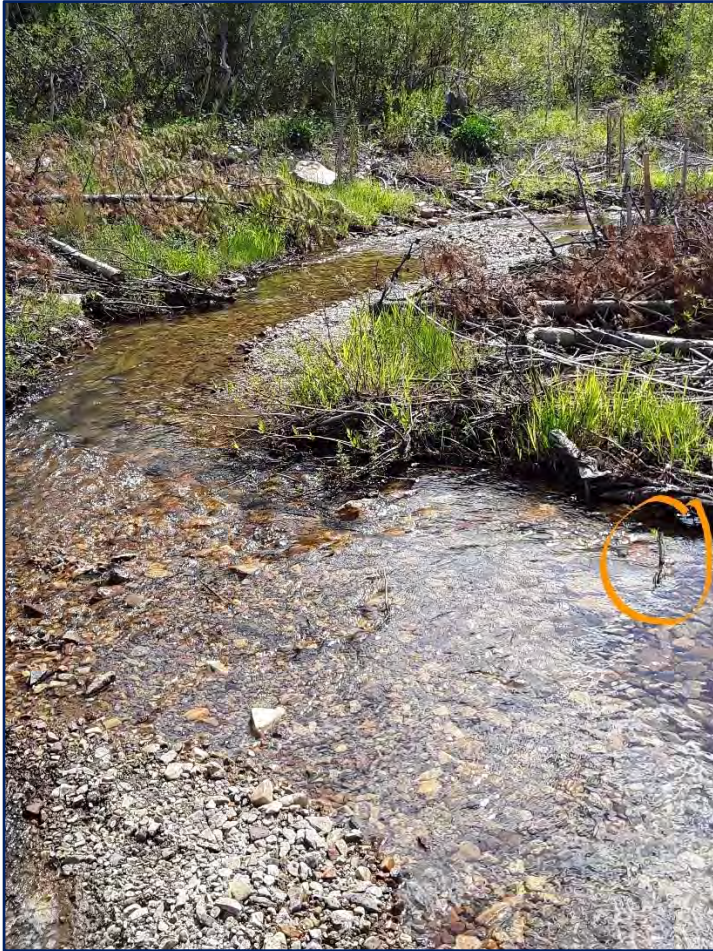
Reach 3 constructed channel section shown in August, 2017 photo. Willow stake in the circle had been planted on a bank, demonstrating channel deformity occurring, as planned

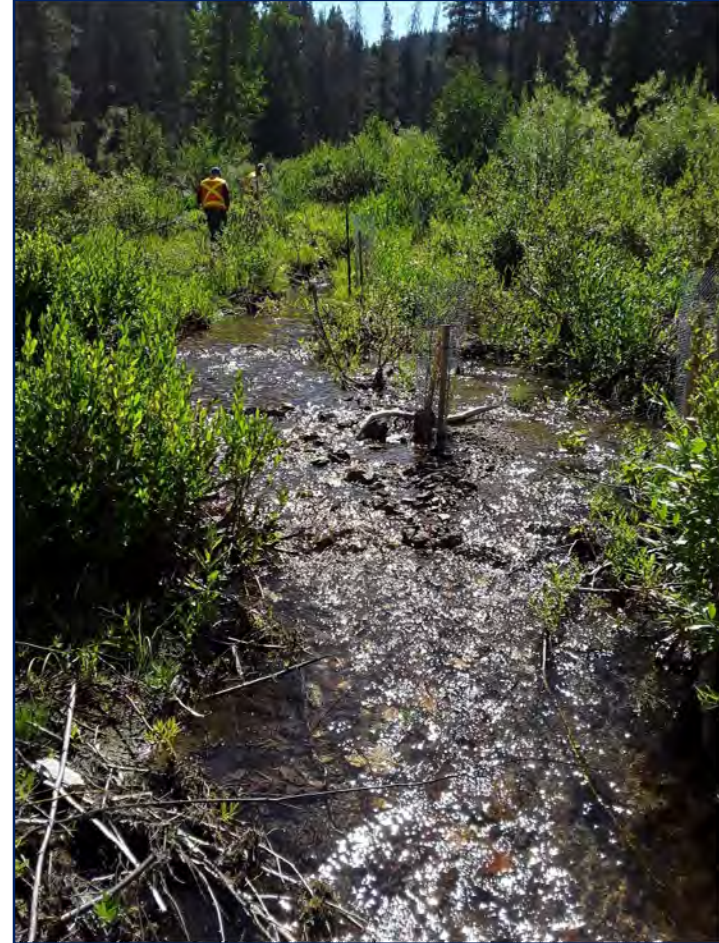
Reach 5 constructed channel showing stream movement onto the floodplain in August, 2017 image. Netted plants denote location of constructed bank in 2016

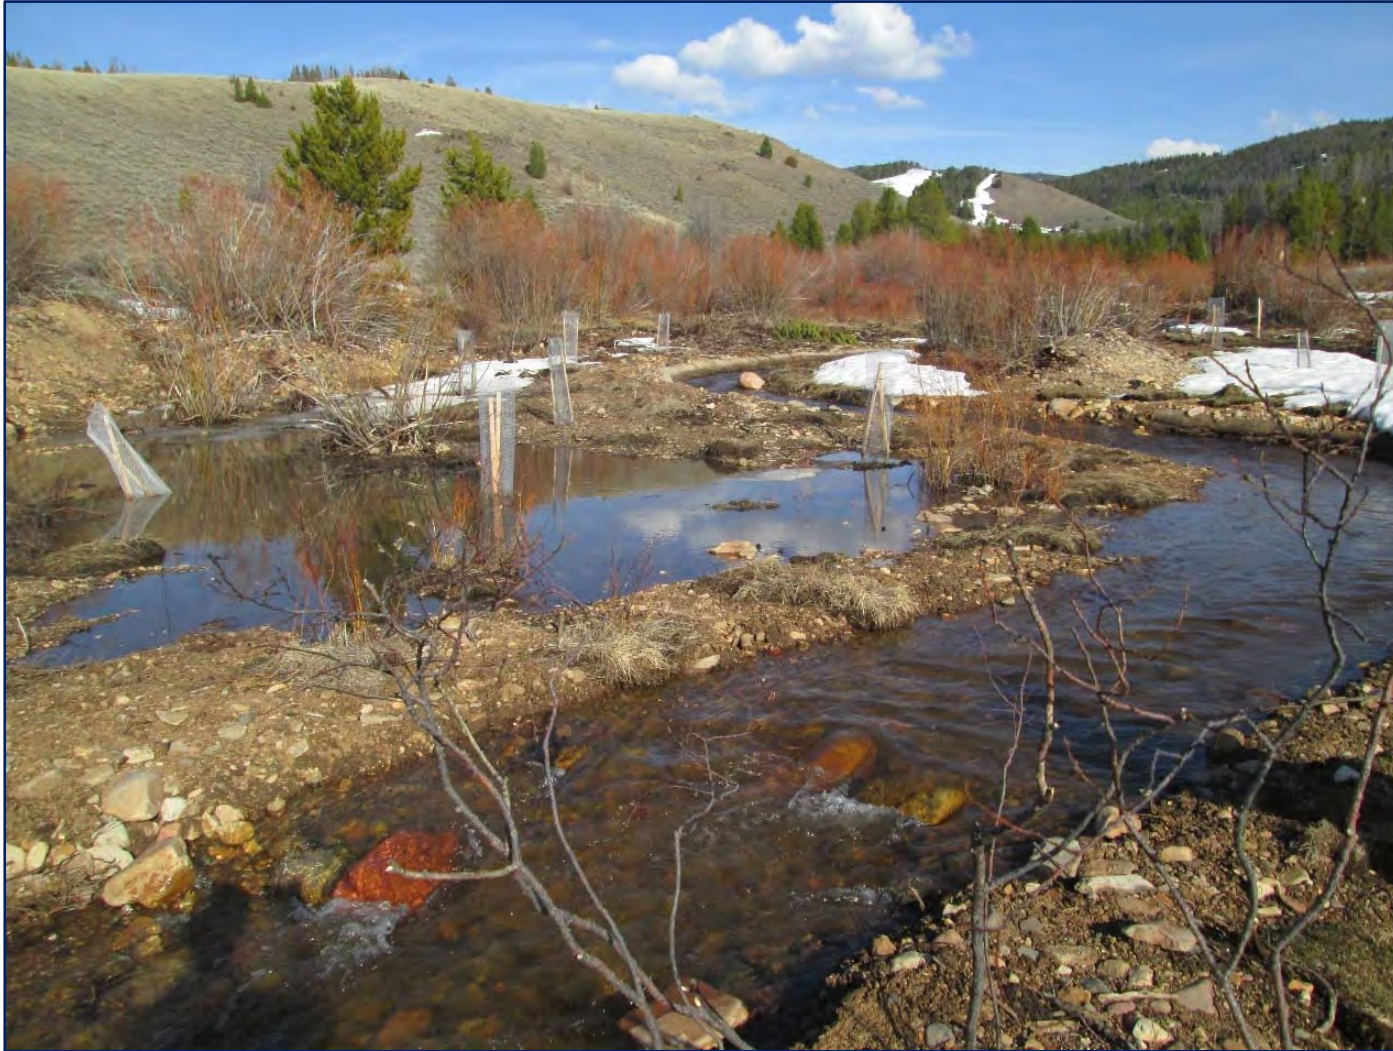
Example of an inundation feature constructed in the floodplain functioning as designed in this image from May, 2017

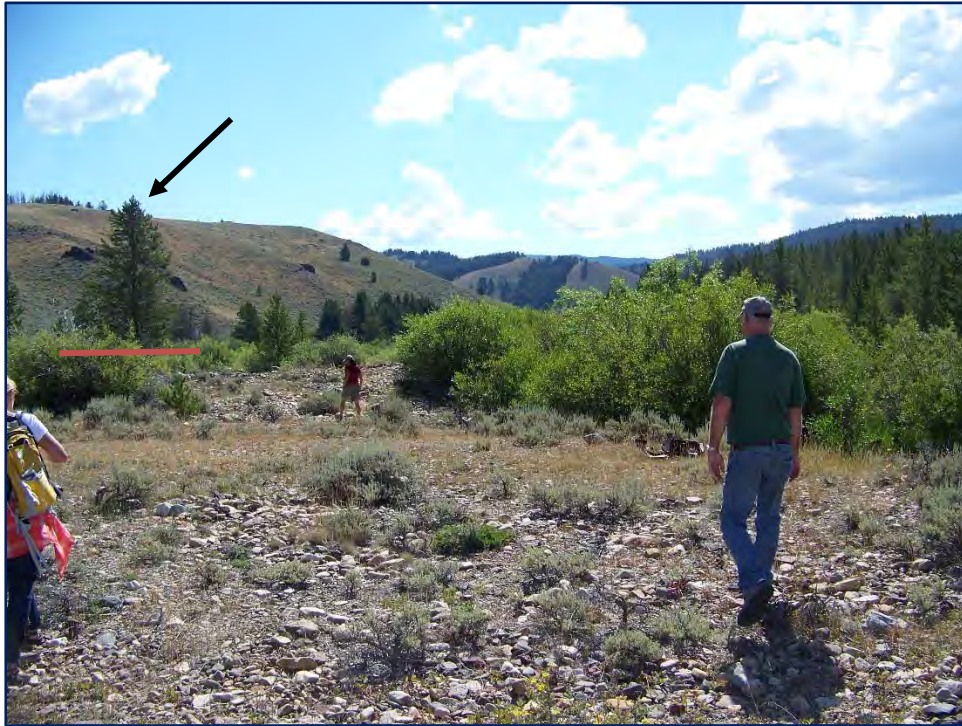
Pre-construction conditions in Reach 1, July, 2015 – tree and red line show ground level at top of placer tailings before construction

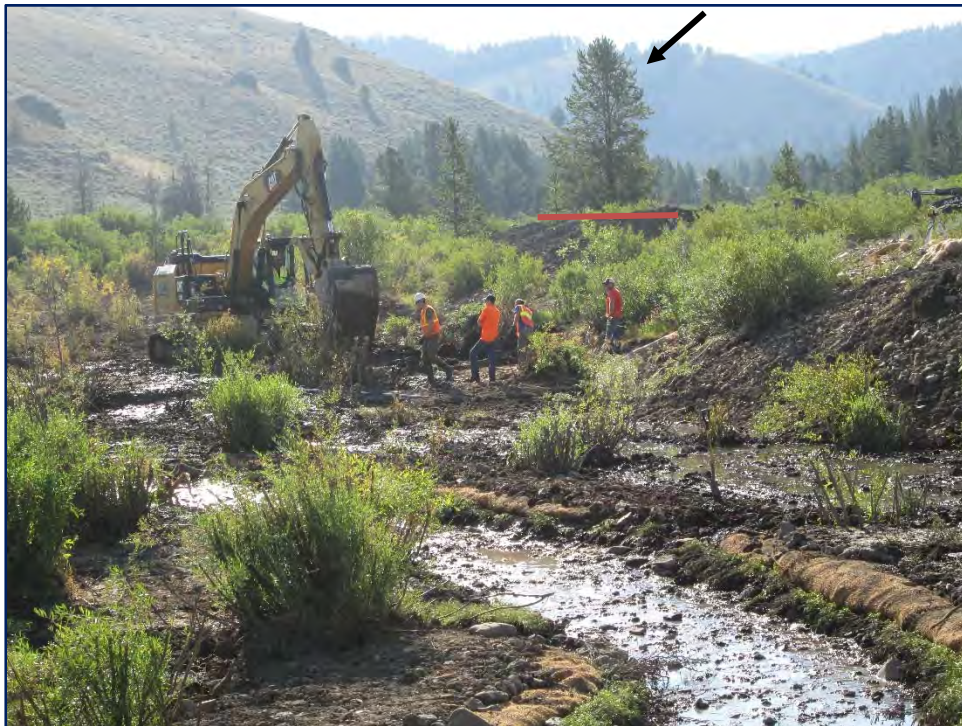
Beginning of floodplain construction and placer tailing removal, August, 2016

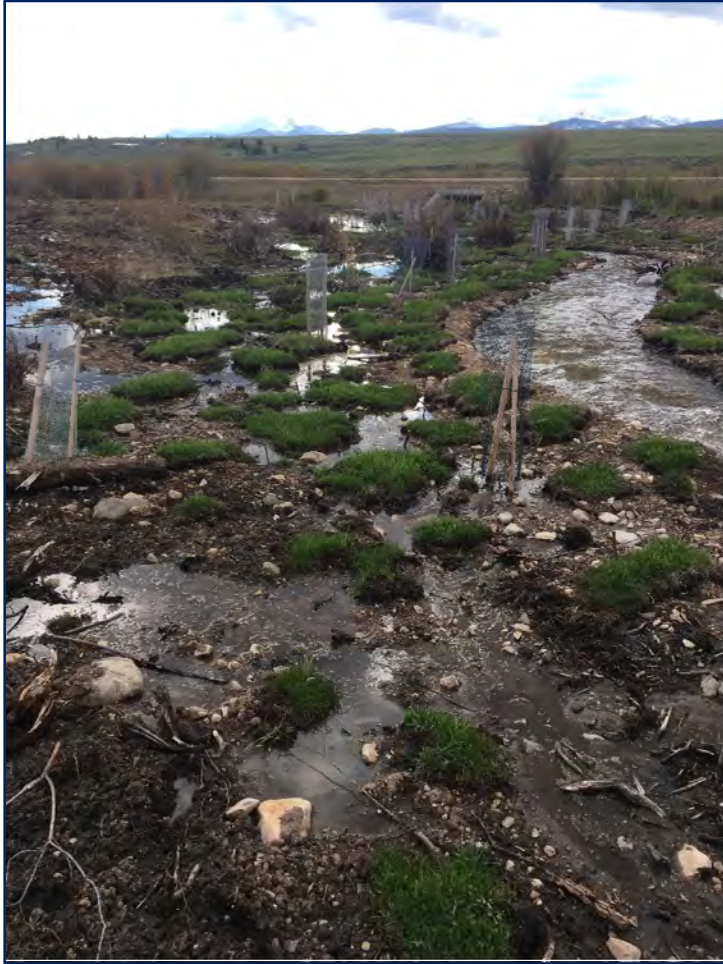
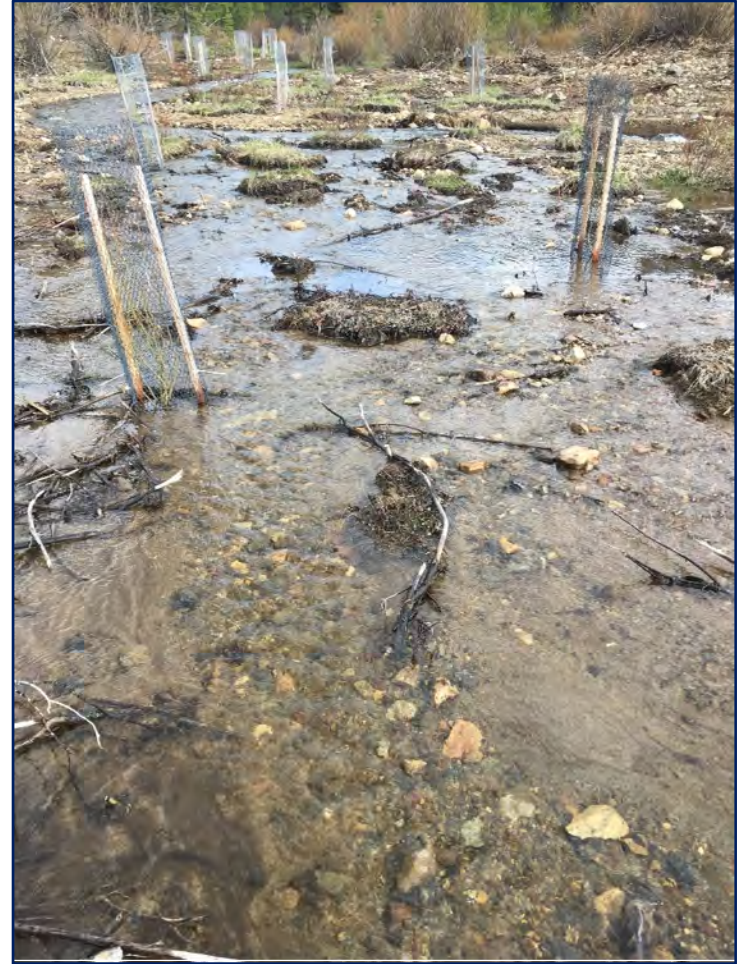
Reach 1 shown in May, 2017 with flowing water across the floodplain

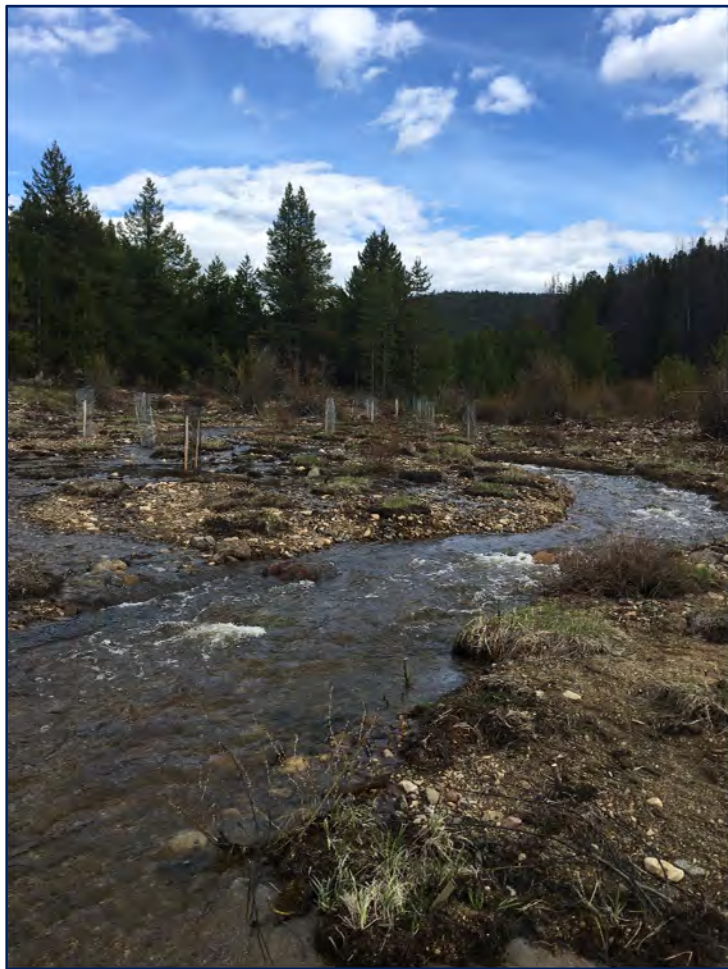
Upper section of Reach 1 in May 2017 showing active floodplain wetlands

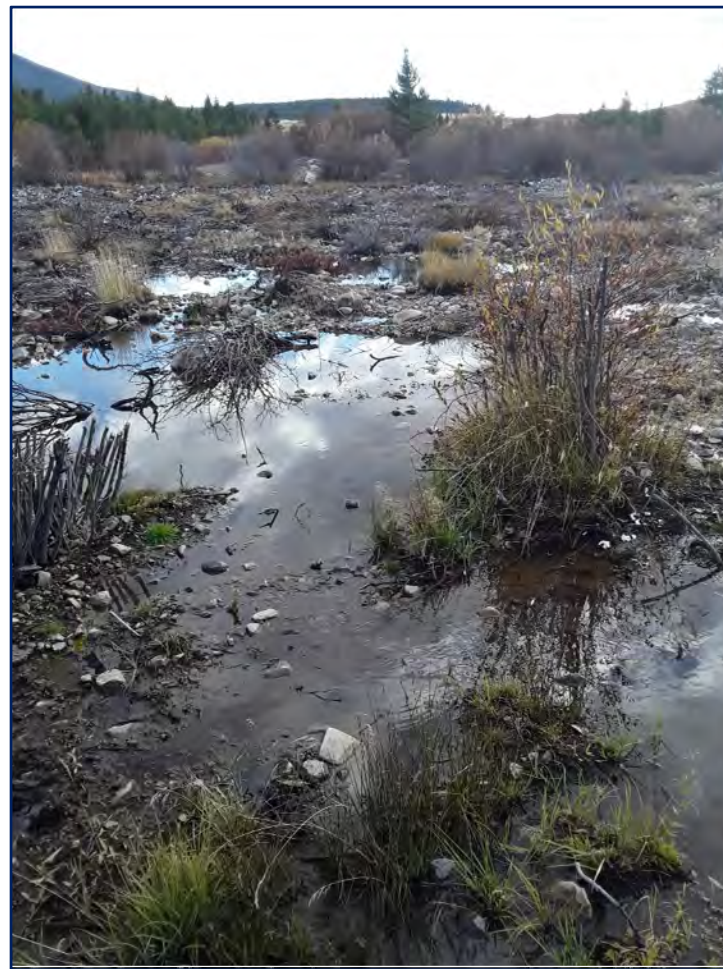
Reach 1 in October 2017, even late in the season, water is plentiful in lower section of the channel

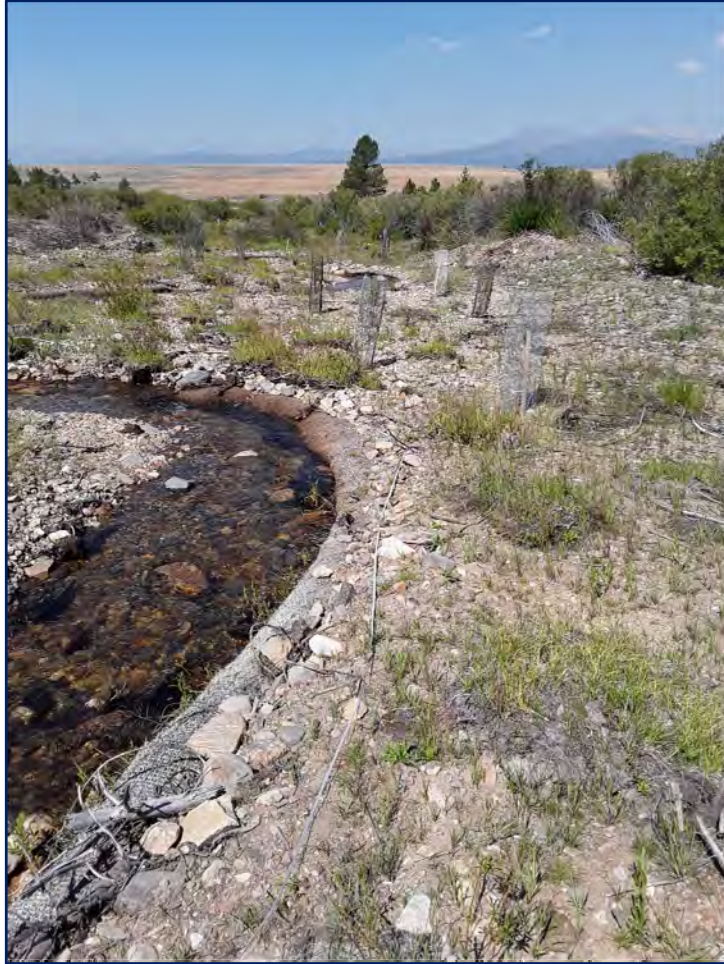
Transplanted sedge mats mostly all took and began recolonizing the site in this August, 2017 image

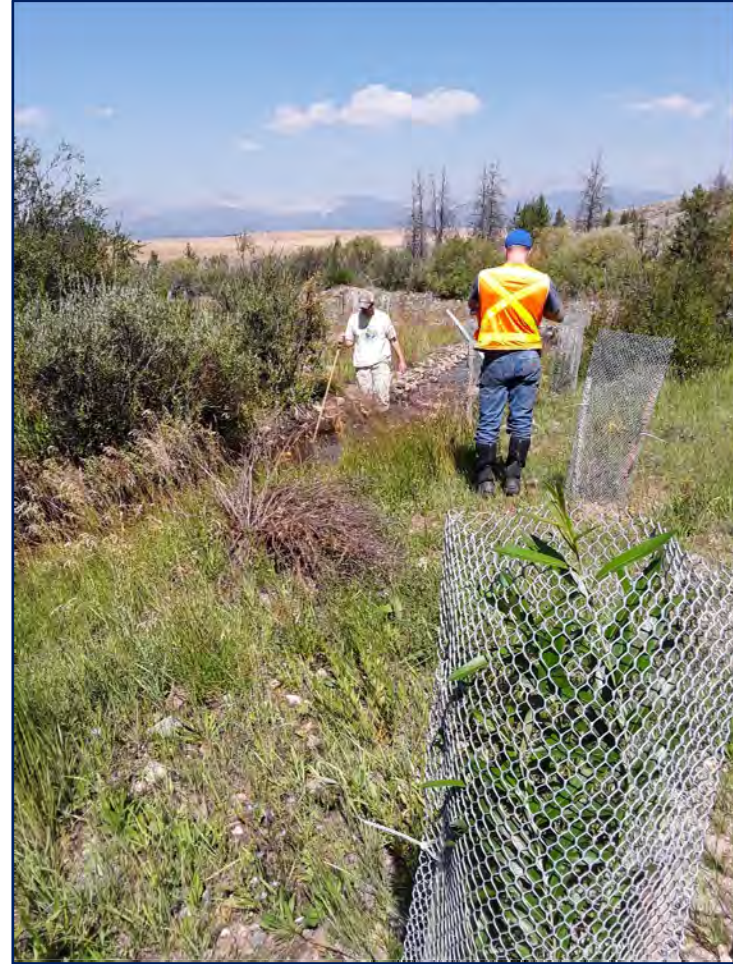
Planted willow thriving and nearly out of its plant protector in August, 2017

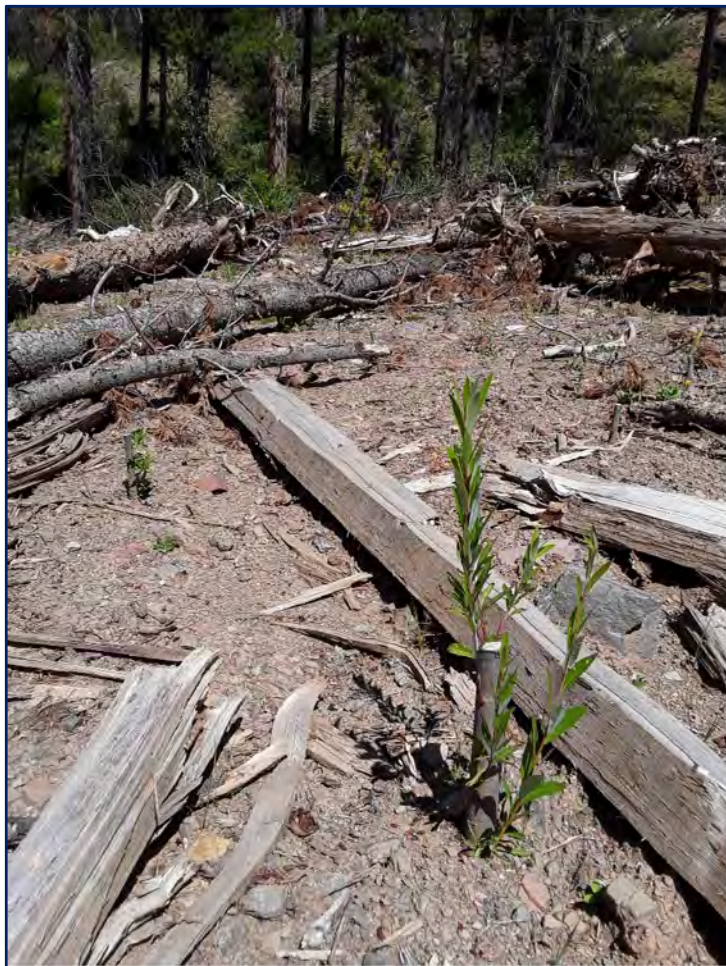
Good survival of willow stakes in the new floodplain seen in this August, 2017 image from Reach 4

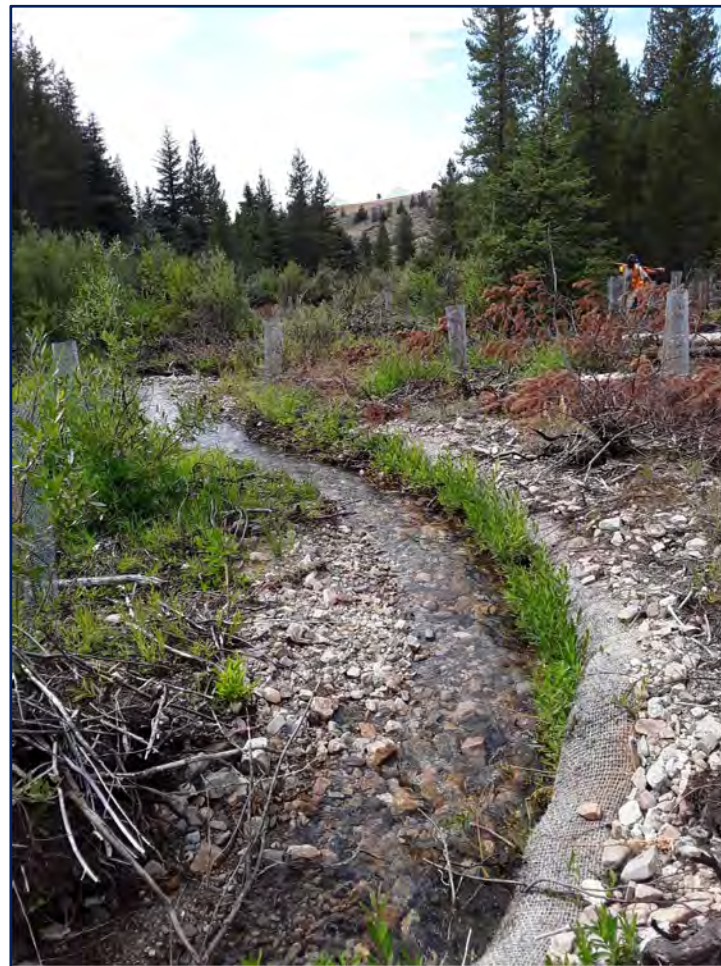
Good survival of willow whips on constructed banks from this August, 2017 image in Reach 5

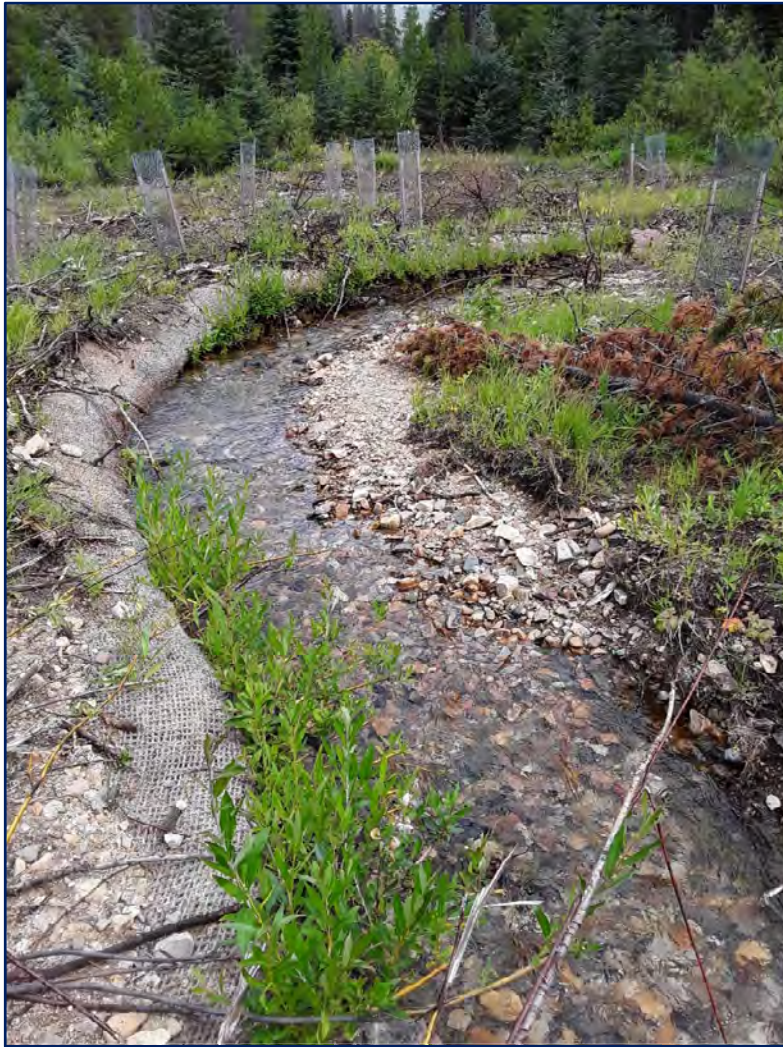
Good survival of willow whips on constructed bank and sedge mats on opposite bank

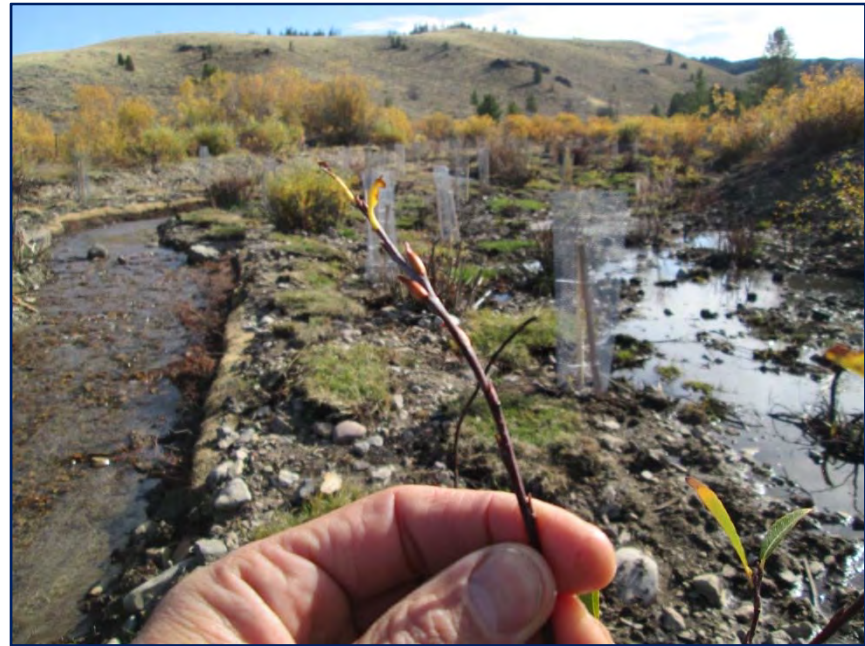
*Buds set for winter on transplanted willow, September, 2016.
Transplanted sod mats thriving in background*
