French Gulch and Moose Creek Restoration Project Final Report

February 2018

BIG HOLE
WATERSHED COMMITTEE
Conservation Through Consensus.

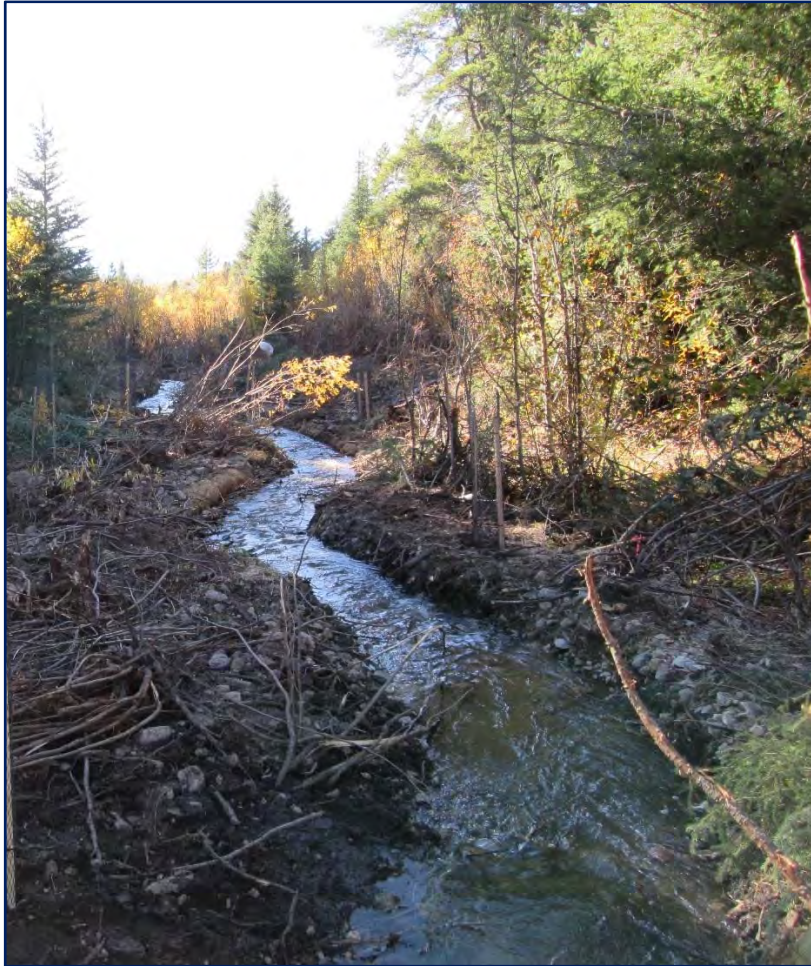
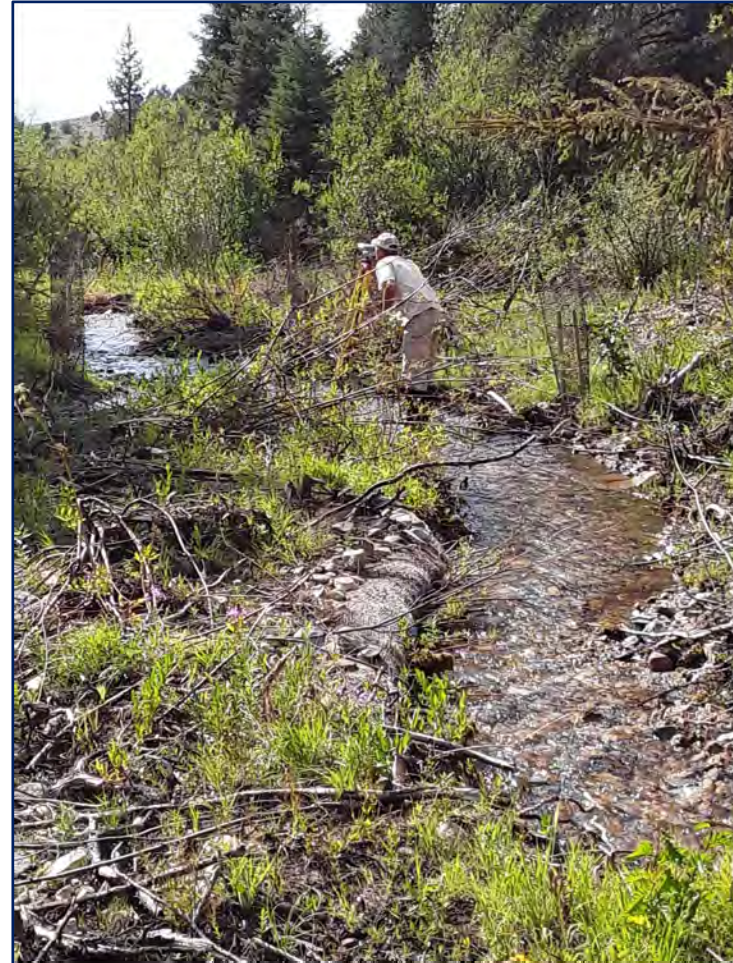
Reach 3 stream construction section just after construction in September 2016 (left) and in August 2017 (right)

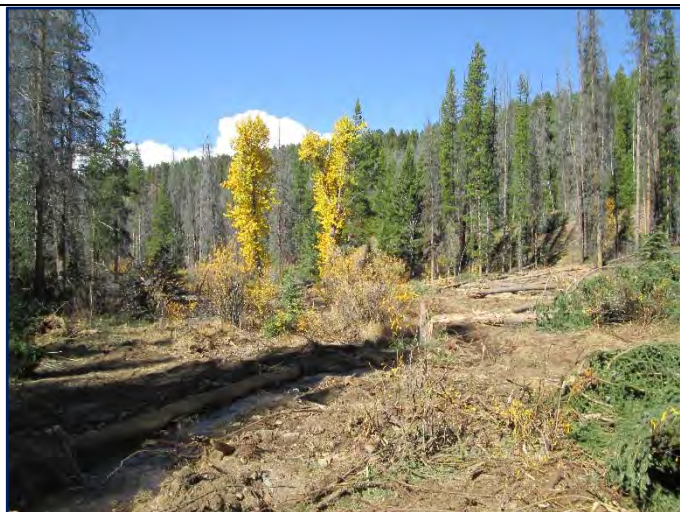
Reach 5 stream construction just after construction in September 2016 (left) and following planting in October 2016 (right)
