# Lower Wise River Water Resources Investigation

September 26, 2013

Big Hole River Watershed, Montana

Big Hole Watershed Committee

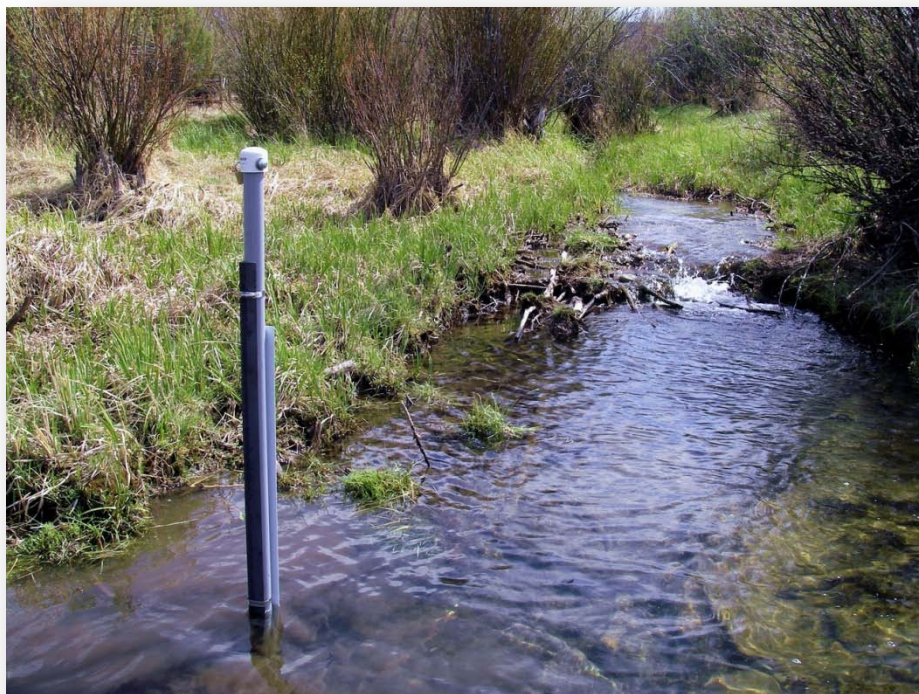
**Figure 1: TruTrack water level recorder installed in Smart Creek**

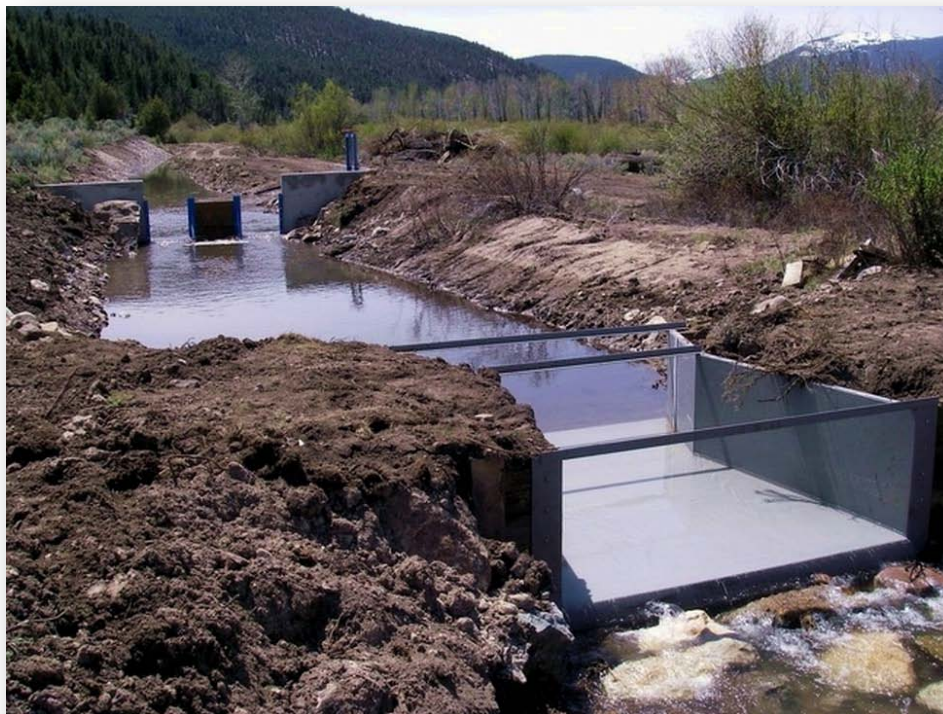
**Figure 14: Upper PKR Ditch improvements include a Cutthroat Flume and a screw-gate turnout at Swamp Creek. (photo by D. Amman)**
