ELKHORN MINE & MILL

2021 Site Characterization Report

Prepared for
Big Hole Watershed Committee
& US Forest Service Northern Region

Prepared by
WindenWater, LCC

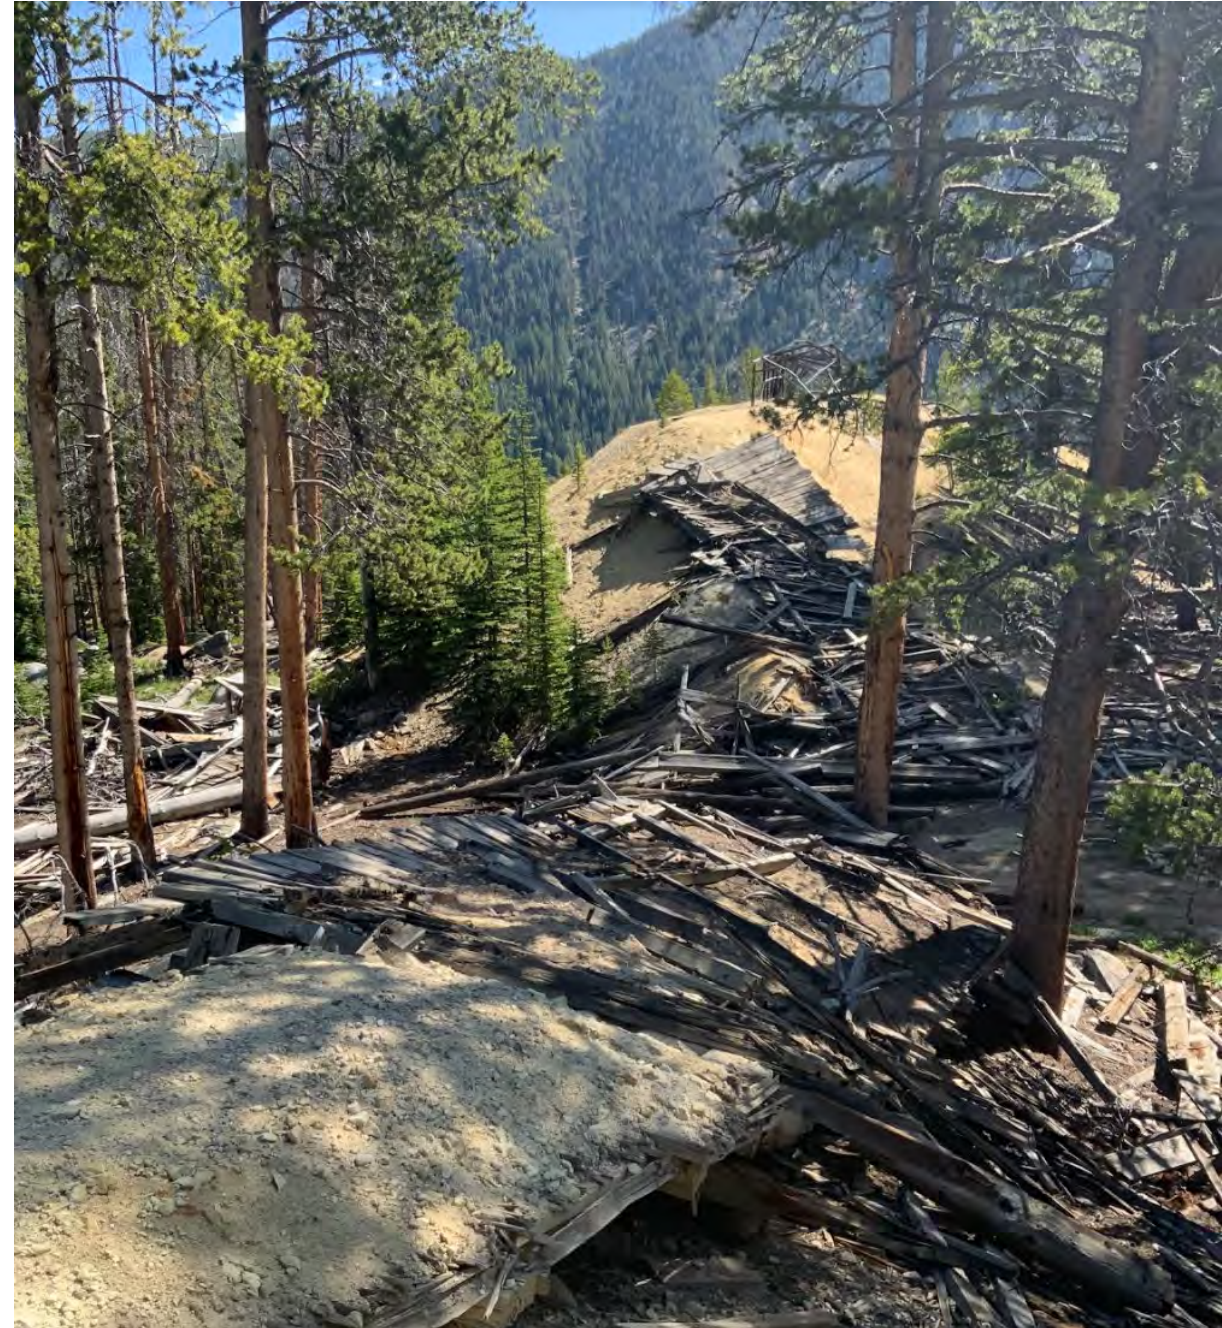
2021 WQ Sampling Locations

- 27 total sites
- 11 longitudinal Elkhorn sites
 - From upstream of mine → to confluence of Wise River
- 10 dispersed AMD sites
- 3 tributaries draining Park Mine complex
- 2 galvanized wells below waste rock pile

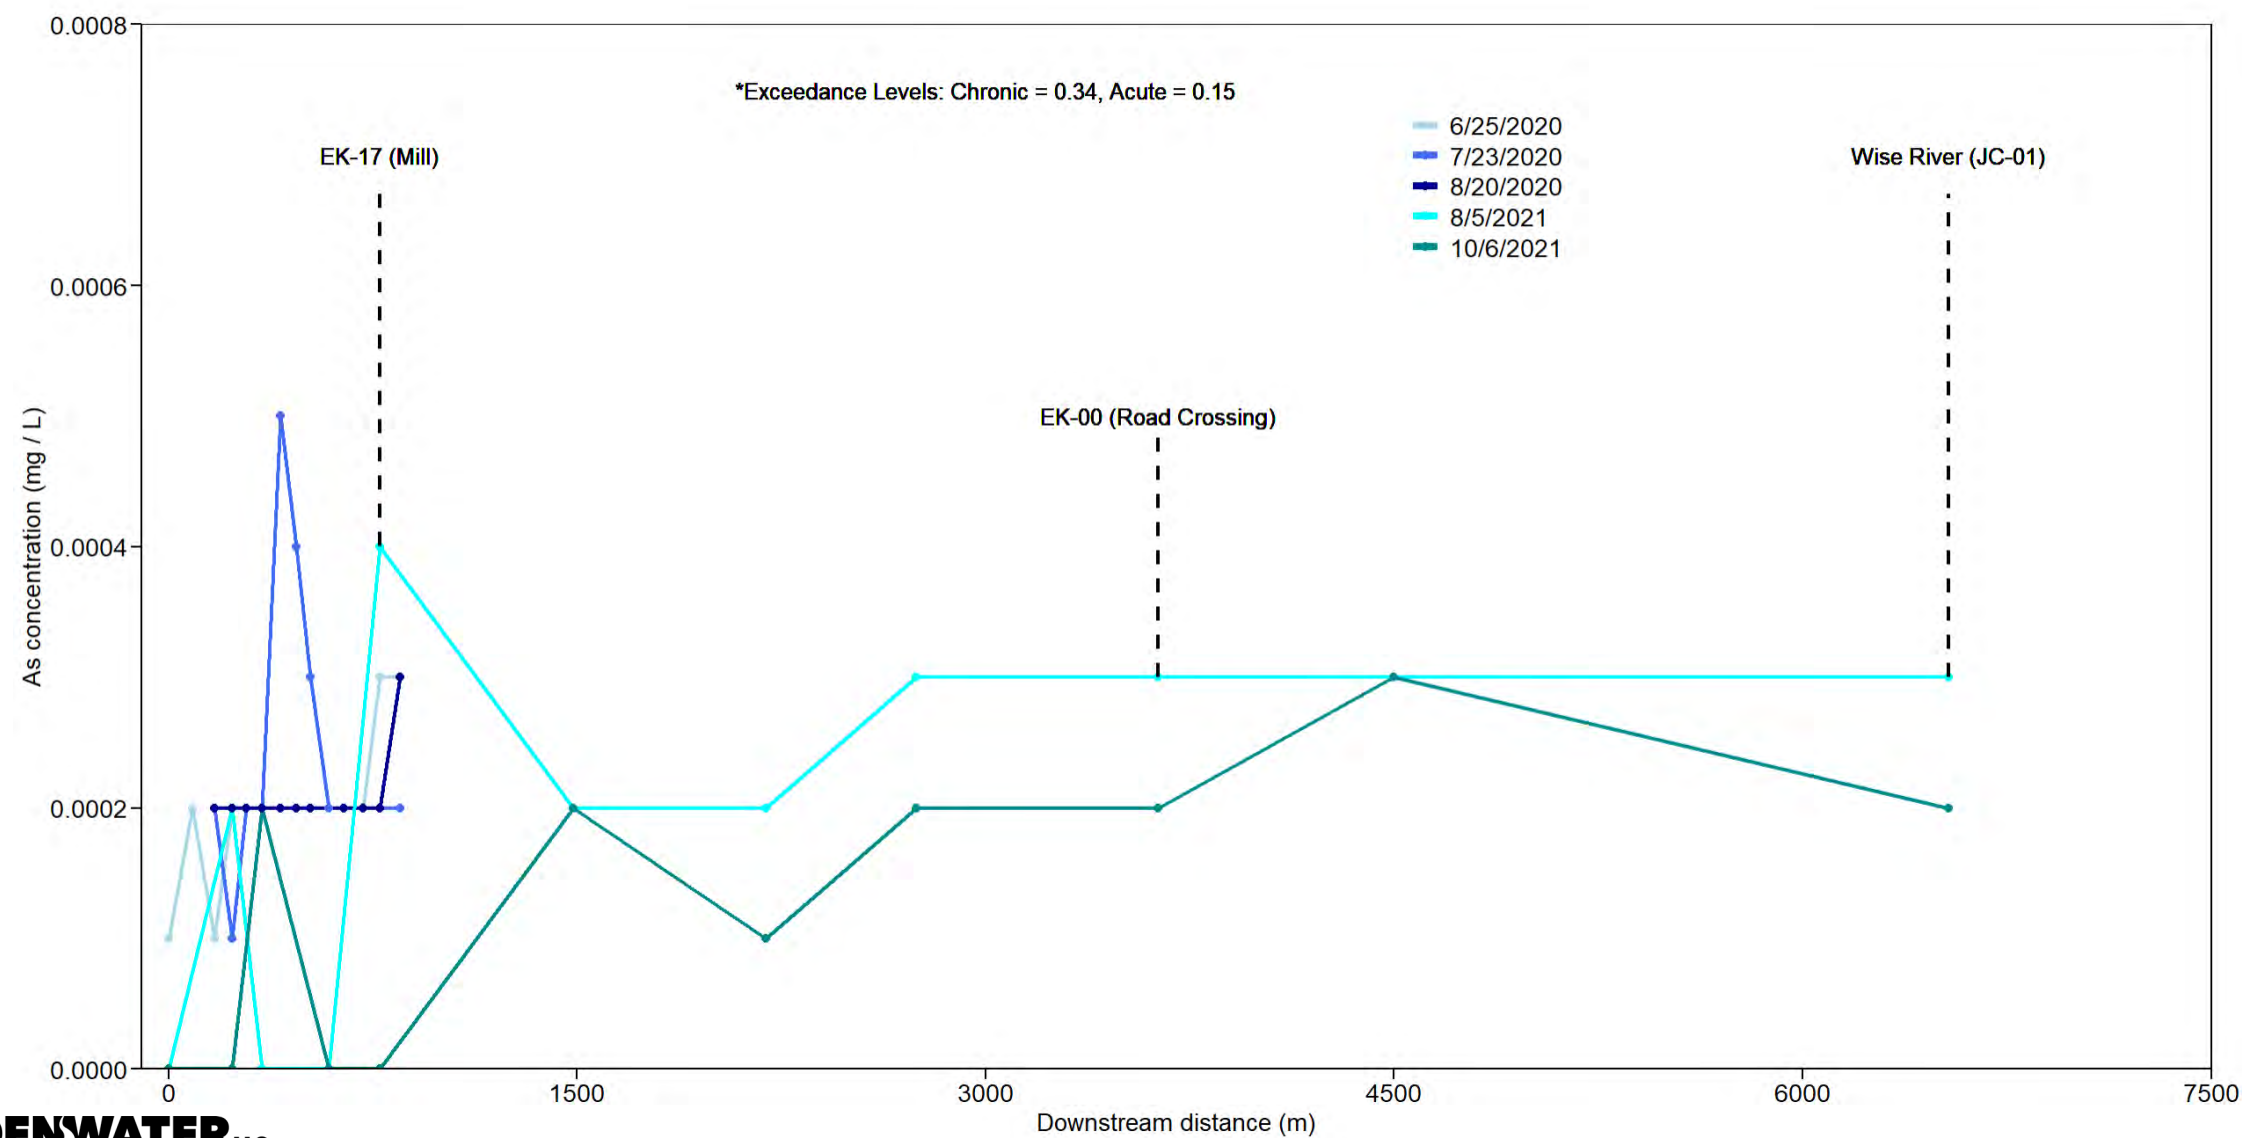
Longitudinal [As]

- Concentrations are **not** in exceedance of acute or chronic toxicity levels
- Measurable spikes in proximity of waste rock pile & Mill; muted in 2021 compared to 2020

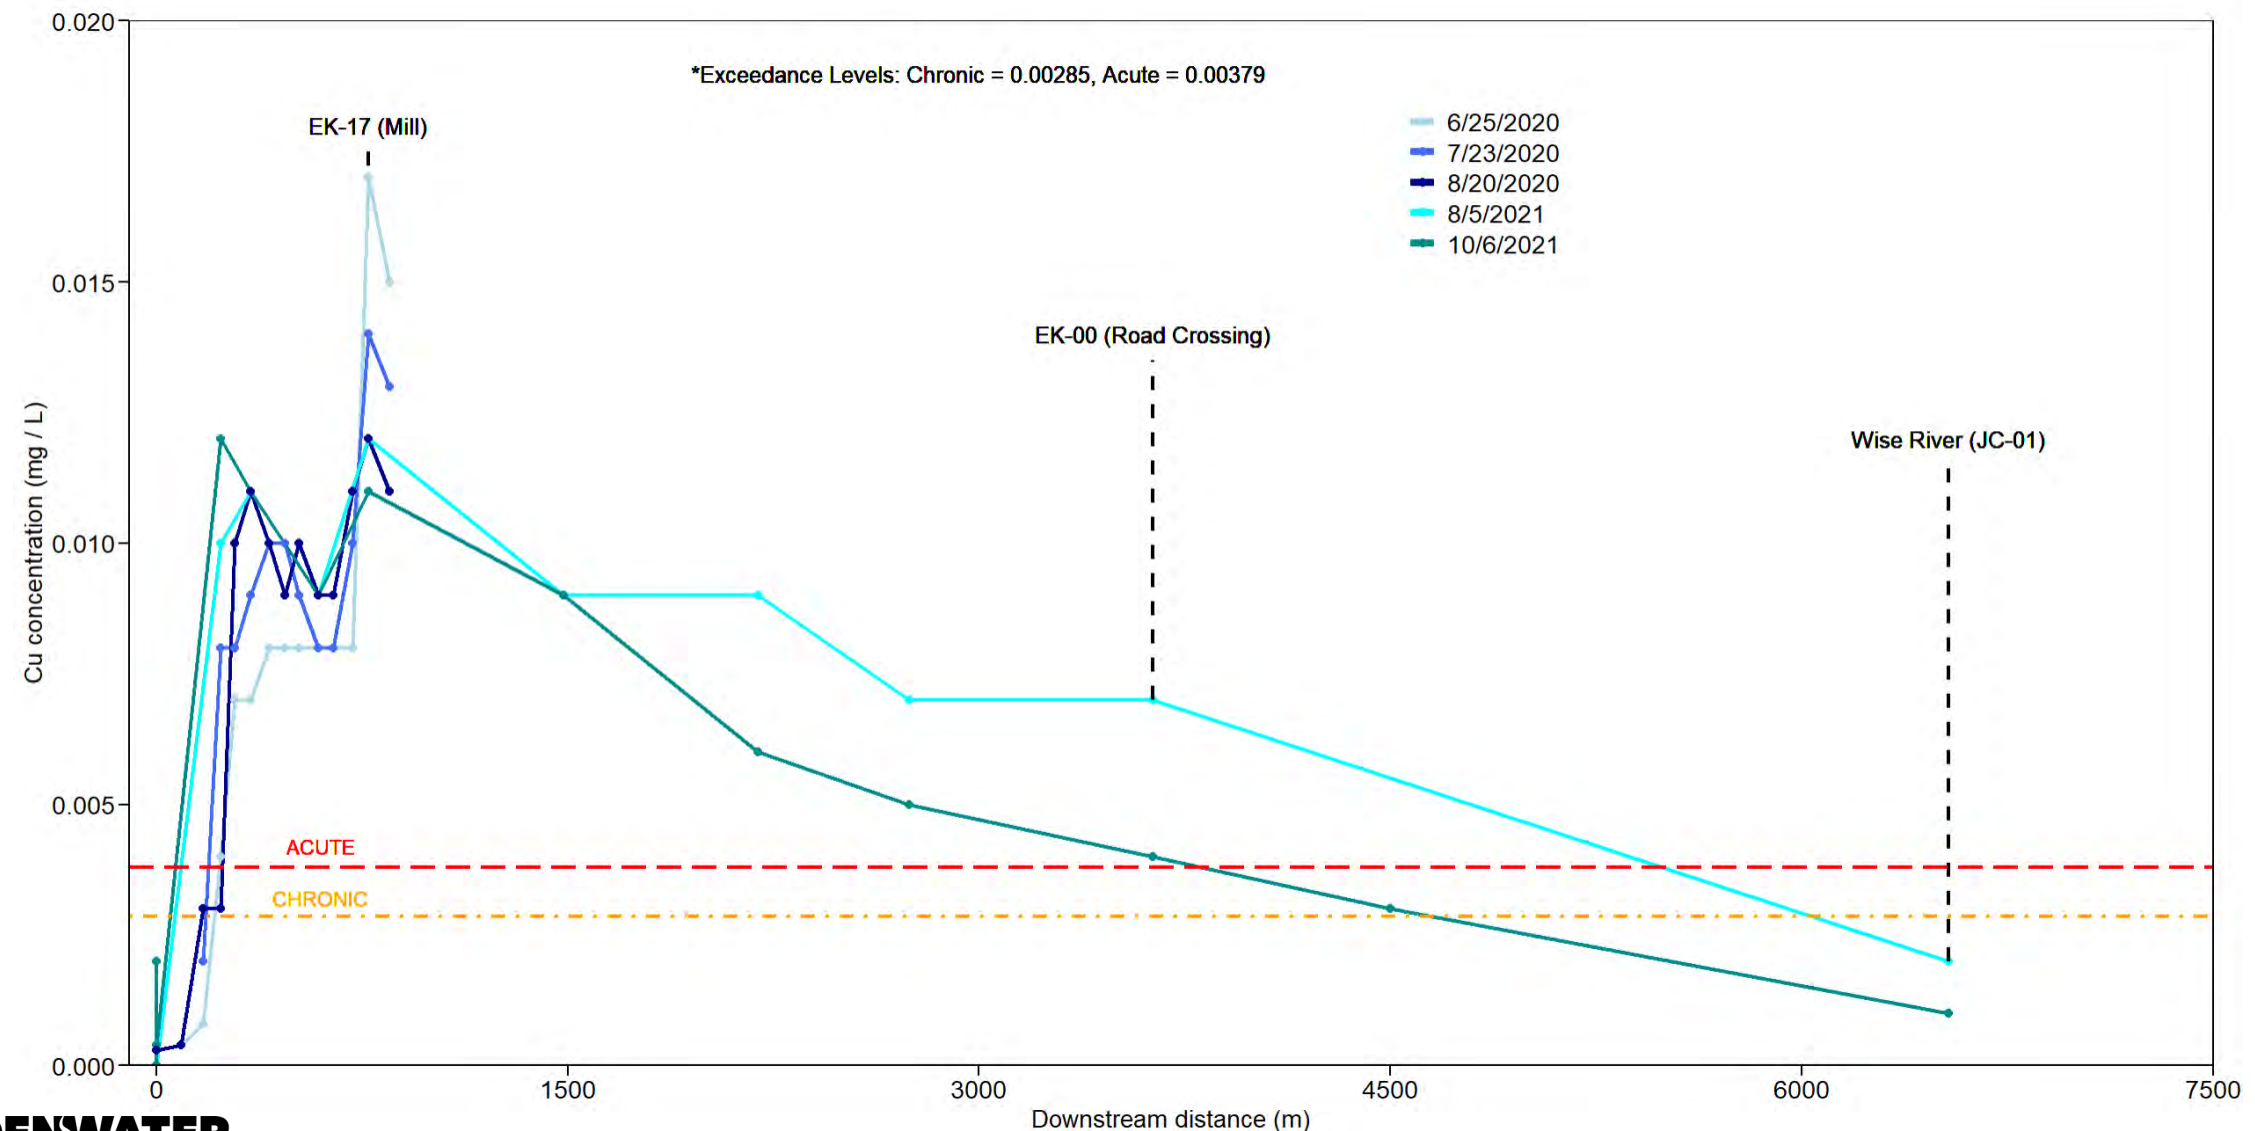
Longitudinal [Cu]

- Concentrations **exceed** acute & chronic toxicity levels from mine downstream to road crossing
- Apparent seasonal and annual variability likely due to runoff & snowpack

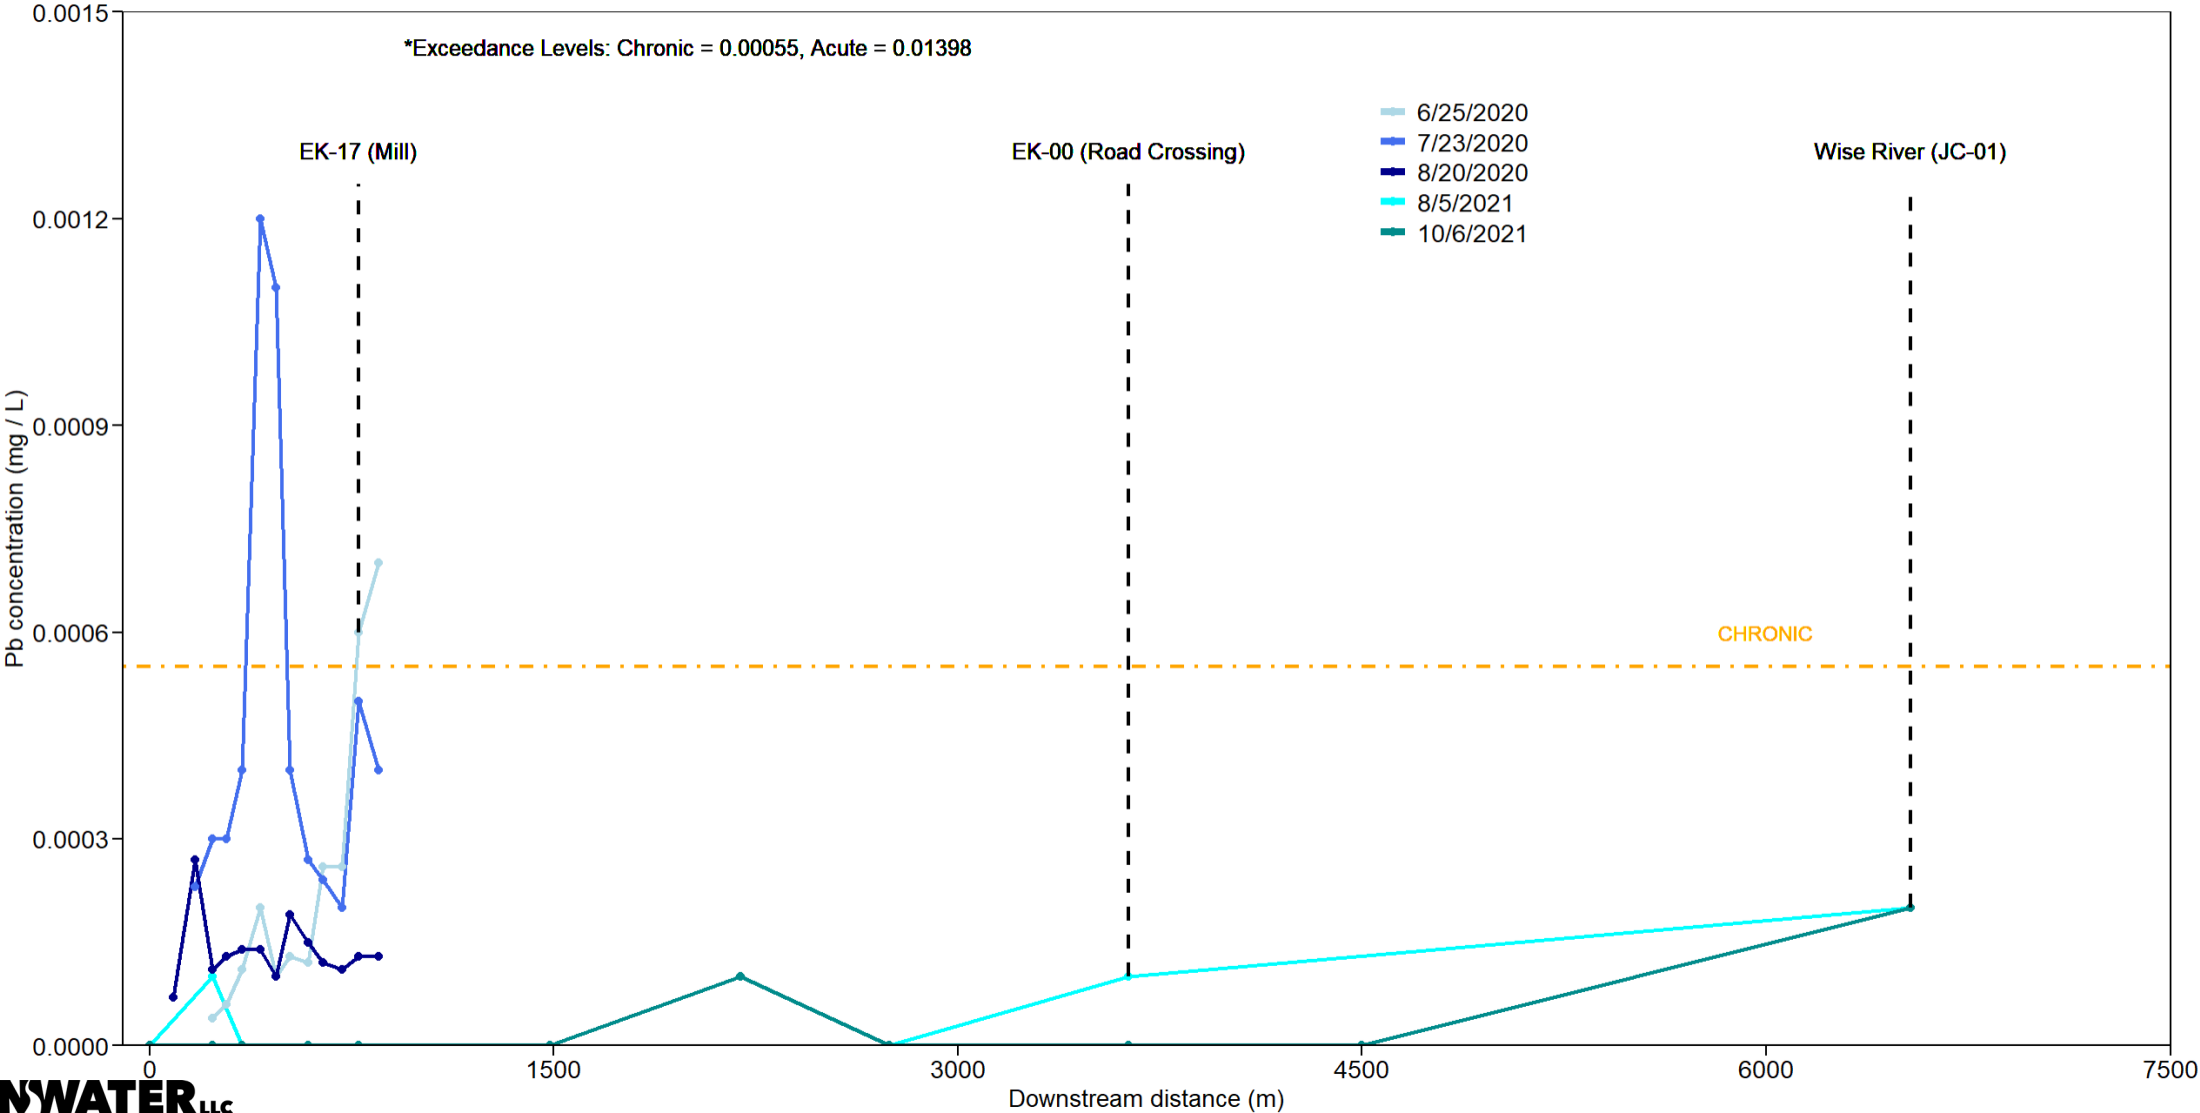
Longitudinal [Pb]

- Concentrations **did not** exceed chronic or acute toxicity levels in 2021
- Muted signal in 2021 compared to 2020; possibly related to drier waste rock pile conditions

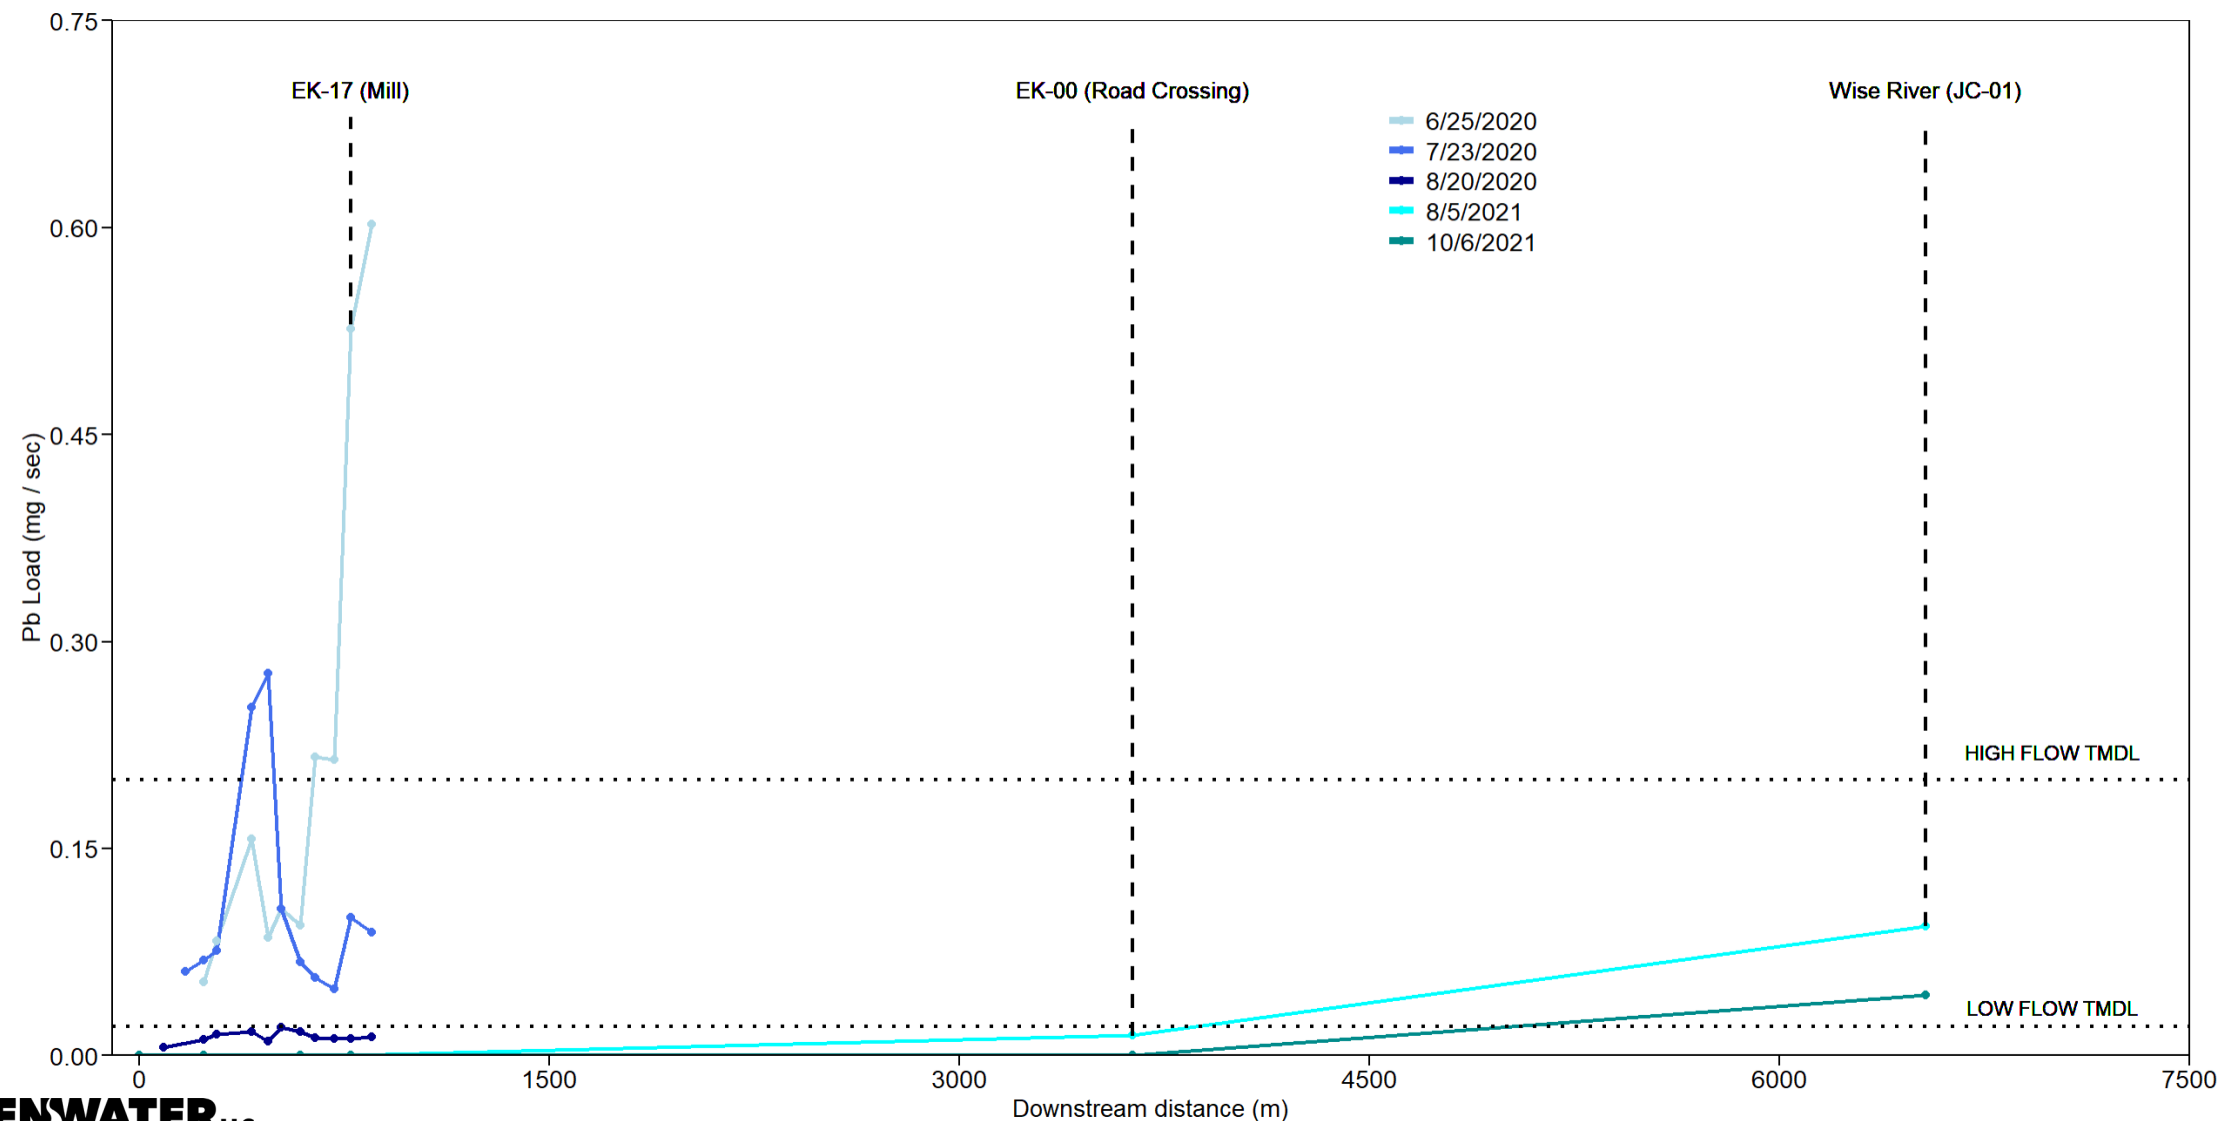
Pb Loading

- Usually **below** TMDL for all flows except very high flows
- Potential other source of Pb from Jacobson Creek

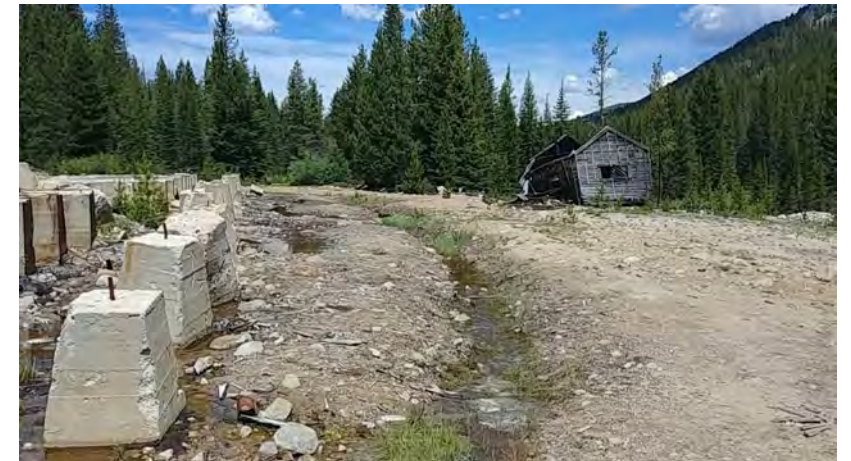
1000' Adit – 1996 to 2021

Gray = comparable

Yellow = slight discrepancy

Red = 2-3 orders of magnitude discrepancy

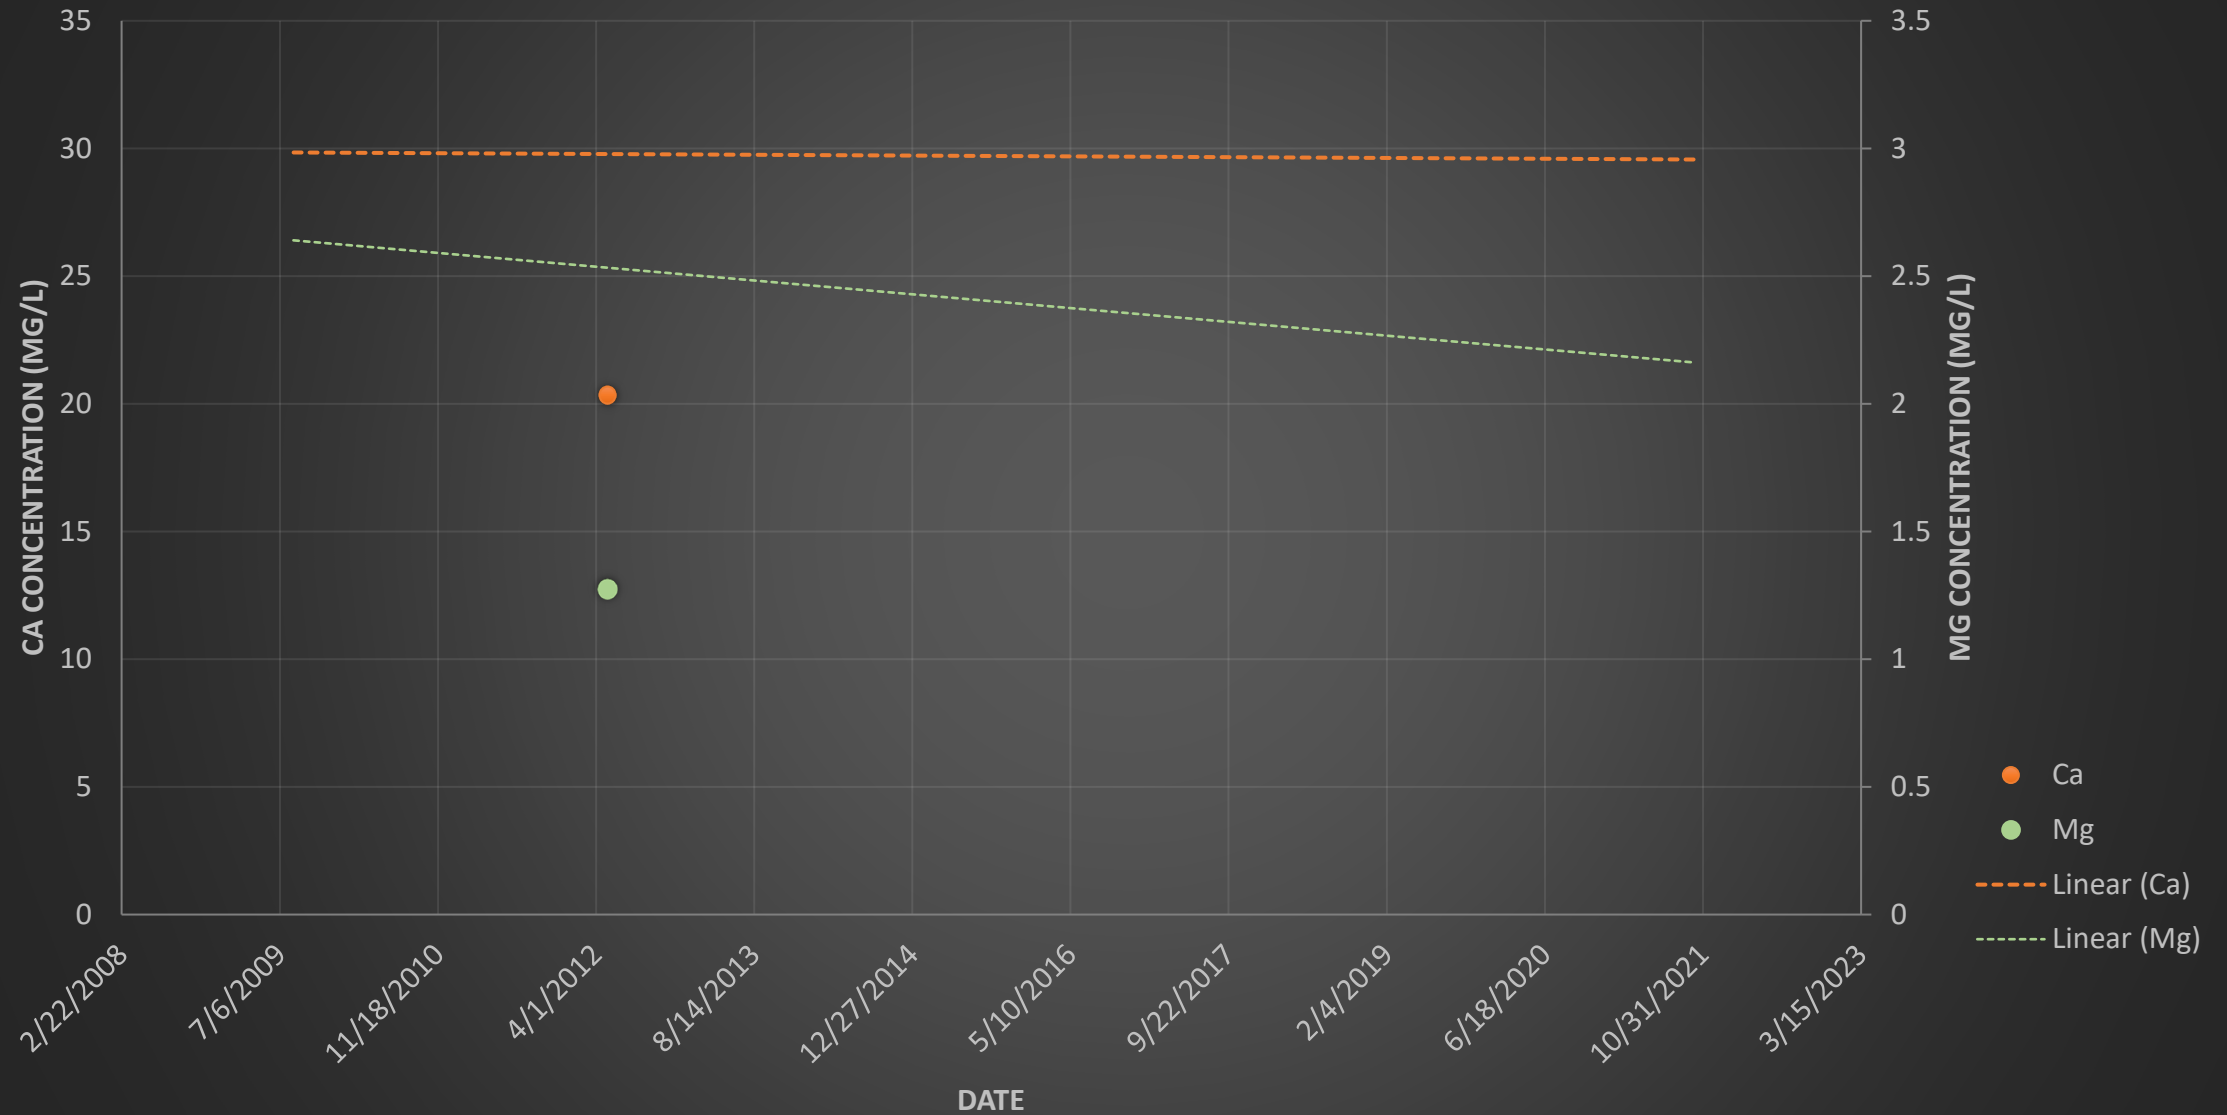
Conservation Ion Concentrations at the 1,000-level adit (2009-2021)

**Ca & Mg concentrations have been relatively stable since 2009*

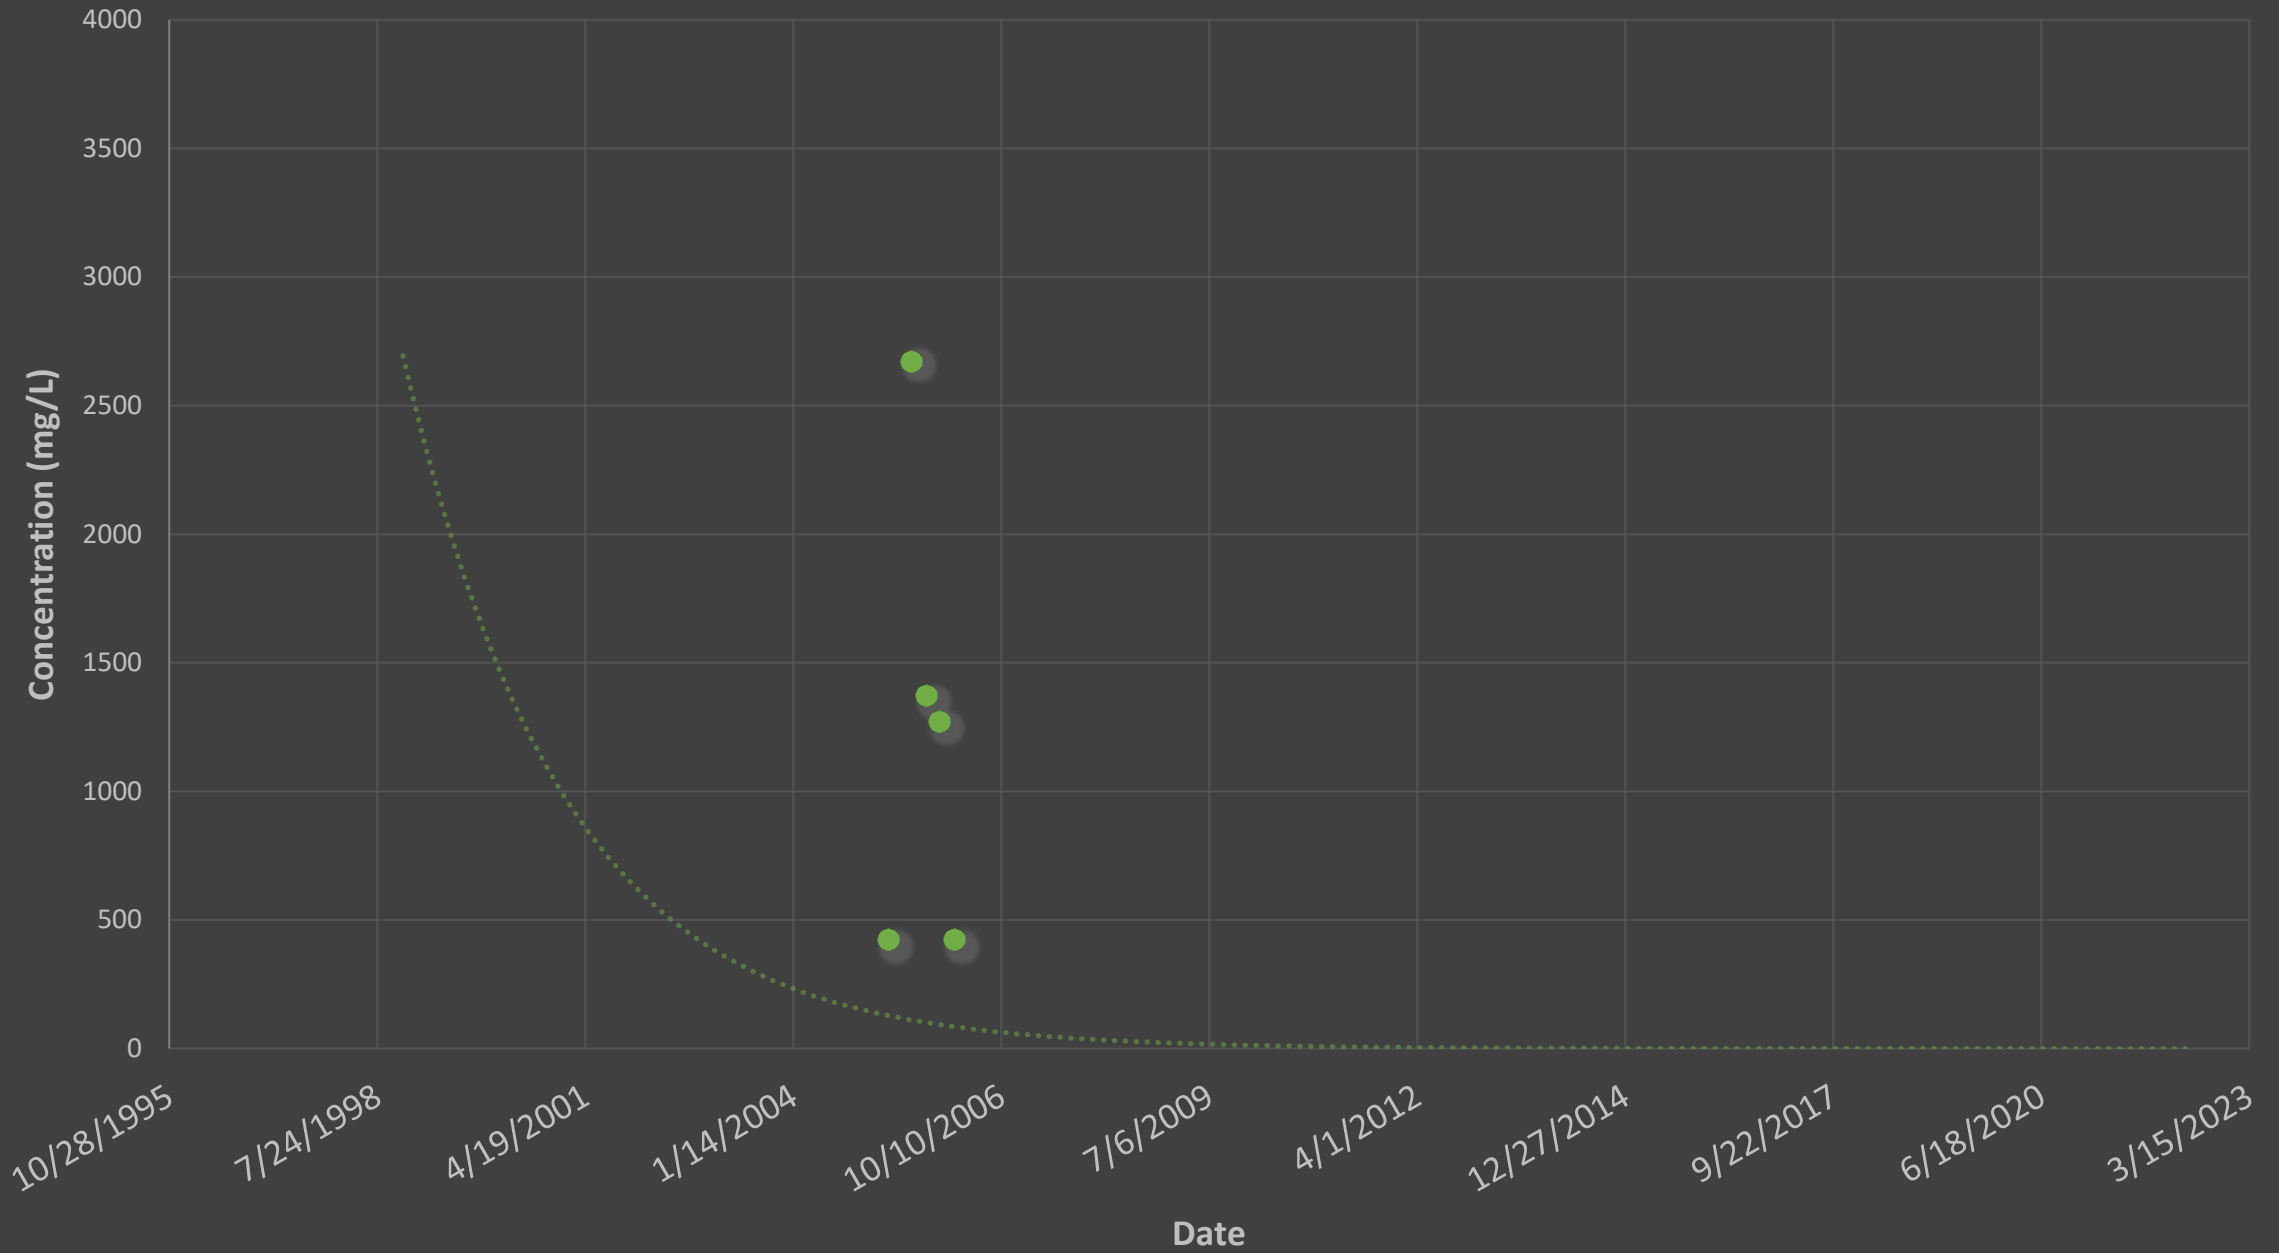
Lead Concentration in 1000-Level Adit Discharge, 1998 - 2021

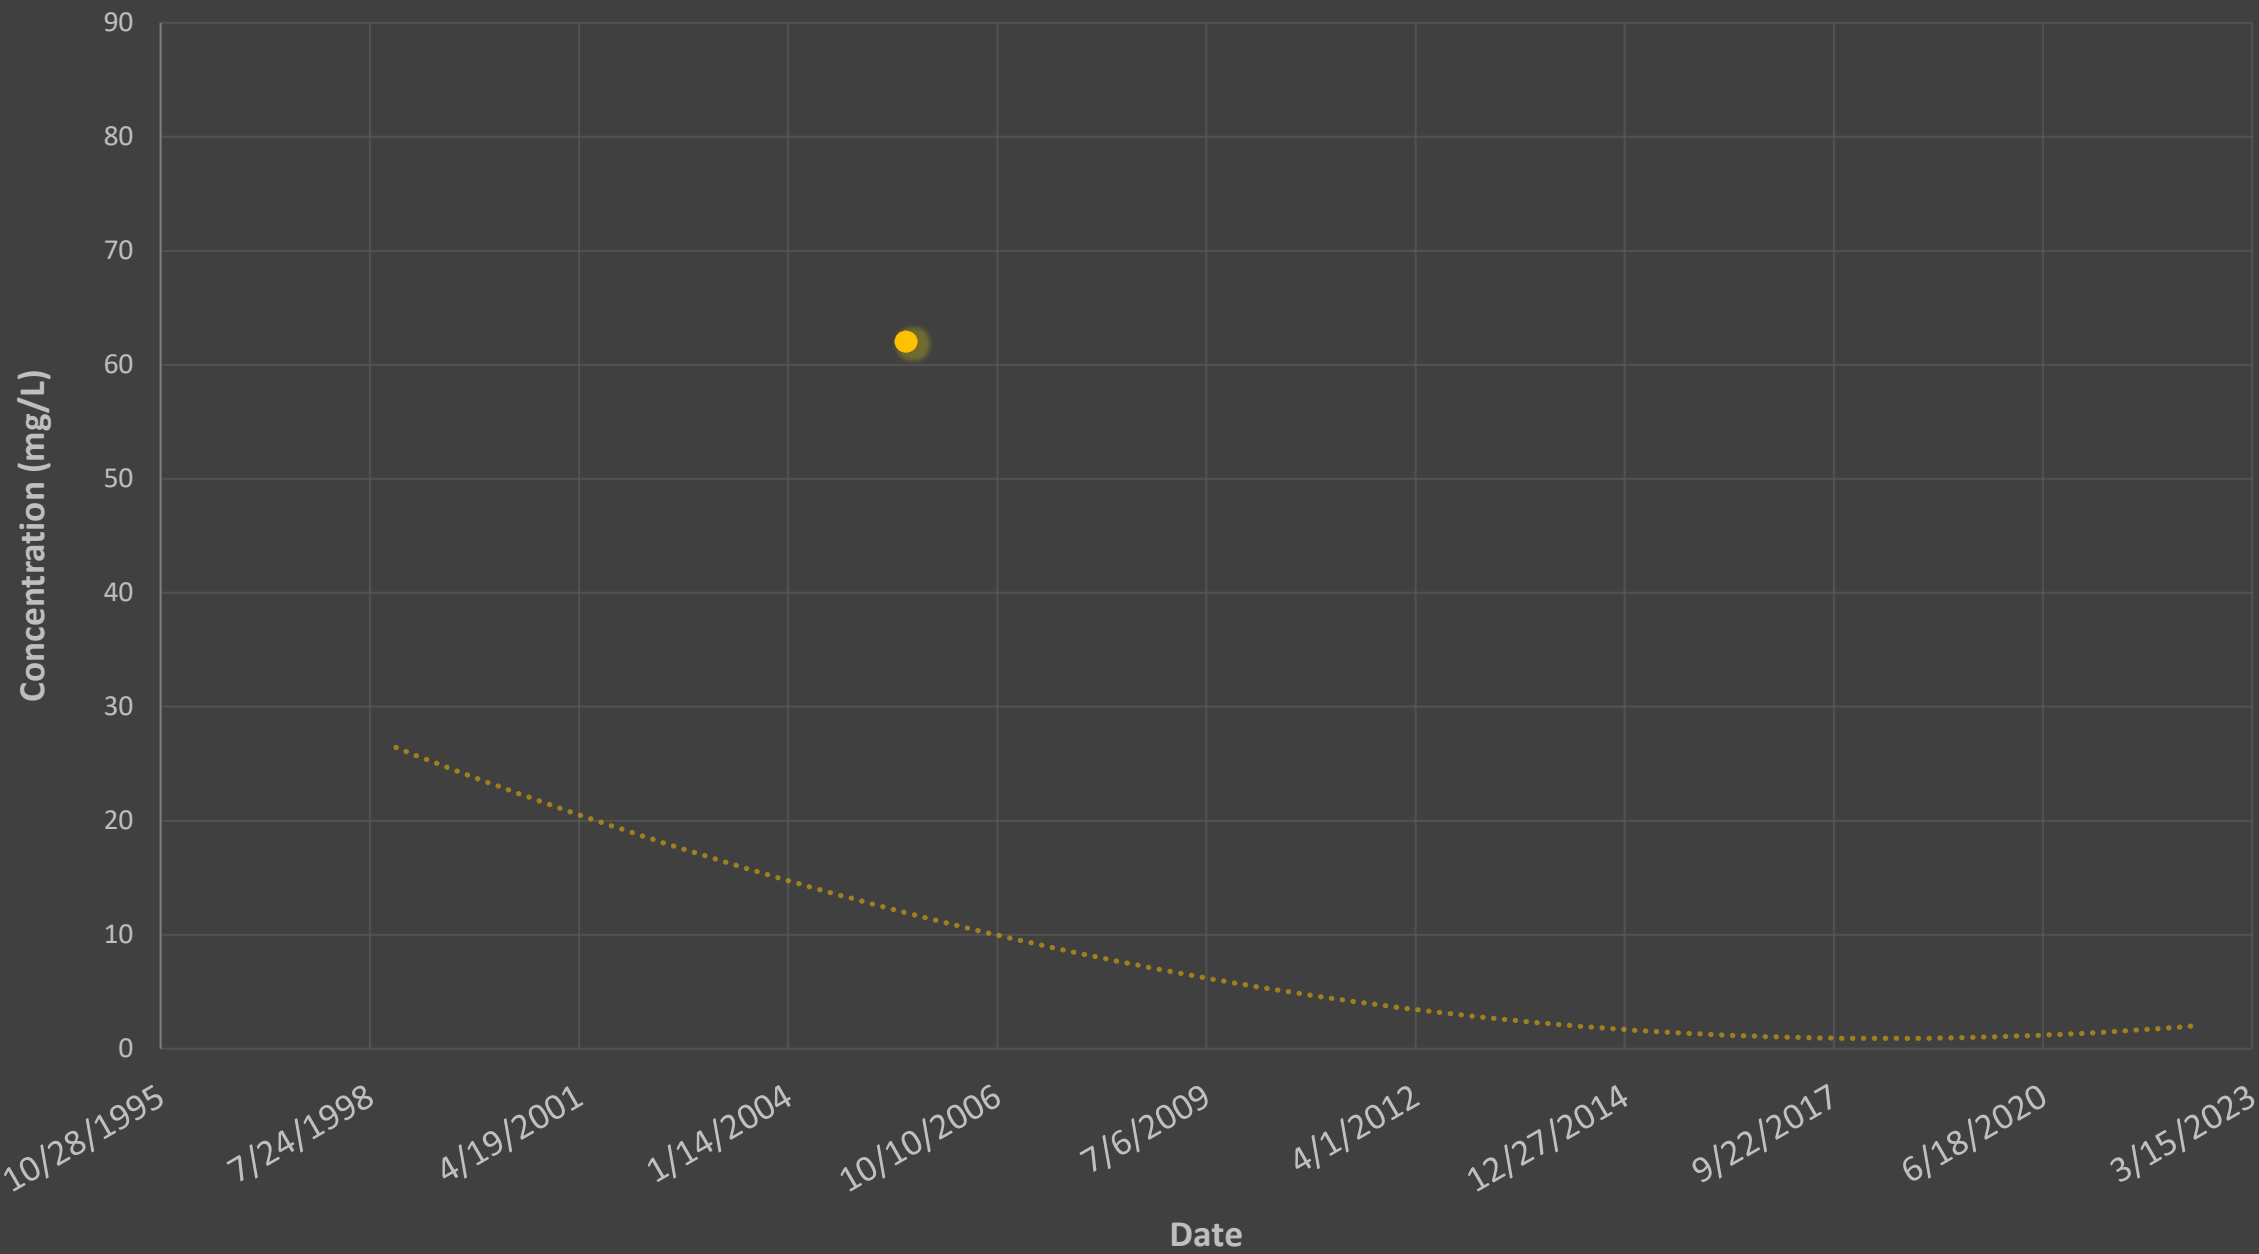
Zinc Concentration in 1000-Level Adit Discharge, 1998 - 2021

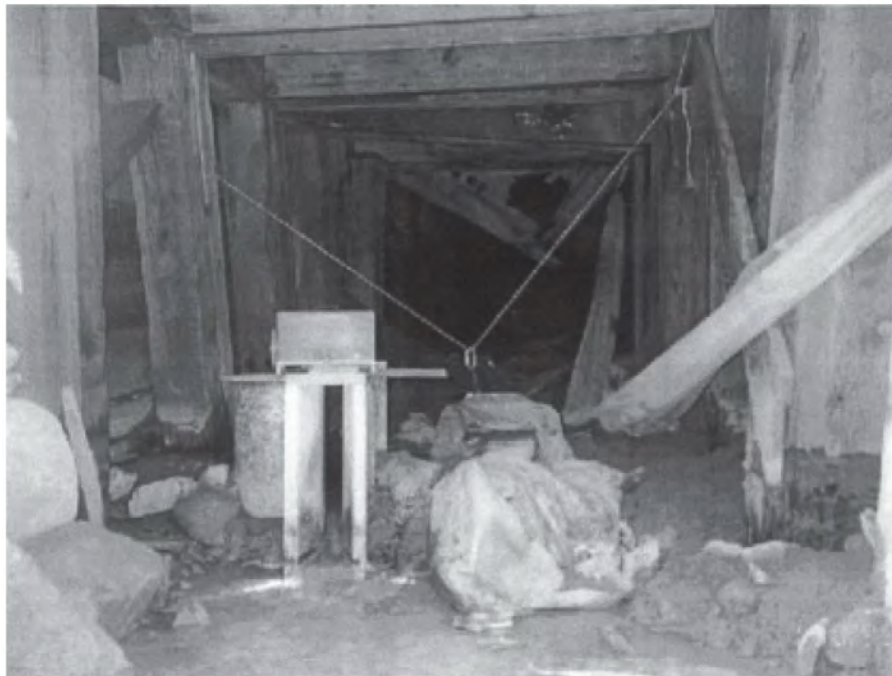
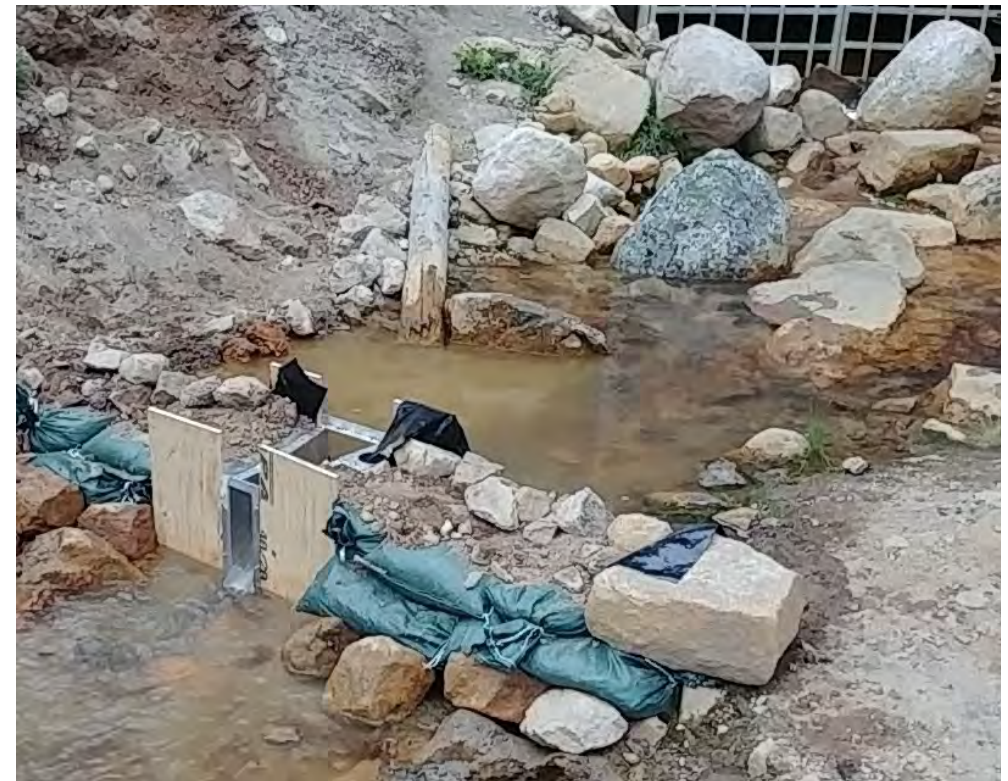
**Calcium (conservative ion) concentrations consistent across studies*
