ELKHORN MINE & MILL

2021 Site Characterization Report

Prepared for
Big Hole Watershed Committee
& US Forest Service Northern Region

Prepared by
WindenWater, LCC

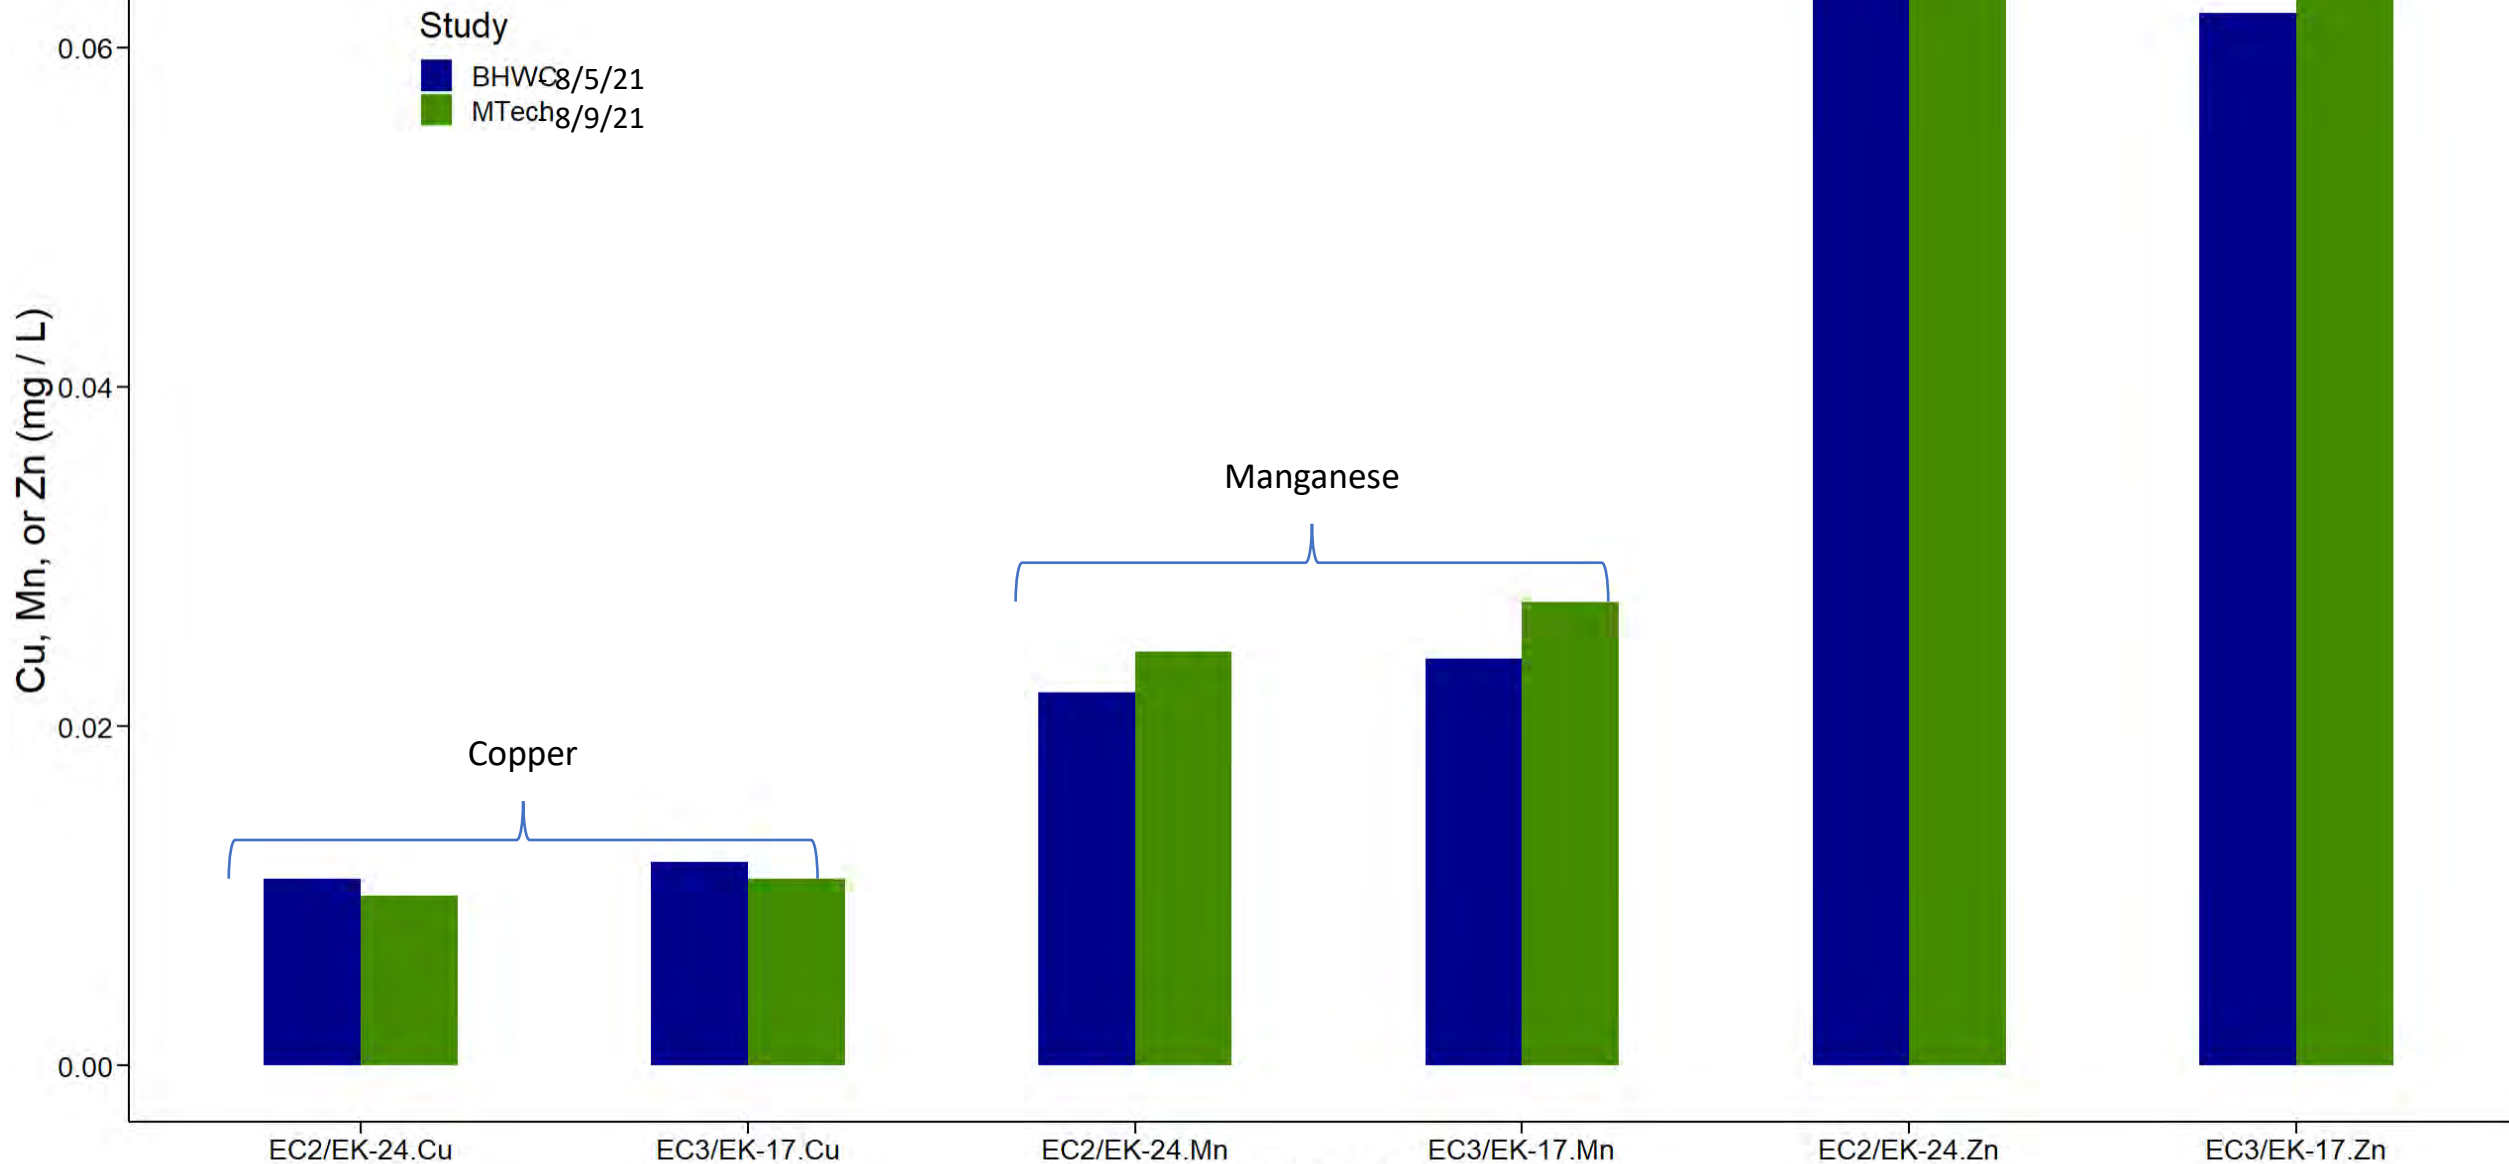
MTech vs. BHWC & Constituent

**Trace metal concentrations consistent across studies*

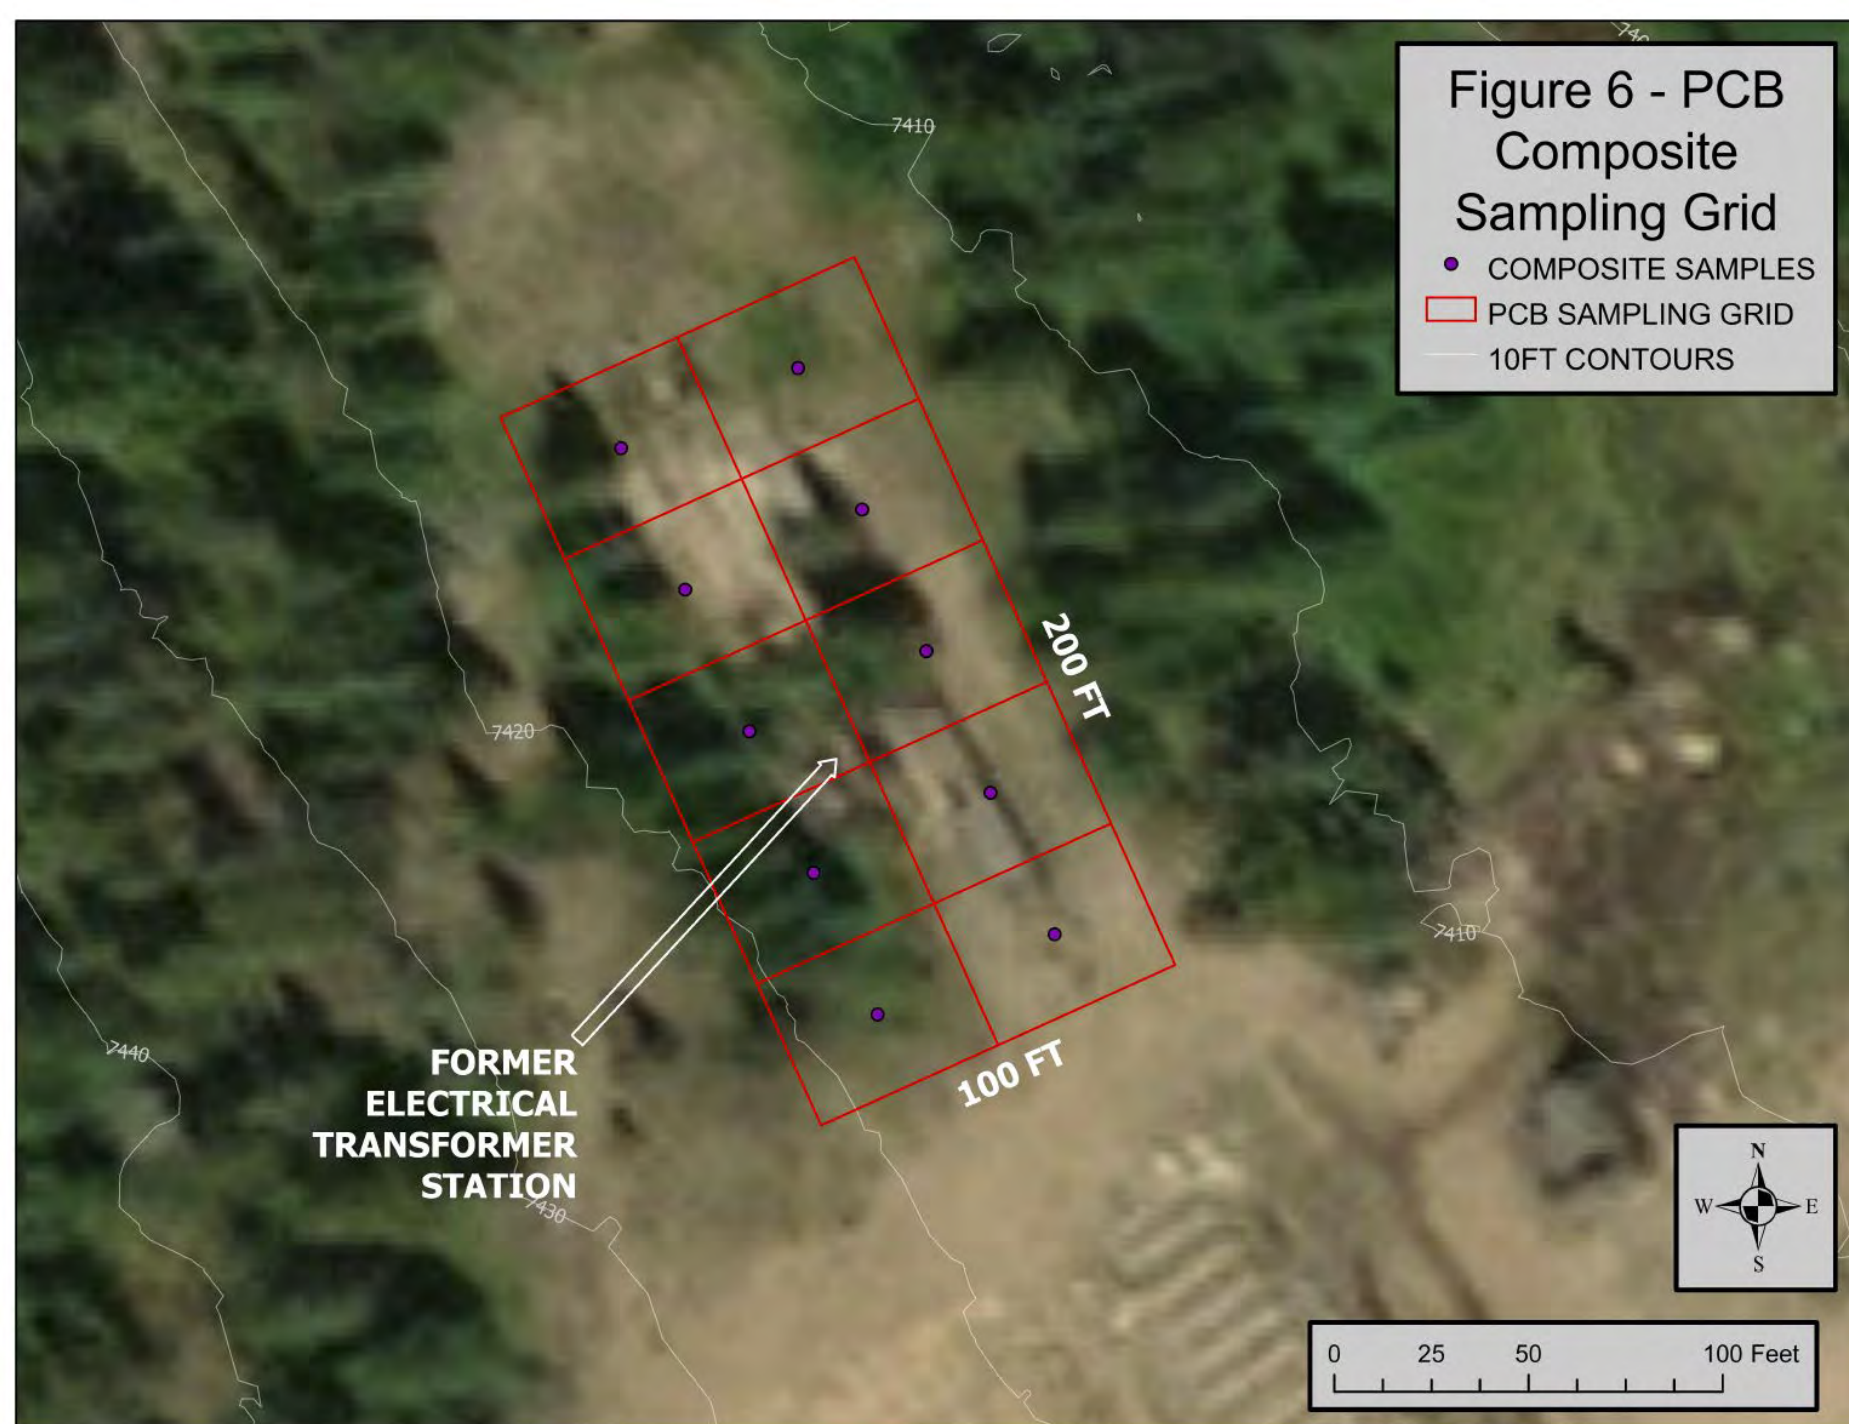
10 subsamples from grid

1 composite sample

1st analytical run
composite = **non-detect**

2nd analytical run
Subsample 1, 3, 5, 7, 9 = **non-detect**

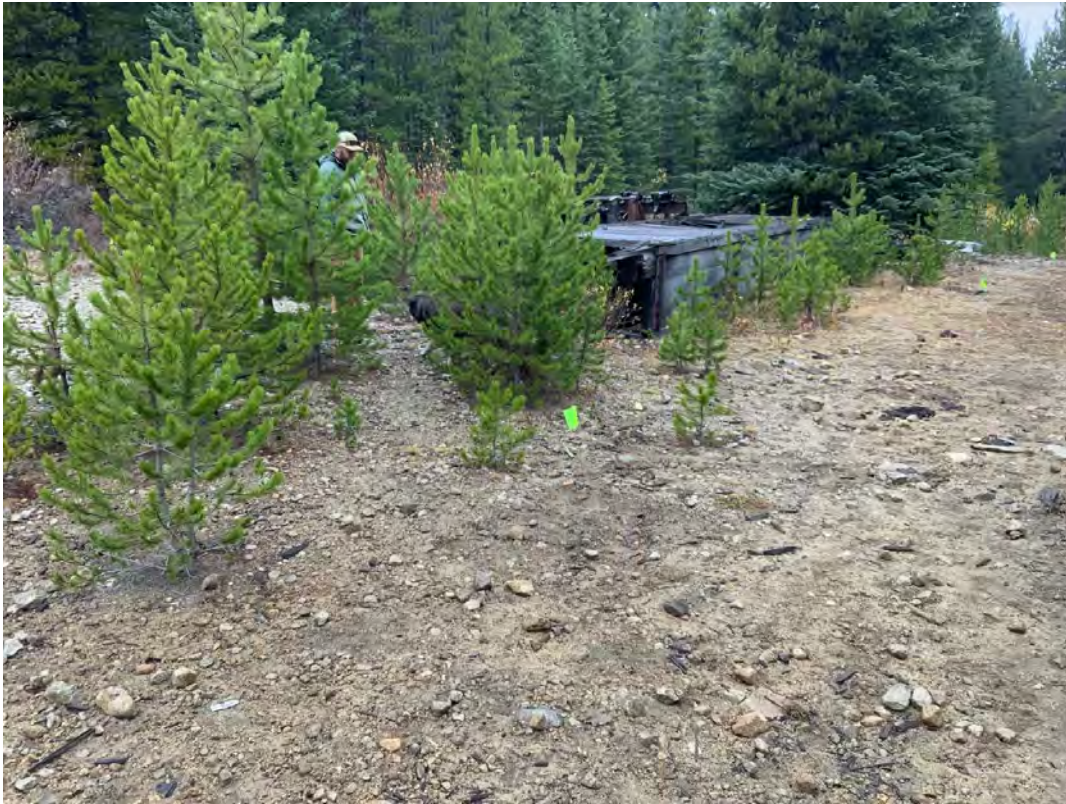
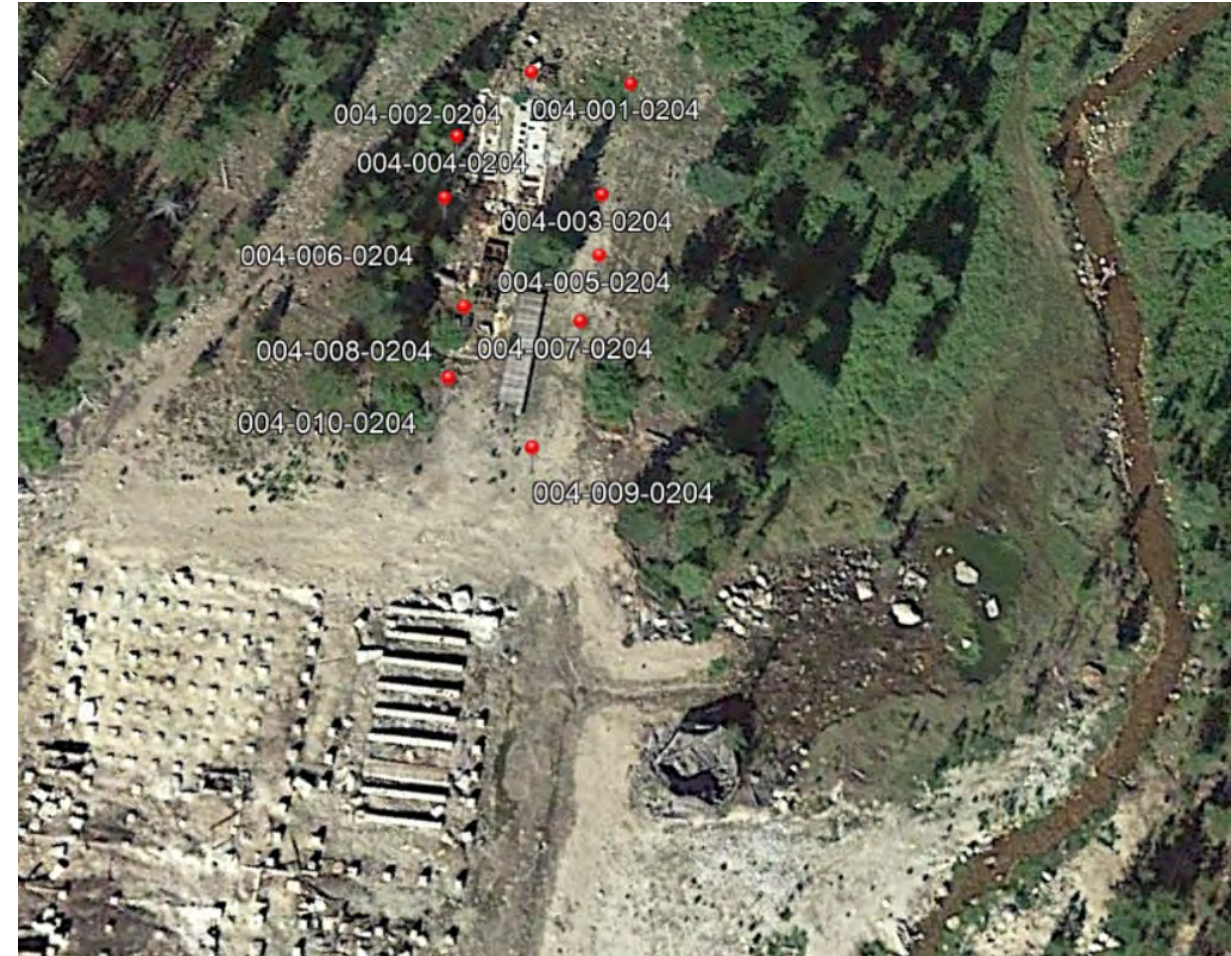
- Total absence of high chlorinated congeners in all samples indicate dispersed PCB contamination is unlikely
- Does not rule out isolated PCB contaminated if electrical waste unearthed during removal activities
- Consider testing groundwater to rule out PCB contamination

*Actual sampling locations varied to accommodate cultural resource buffers and to avoid concrete pad

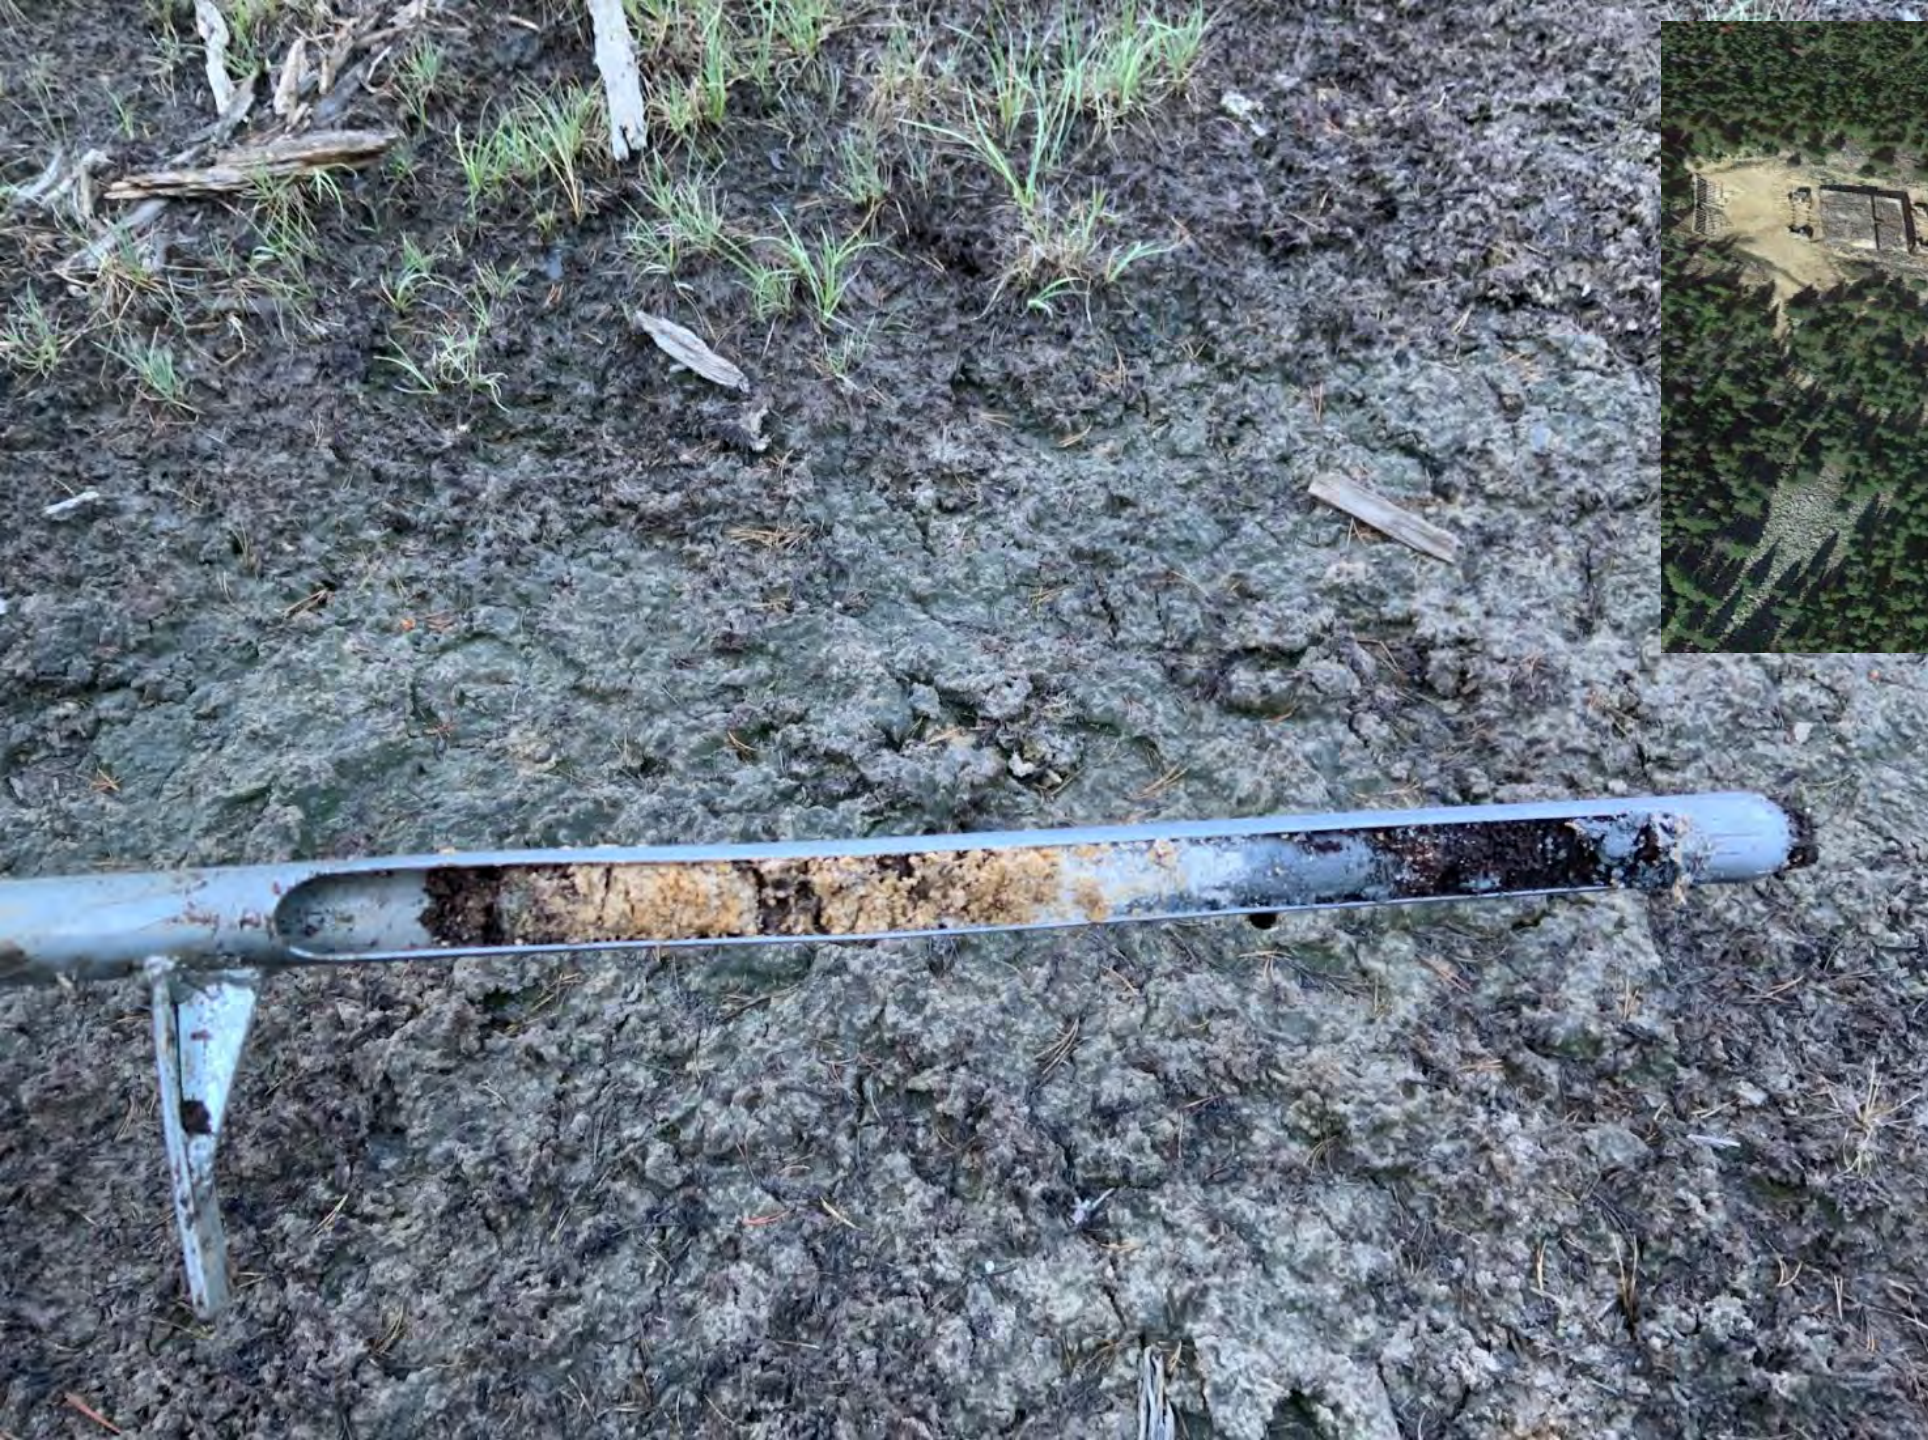
- Fine, chalky, milled wastes
- Crusts & algae
- Little vegetation
- Overlaying organic horizon at depth

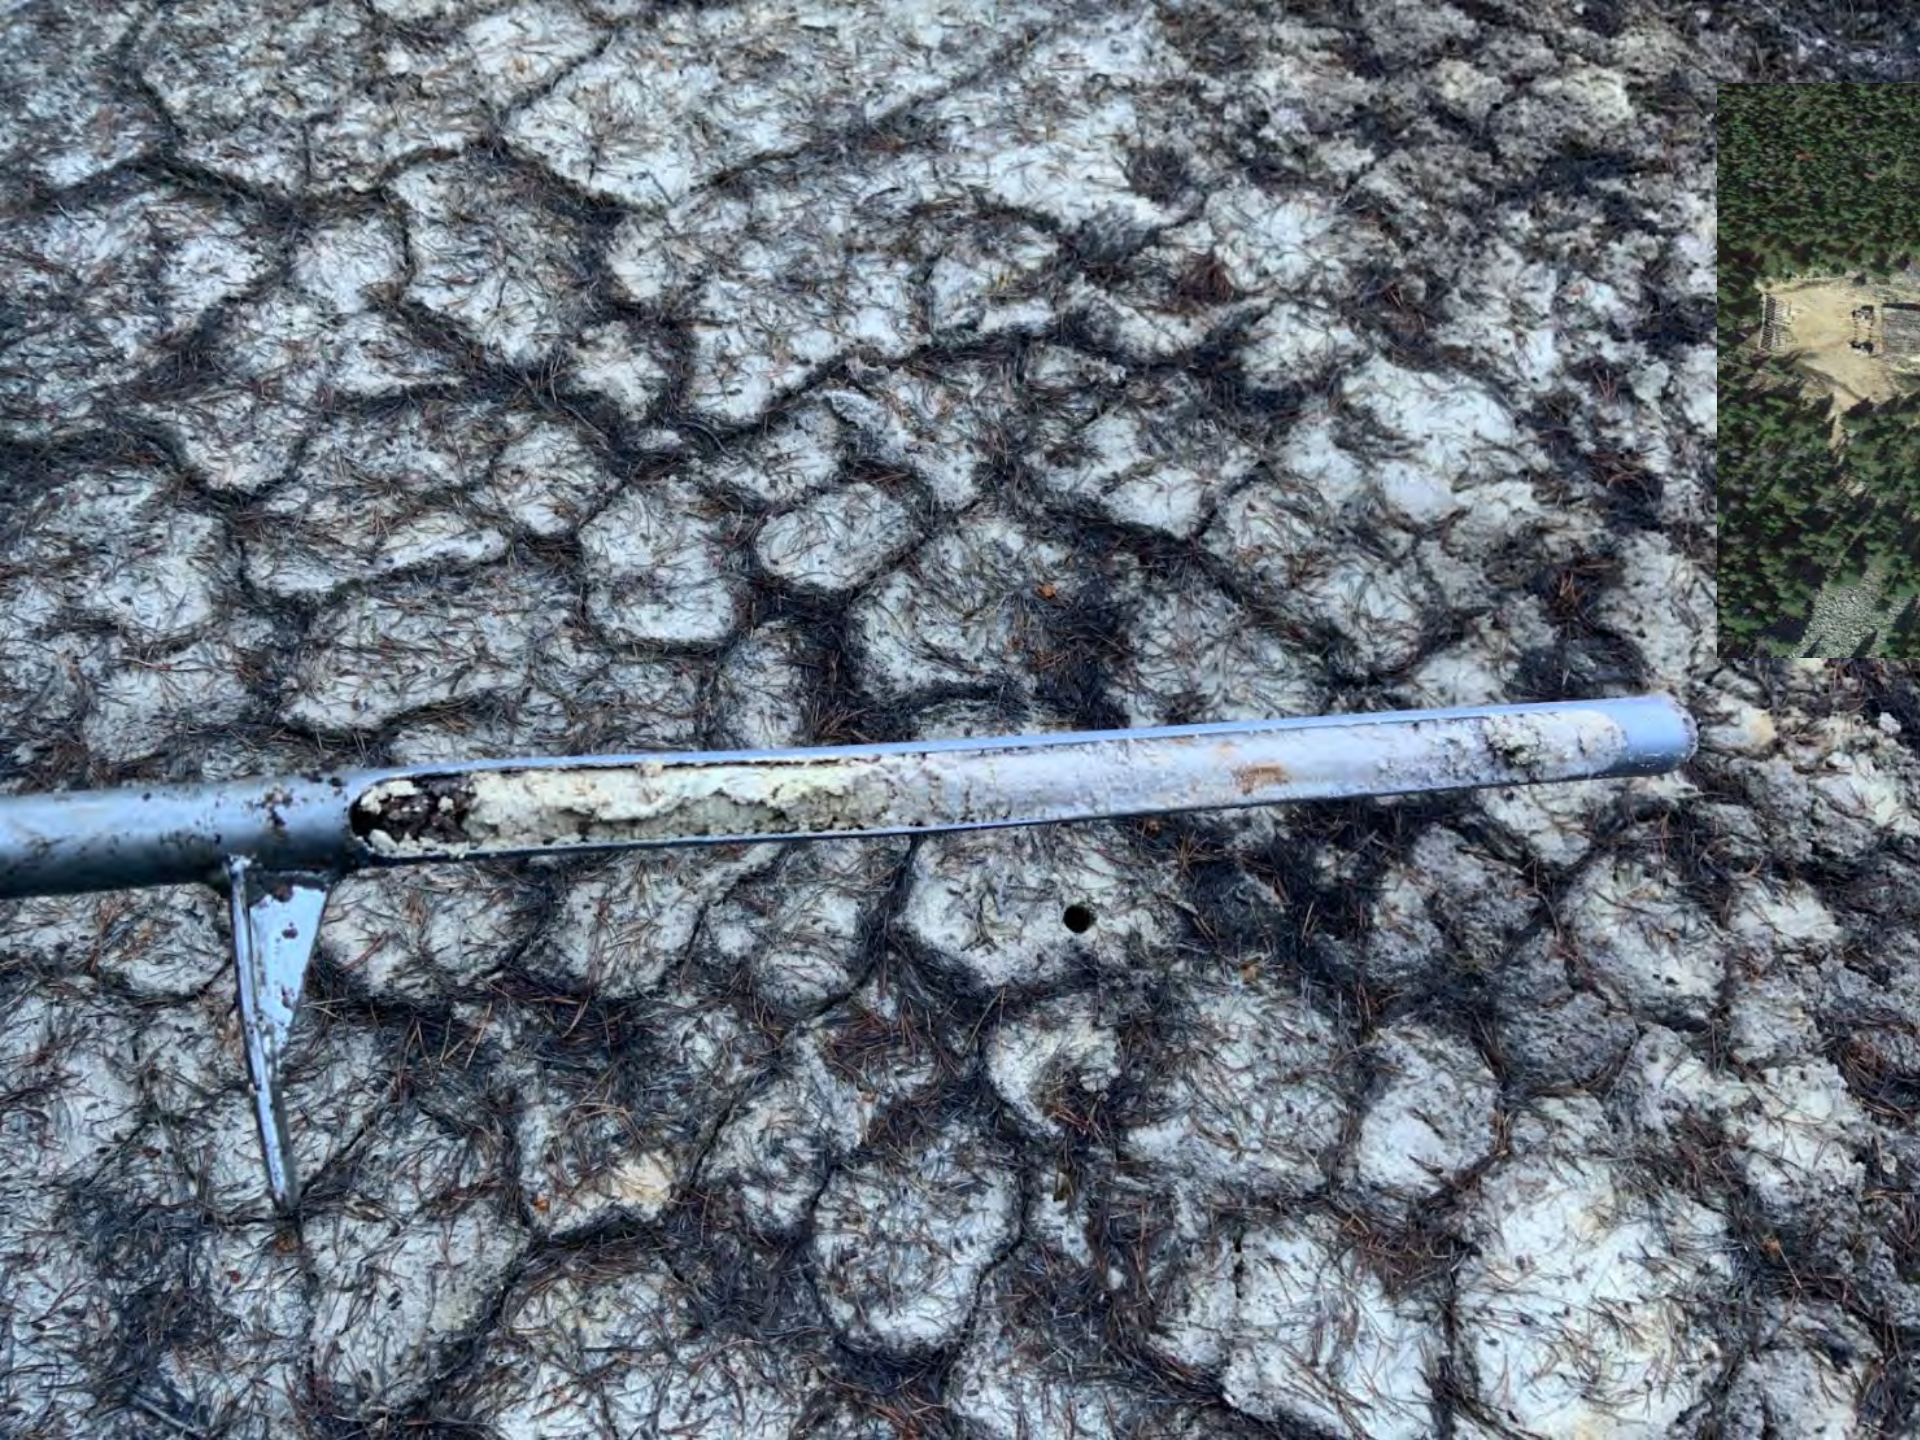
- Fine, chalky milled wastes
- No vegetation
- Deeper than 16"

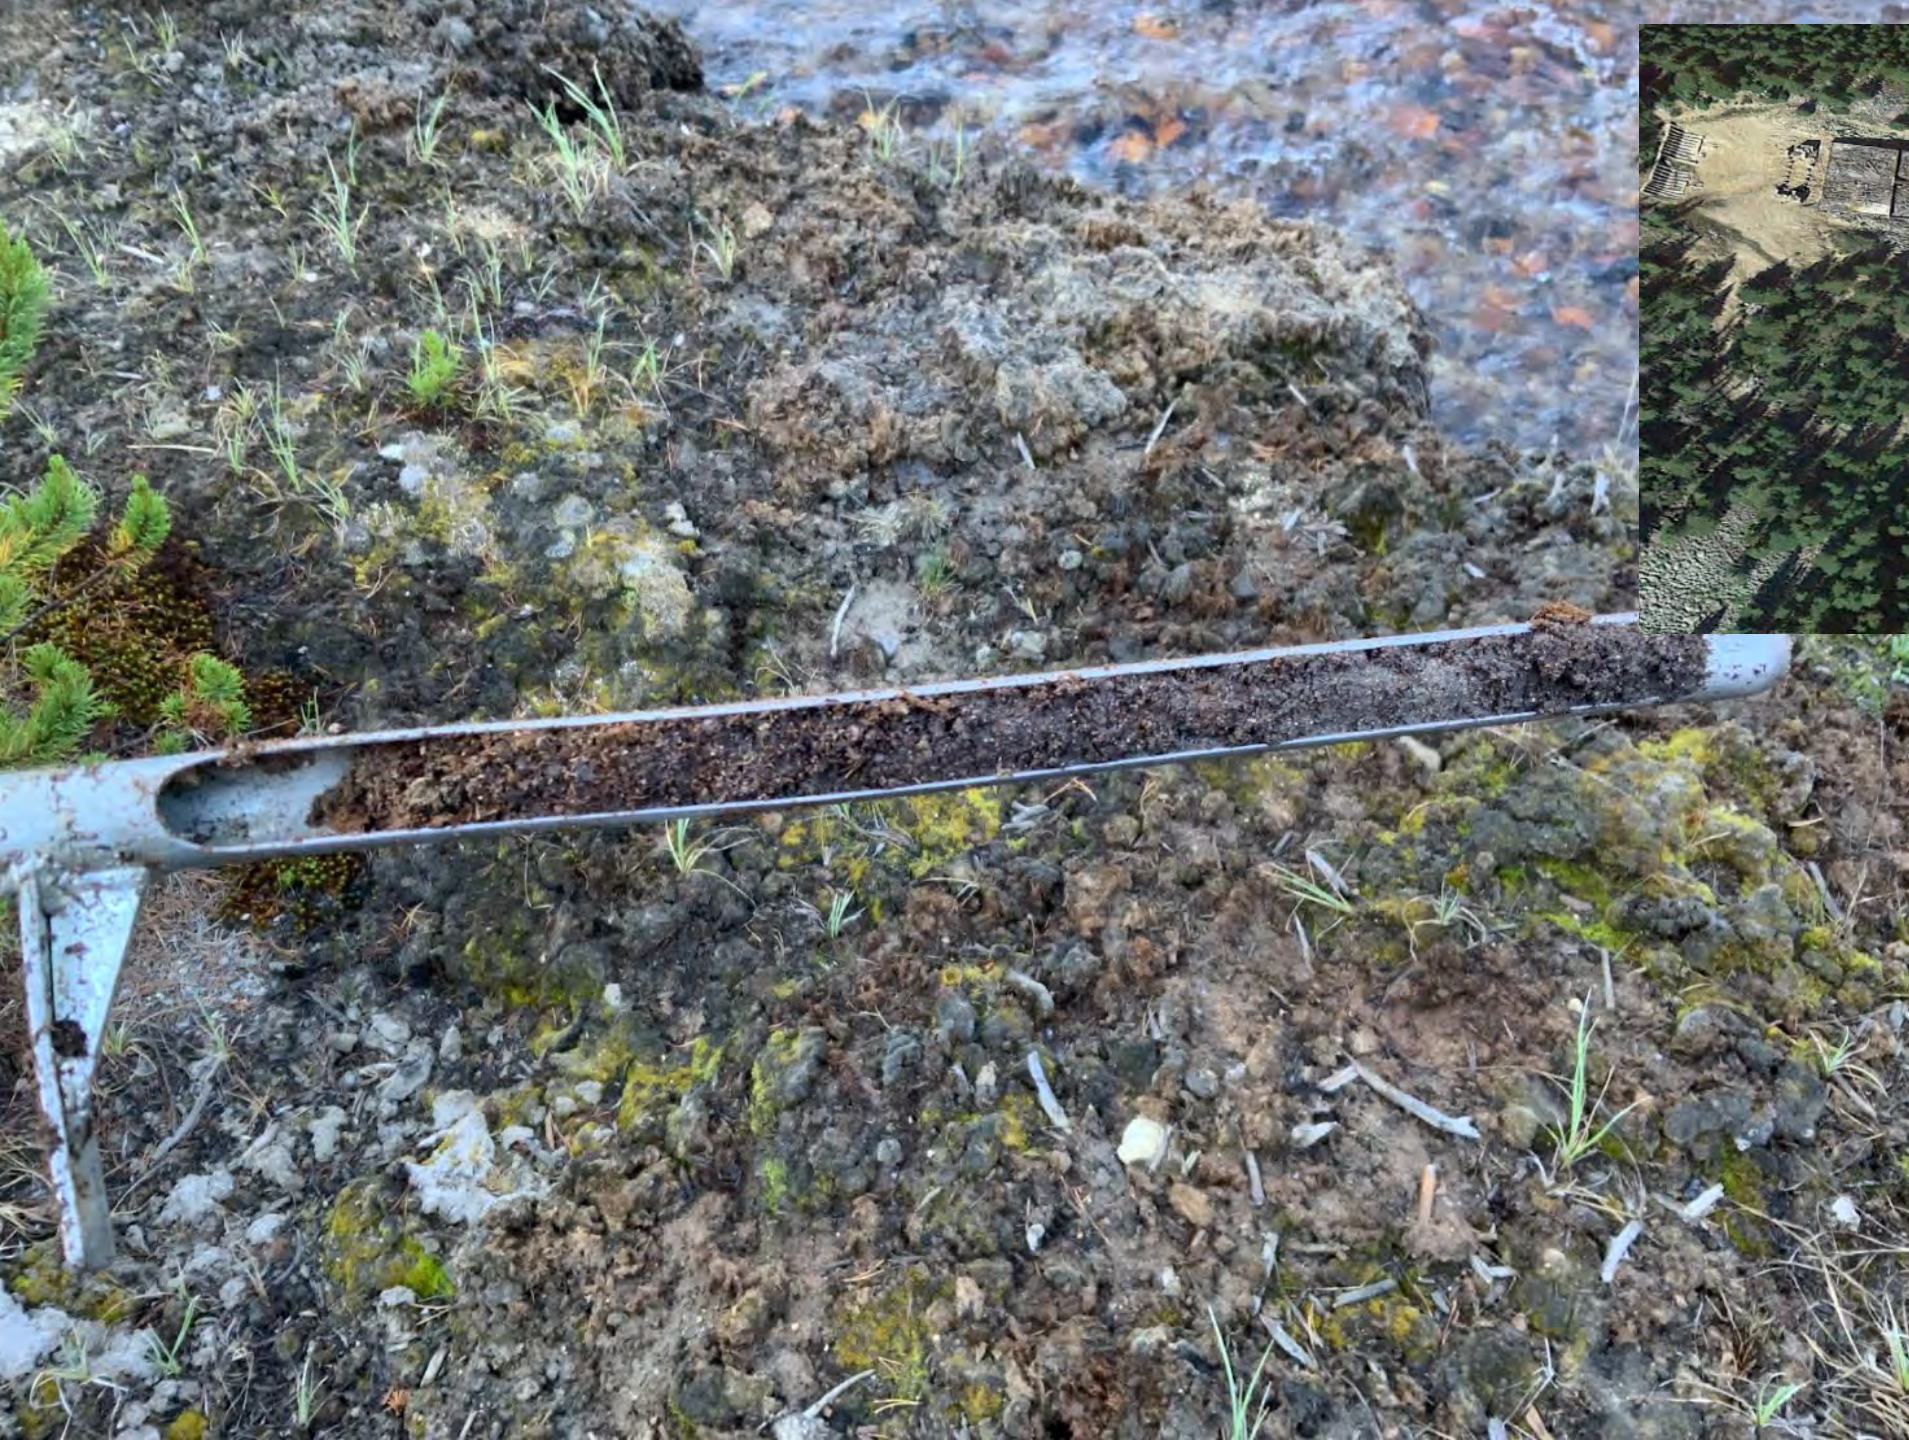
- Mix of sand, ore, organics, mill wastes
- Heavily worked during Phase 4 cleanup
- Sparse mosses, stunted grasses & lodgepole

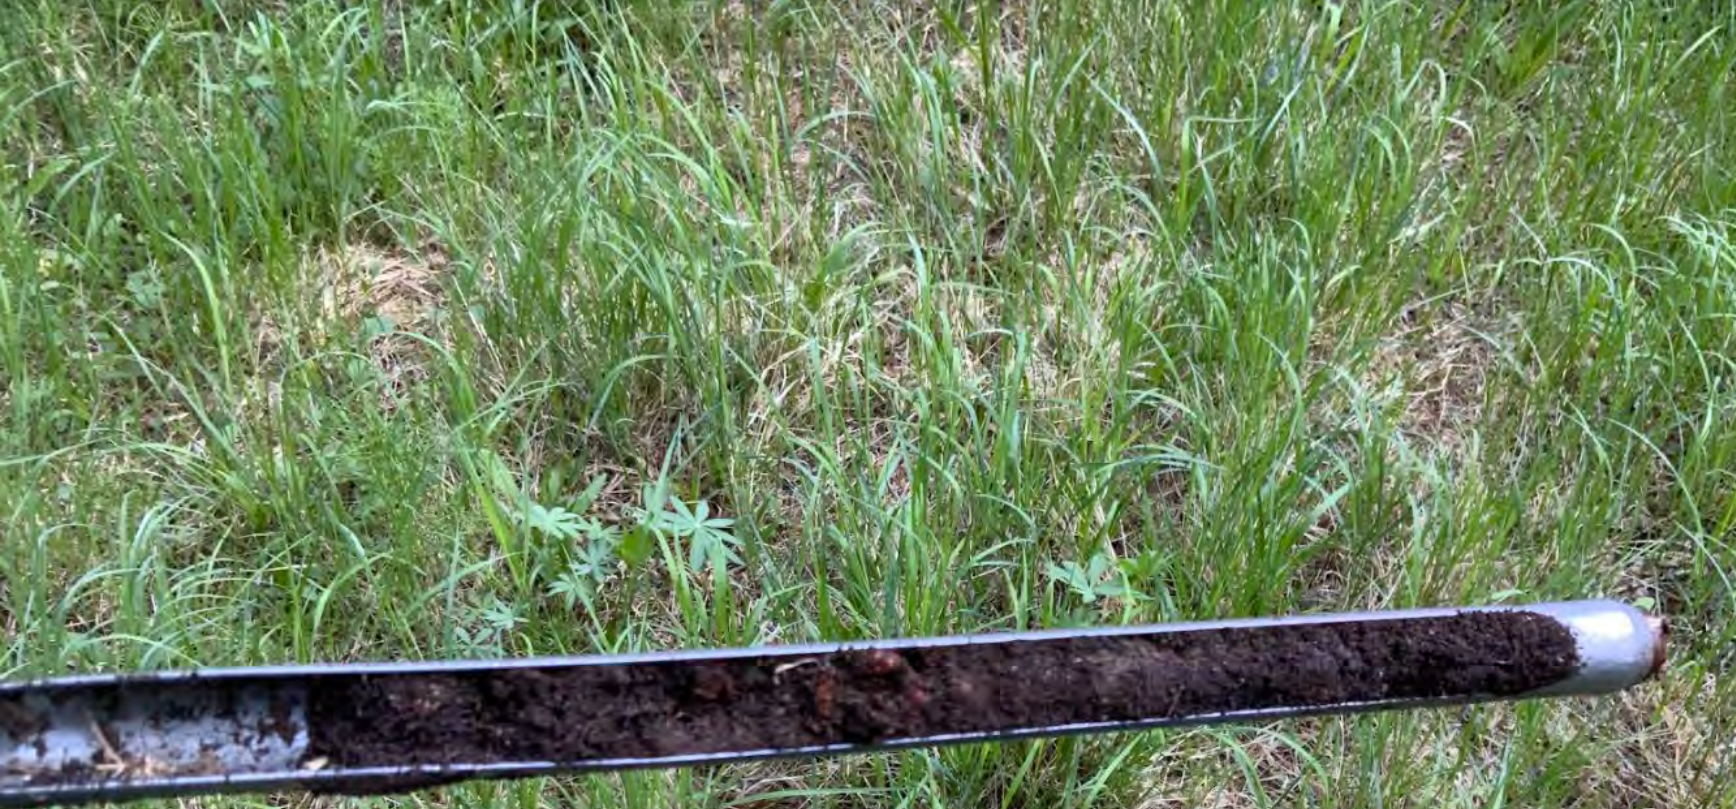
- Dark, organic soils
- Healthy, dense vegetation
- No obvious impacted soils

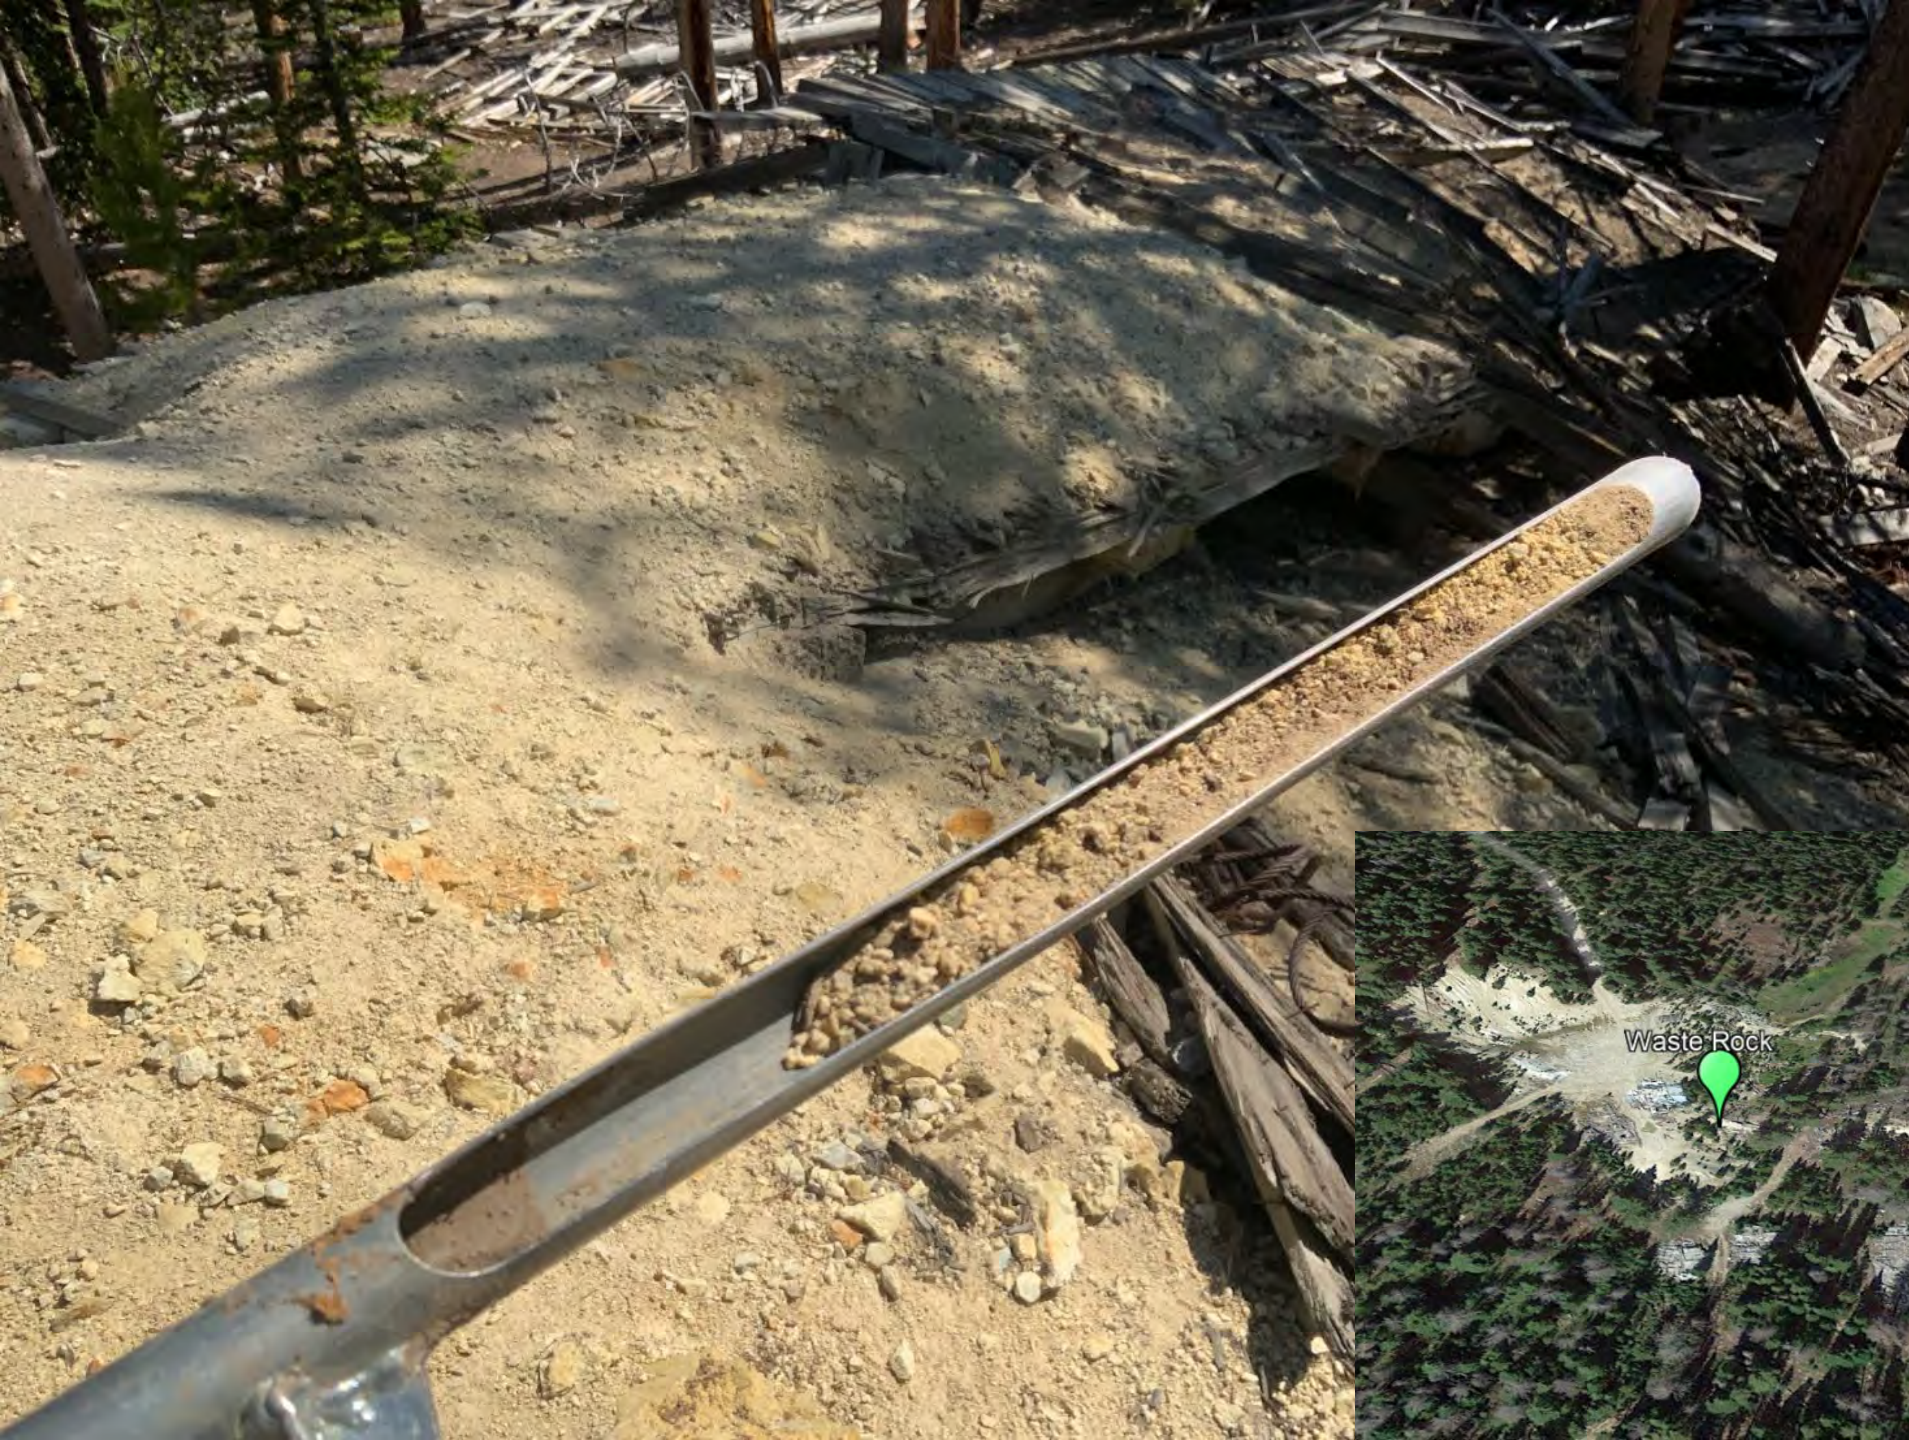
- Coarse sands, gravels
- Widely dispersed
- Deep

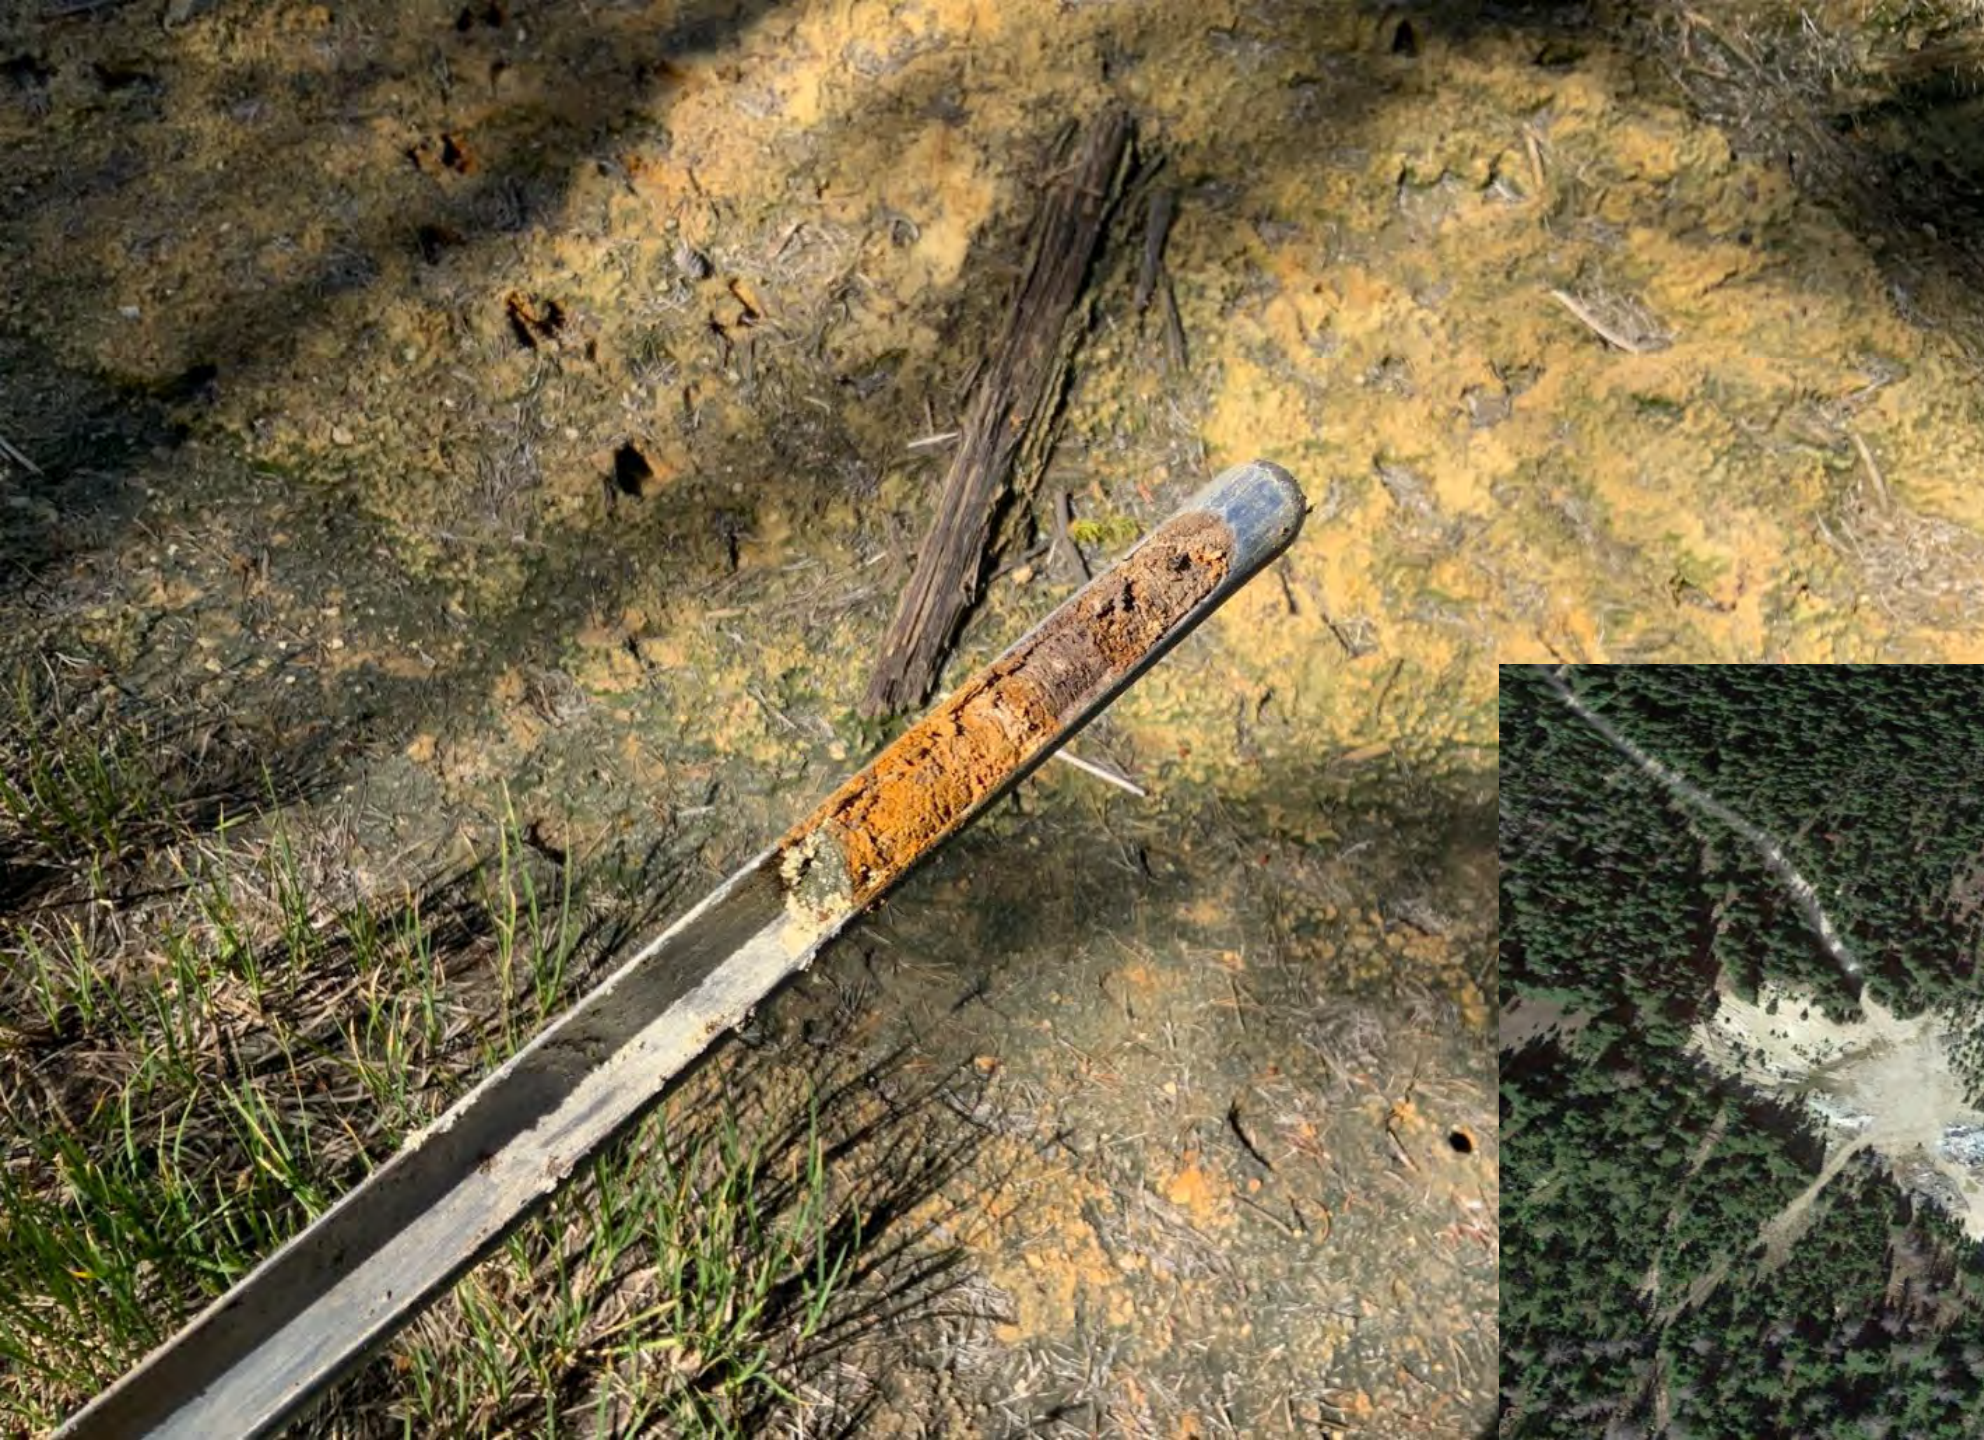
- Coarse and fine sands
- Resembles a 'slicken'; no vegetation
- Deposited from Upper Camp runoff
- Retained by a berm
