ELKHORN MINE & MILL

2021 Site Characterization Report

Prepared for
Big Hole Watershed Committee
& US Forest Service Northern Region

Prepared by
WindenWater, LCC

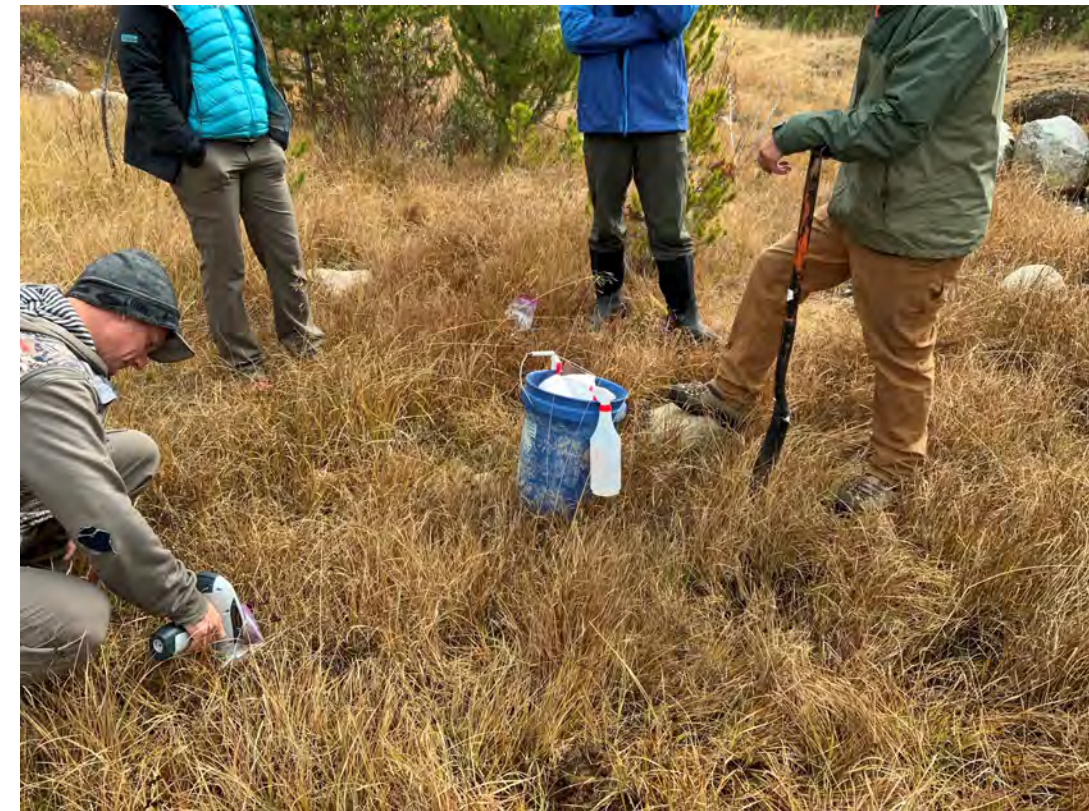
Preliminary XRF Screening

- ✓ Field verify visual delineations of impacted areas
- ✓ Dry-run proposed field methods
- ✓ Revise SAP-QAPP protocols
- ✓ Evaluate Pass/Fail Criteria
