# UPPER OREGON CREEK RESTORATION PROJECT MONITORING PLAN

March 2022

**BIG HOLE**  
**WATERSHED COMMITTEE**  
*Conservation Through Consensus.*

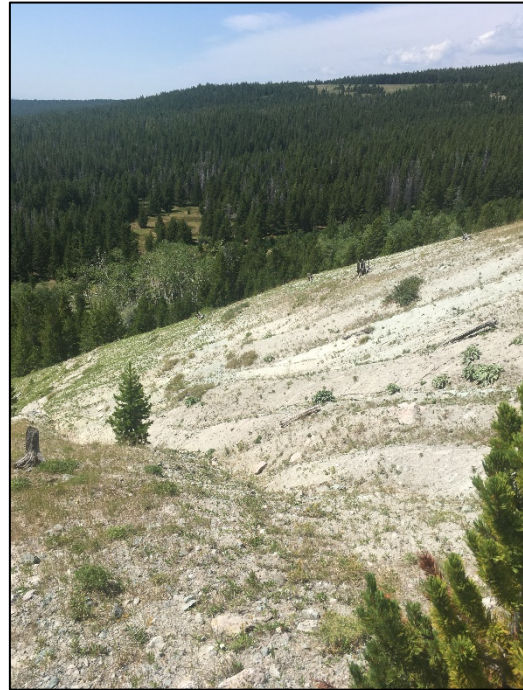
Figure 3. Existing upland conditions above upper Oregon Creek. Note the formation of rills that form large gullies

Since the closing of the Anaconda Smelter in 1980 and the cessation of aerial emissions, natural regeneration has increased substantially in the uplands, particularly in the last 20 years, as seed sources from forested areas have begun expanding into the bare areas. However, where welded volcanic tuff is the dominant geologic mineral component, natural vegetation has been slow to re-establish. The welded tuff material is friable, with very low levels of basic plant nutrients, low water-holding capacity, and easily moved by forces of water, wind, and ice. Larger rain events in the spring and summer, more so than annual snowmelt, easily carve rills in this material as overland flow carries sediment off slopes.

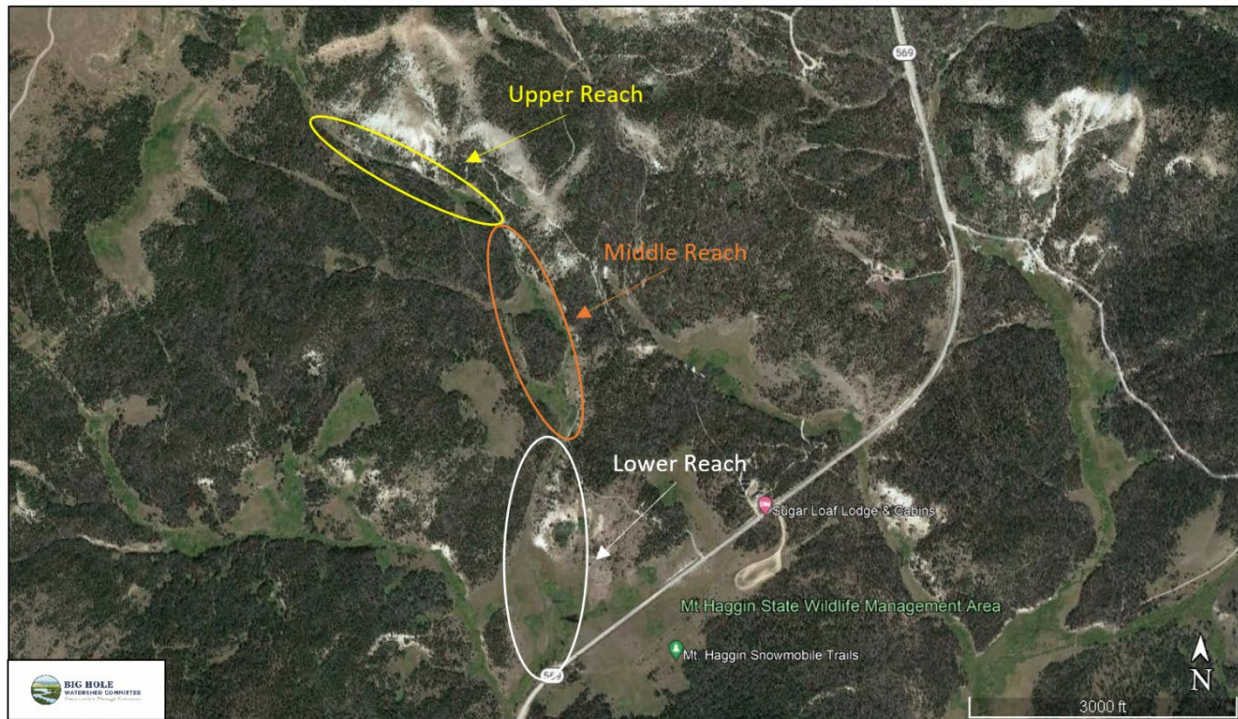
Figure 6. Stream Reaches within the project area.

The project area encompasses three distinct stream reaches as shown in **Table 1** and **Figure 6**.

Table 1. Project Stream Reach Locations				
<i>Reach ID</i>	<i>Begin Lat</i>	<i>Begin Long</i>	<i>End Lat.</i>	<i>End Long.</i>
<i>Upper Reach</i>	<i>46.0141</i>	<i>-113.0047</i>	<i>46.0110</i>	<i>-113.0009</i>
<i>Middle Reach</i>	<i>46.0110</i>	<i>-113.0009</i>	<i>46.0033</i>	<i>-112.9979</i>
<i>Lower Reach</i>	<i>46.0025</i>	<i>-112.9862</i>	<i>45.9974</i>	<i>-112.9979</i>

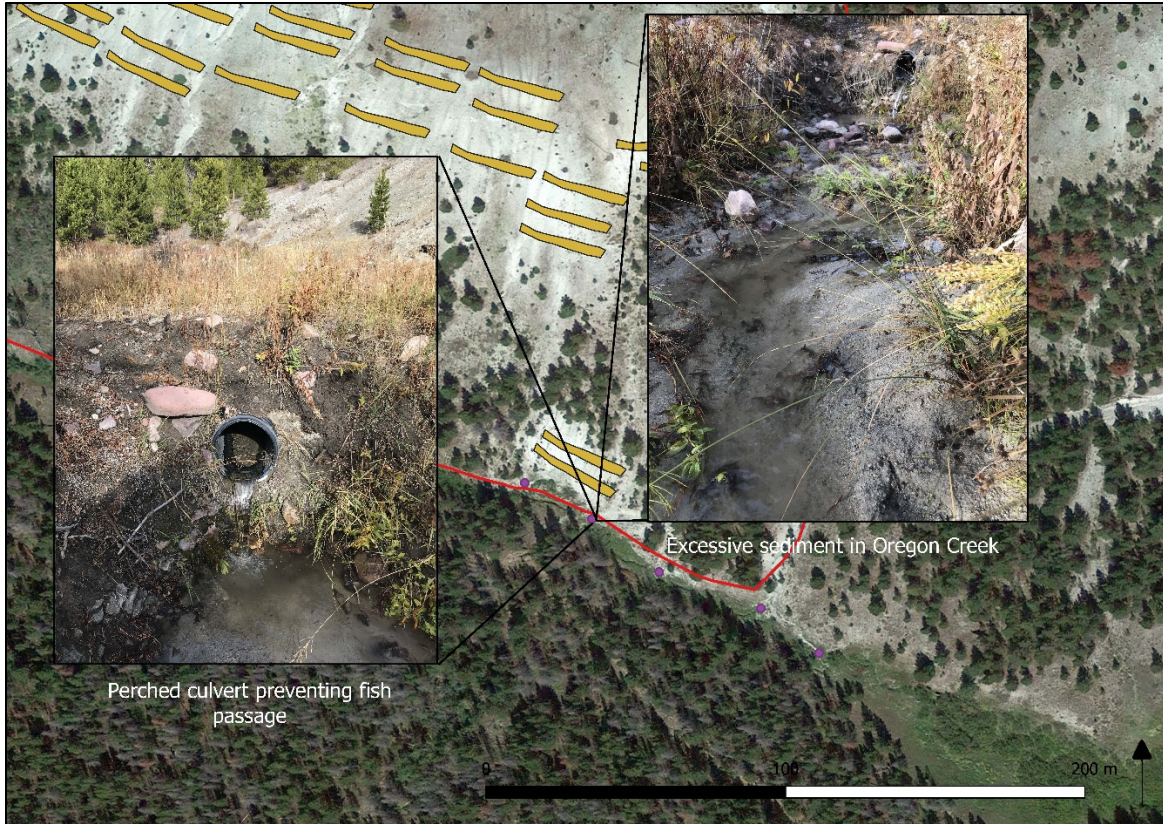
Figure 8. Perched culvert and sediment choked stream in the upper reaches of project area.

*Upper reach:* The upper reach exhibits the most severely sediment choked reach in the entire stream. The majority of the sediment inputs come from the adjacent upland gully networks washing directly into the stream. The stream is perennial in this reach. There is an old perched culvert in this reach that will be removed during BDA construction (**Figure 8**). The perched culvert is currently blocking .5 miles of Oregon Creek headwaters. Floodplain vegetation consists of robust willow and riparian vegetation communities.

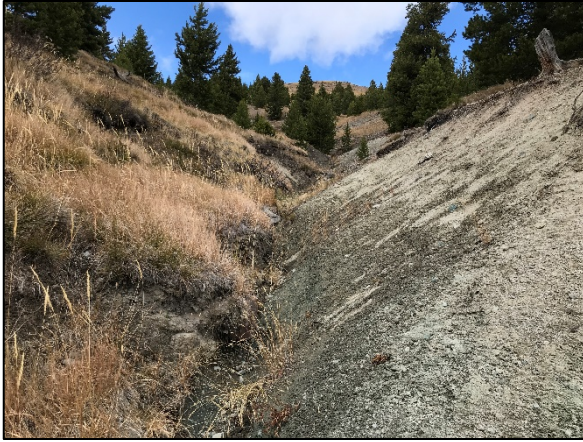
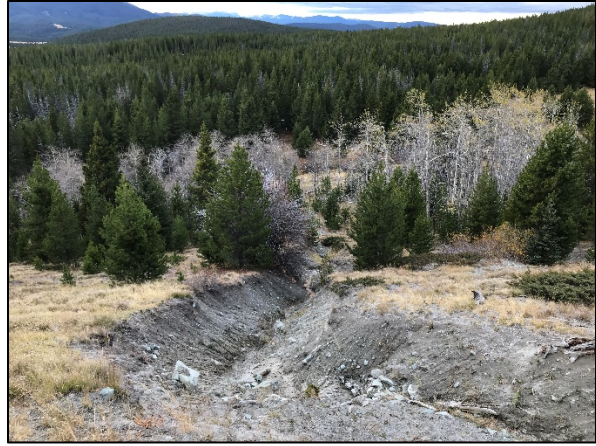
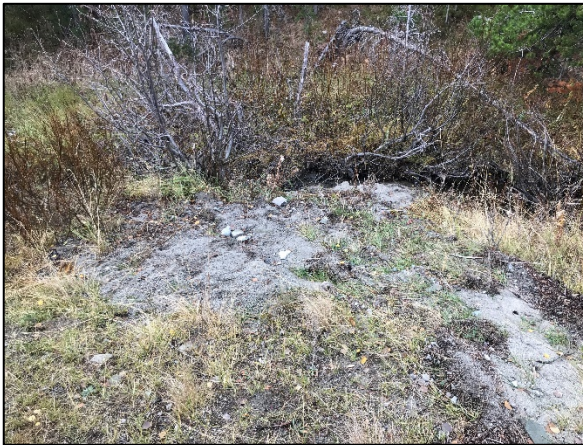
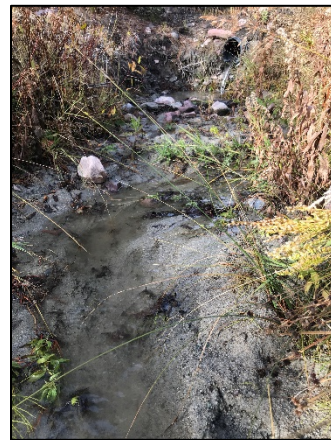
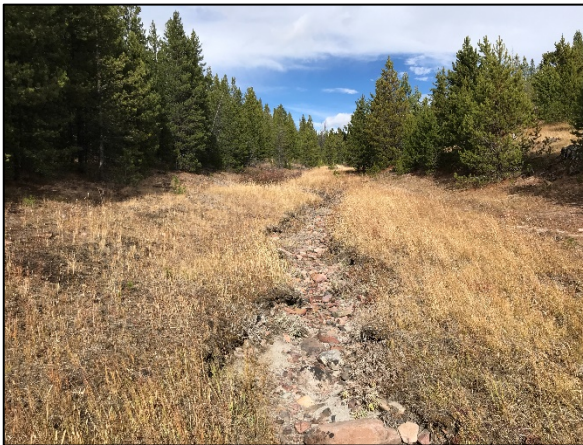
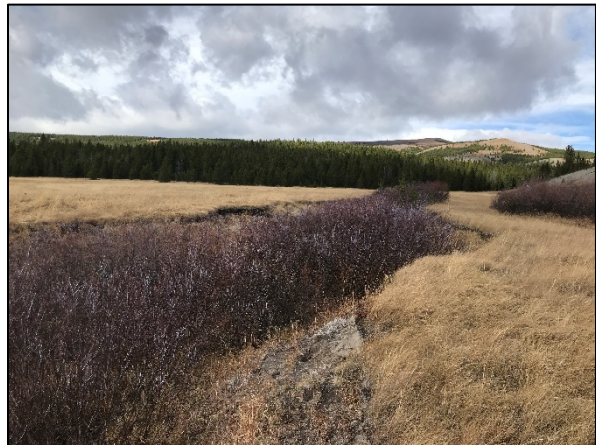
Figure 9. Existing conditions (clockwise from upper left): Large, mostly dry gully above upper reach; One of many gullies above the upper reach that transports sediment directly into Oregon Creek; Sediment plume depositing sediment into Oregon Creek; Sediment choked stream in the upper reach, below bare uplands; Dry, incised stream channel in the lower reach; Severely incised and straightened channel in lower reach/"stage O" site.
