Upper Oregon Creek Restoration Project Final Report

MONTANA DEPARTMENT OF ENVIRONMENTAL QUALITY (DEQ)

May 2024

BIG HOLE WATERSHED COMMITTEE (BHWC)

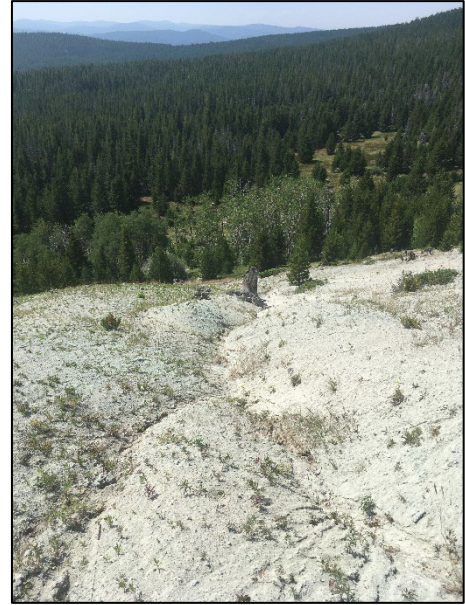
Figure 2. Upland conditions prior to the project.

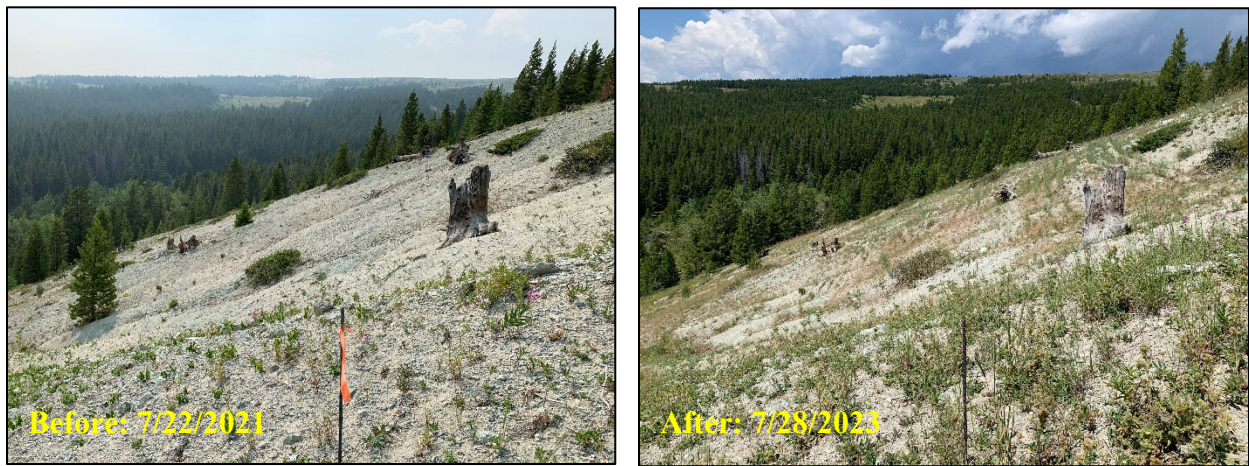
Figure 4. Upper Oregon Creek photo point 8 before and after photo series.

On 7/28/23, BHWC revisited the project site to take after photos. All nine photo points were visited and documented. Figure 4 and Figure 5 display examples of the 2023 before and after photos (photo points 8 and 9).

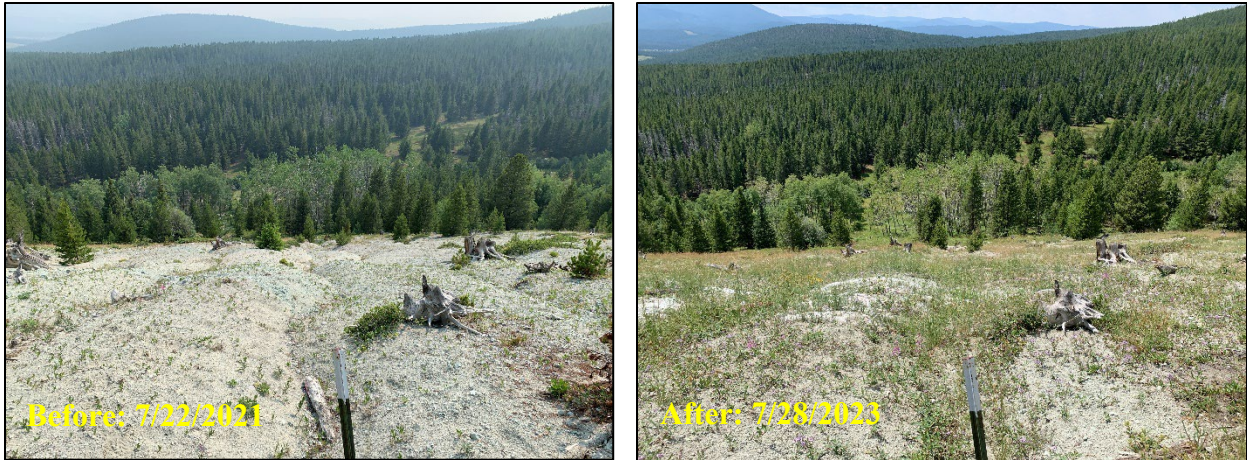
Figure 5. Upper Oregon Creek photo point 9 before and after photo series.

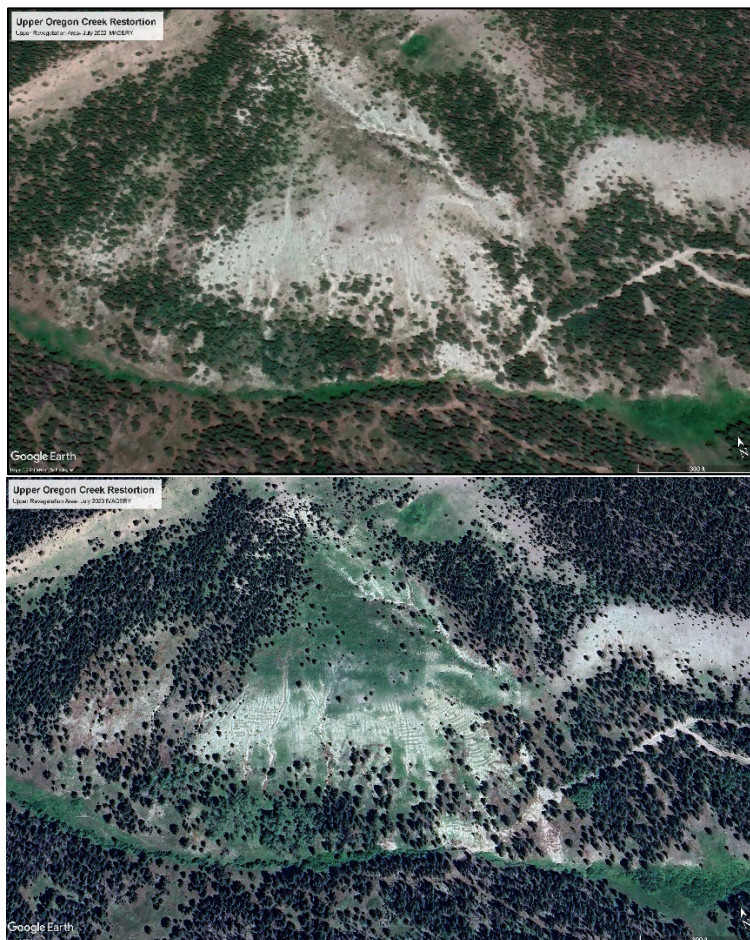
Figure 6. 2022 satellite imagery (top) compared to 2023 satellite imagery (bottom) displays the success of the vegetation treatments implemented with this project.

All photo points show drastic improvements and recovery trends. Photo points 1-4 highlight the instream and “Stage 0” portions of the project, whereas photo points 5-9 highlight the striking vegetation community improvements and robust vegetation establishment. Pre and post-project satellite imagery also demonstrates the widespread vegetation establishment in the uplands (Figure 6).

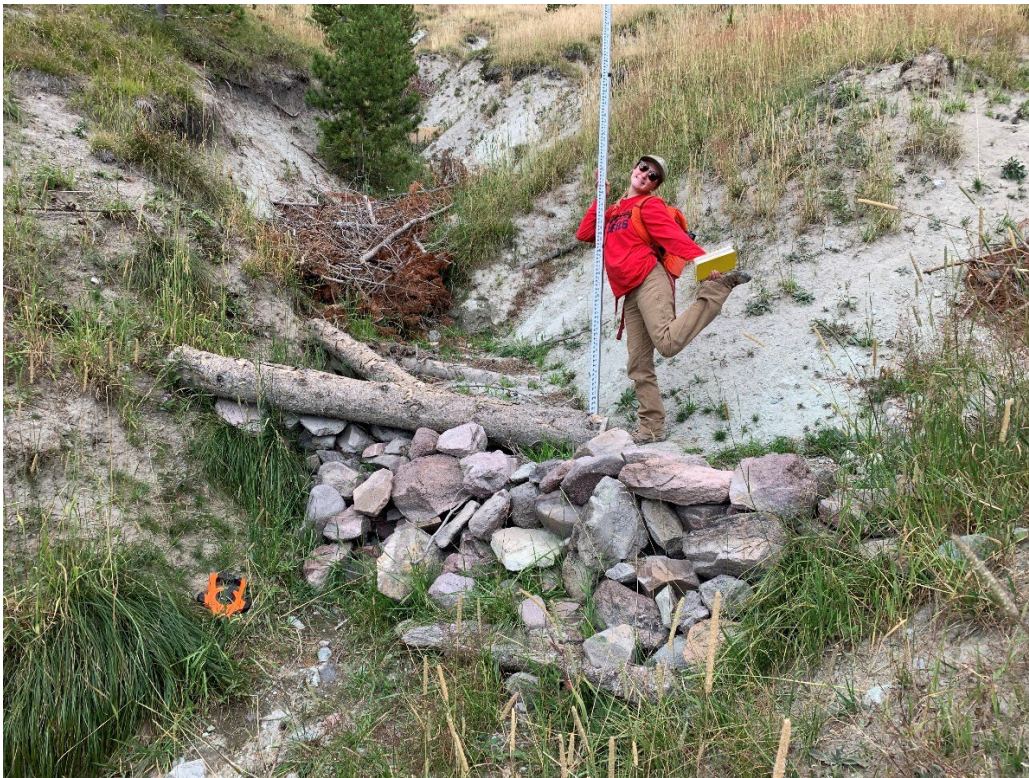
Figure 7. BHWC intern measuring captured sediment behind 3 different gully check structures

Gully slash filters and in-stream structures certainly provided additional sediment catchment, but this sediment capture was not measured. Based on channel dimensions where beaver mimicry structures were installed, a rough estimate of 4.5 cubic feet of catchment was recorded.

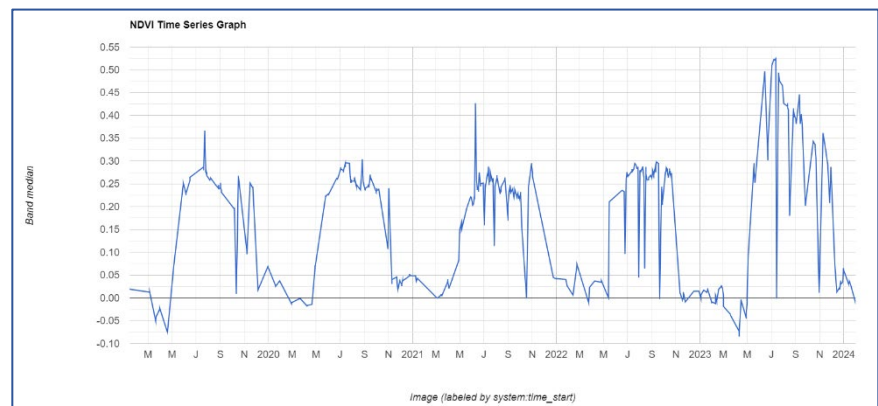
Figure 8. NDVI Time-Series of Oregon Cr. Upland Polygon

NDVI imagery is an excellent way to capture vegetative vigor and response to restoration actions on a landscape scale. With the goal of covering the bare soils with native vegetation to begin to abate downstream sedimentation, the measure of change in vegetation cover on treated uplands was our target for monitoring. We used an [NDVI mapping tool](#) developed at Yale University to assess the change in vegetation cover on a 9-acre upland slope at the upper end of the project.

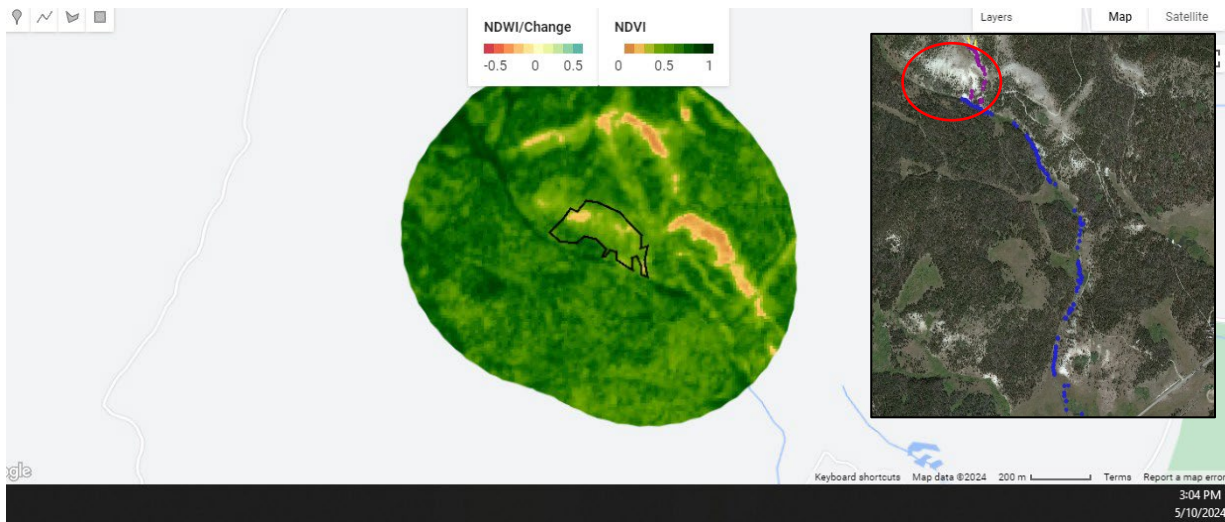
Figure 10. 2023 NDVI Image Upper Oregon

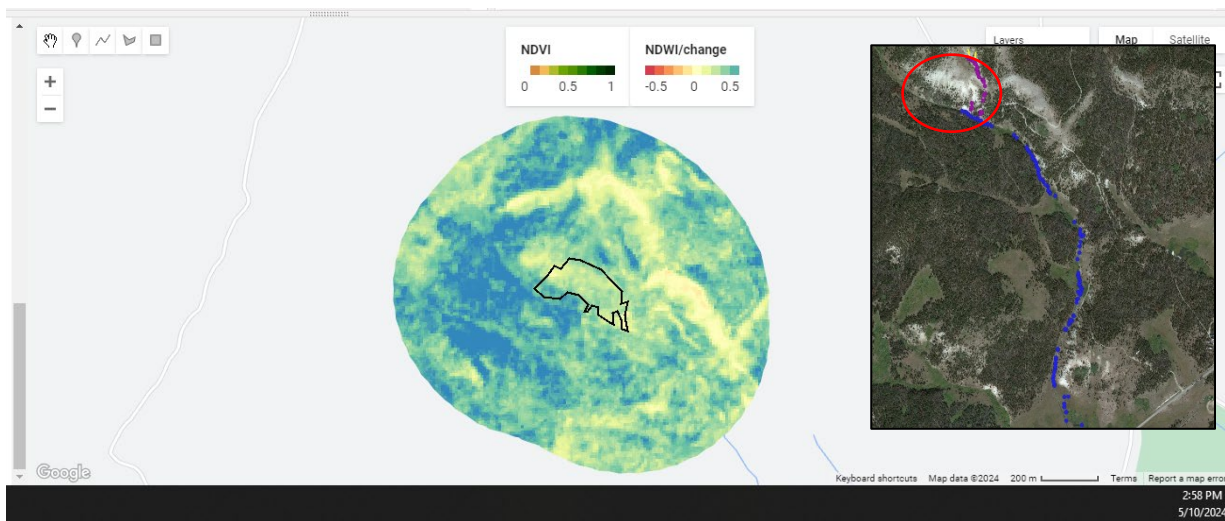
Figure 11. Change in NDVI 2019-2024

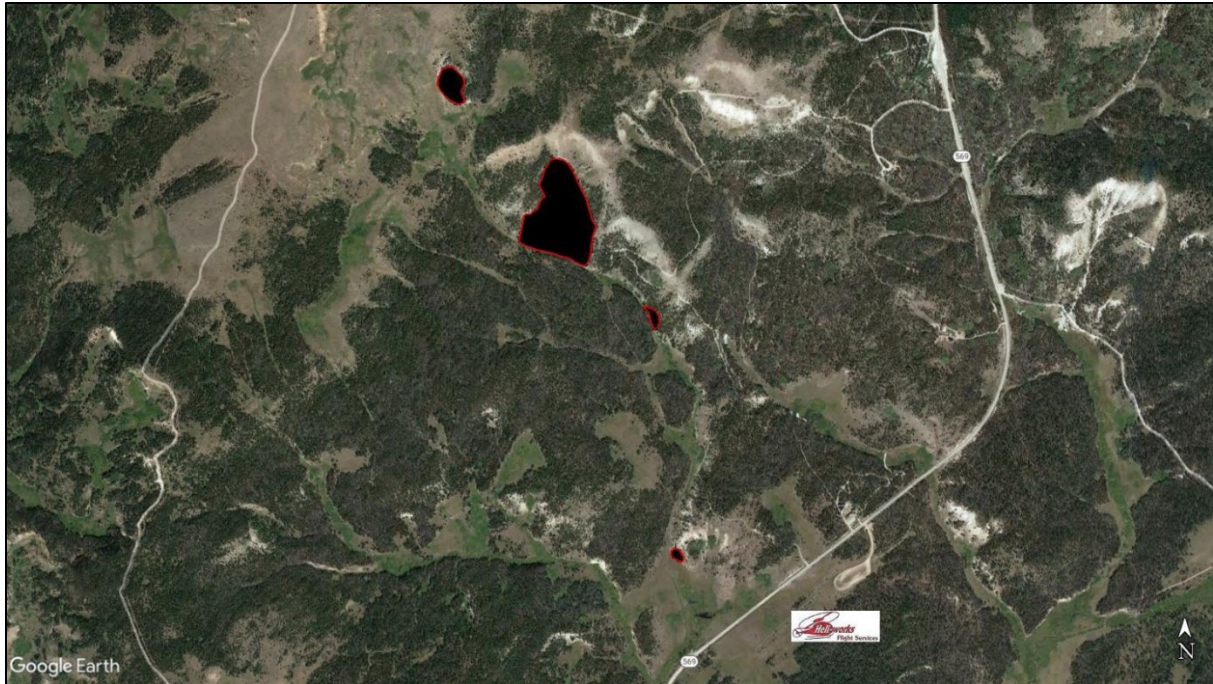
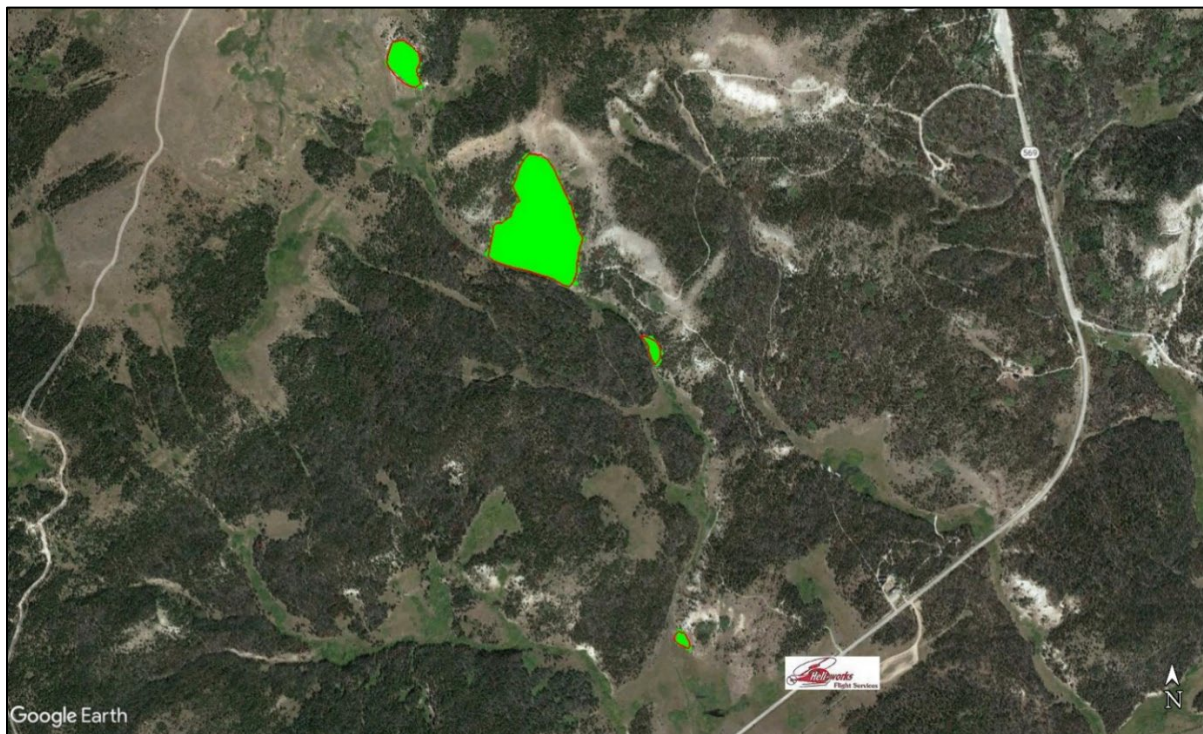
Figure 12. Heli Works 2022 fertilizer (black) and seed (green) exact flight paths

The 25 acres of bare upland slopes received the broadcast fertilizer (Sustane 8-2-4) treatment. Treatments were conducted by Heli-Works Flight Services from September 8th-11th. The aerial (helicopter) seed application to the 25 acres of uplands was completed on October 18th, 2022. Heli-Works Flight Services applied the native seed mix at a rate of 16/lbs per acre (Figure 12).

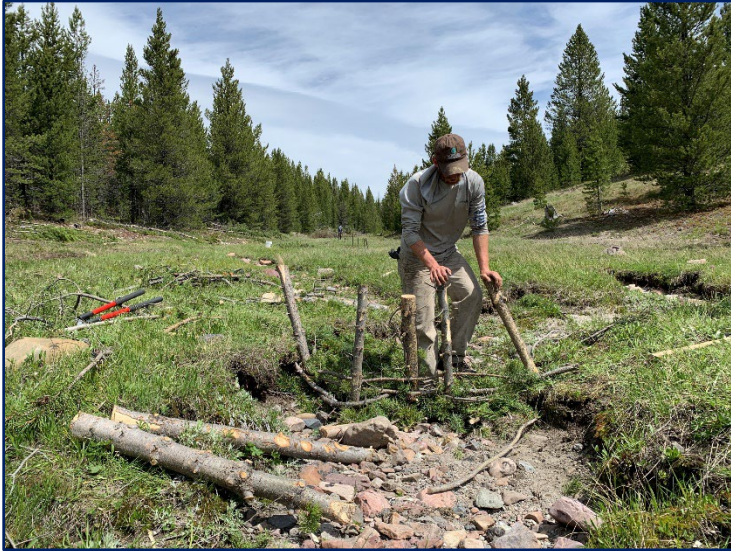
Installation of lower reach BDA (2022).

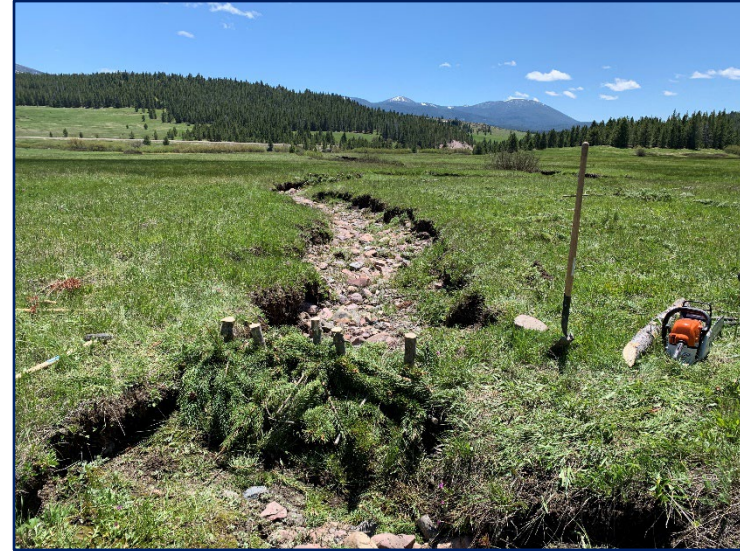
Completion of BDA in the lower reach (2022).

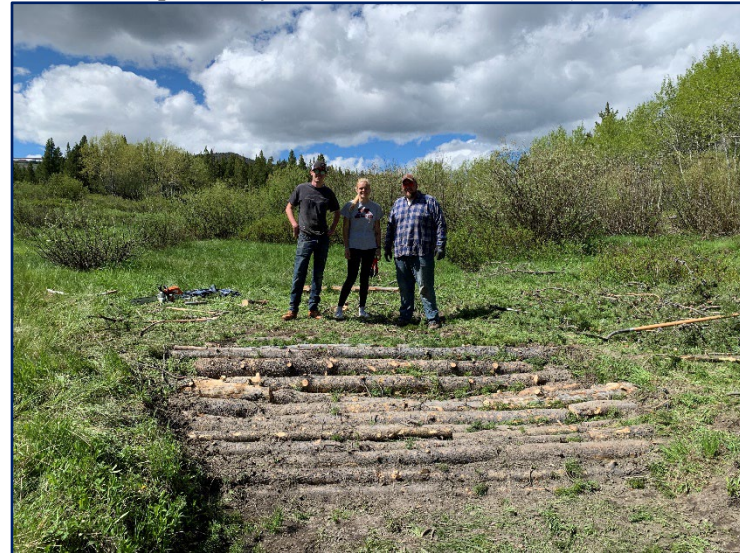
Volunteers proud of their work on a large head-cut stabilization structure in the middle reach (2022).

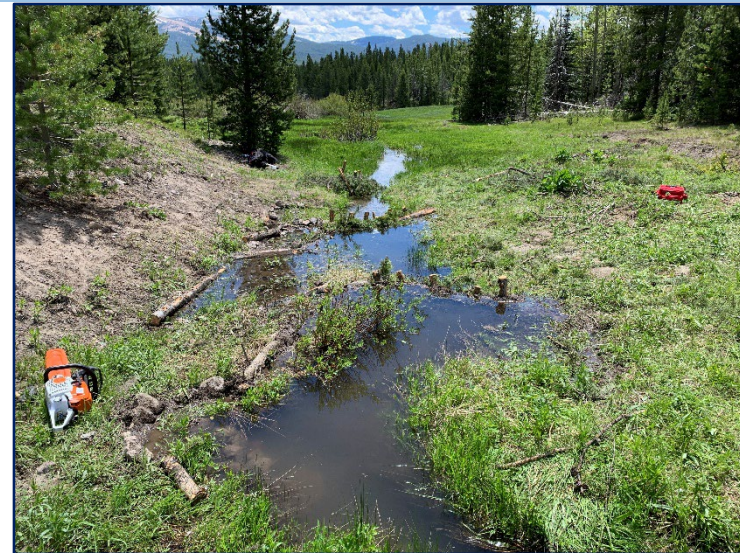
Newly constructed BDA series in the upper reach (2022).

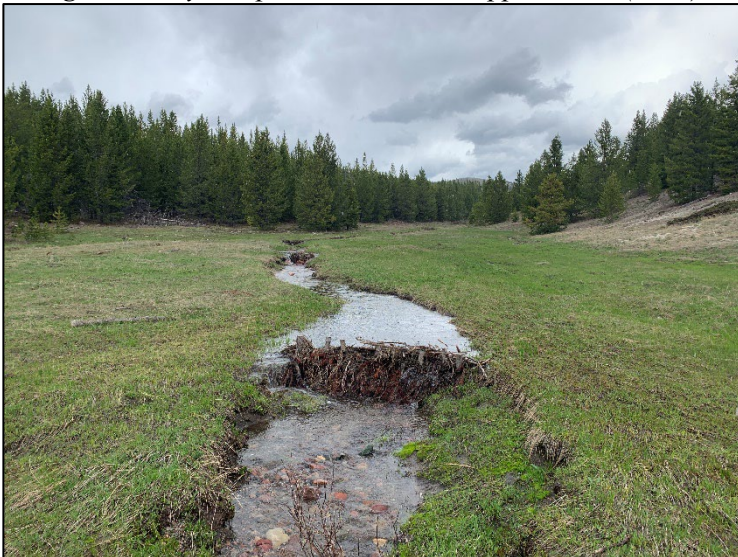
Activated BDA in the lower reach (spring, 2023).

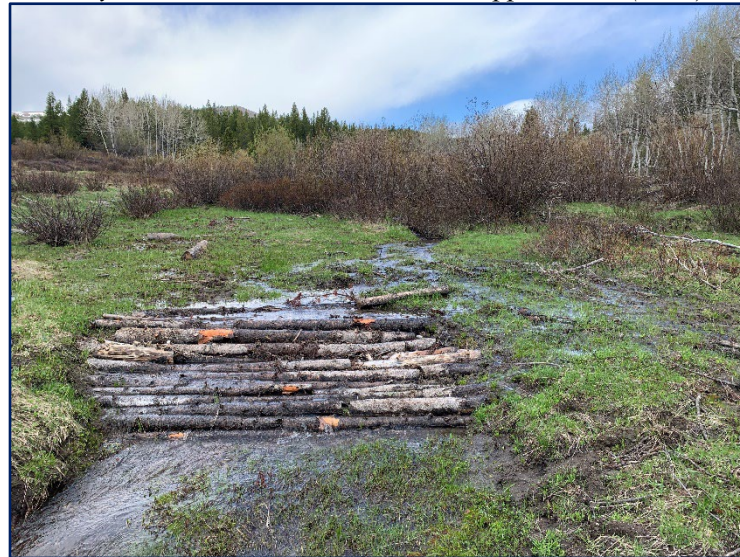
Large head cut activated and properly functioning (spring, 2023)

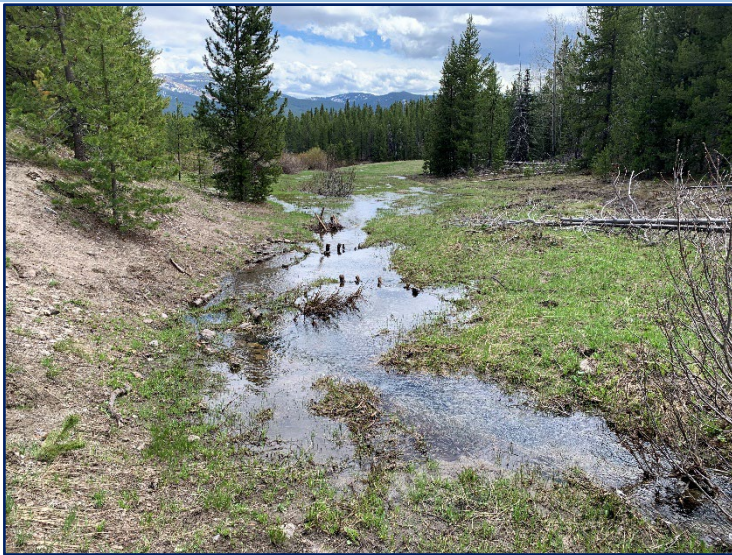
Good floodplain activation in BDA series (spring, 2023).

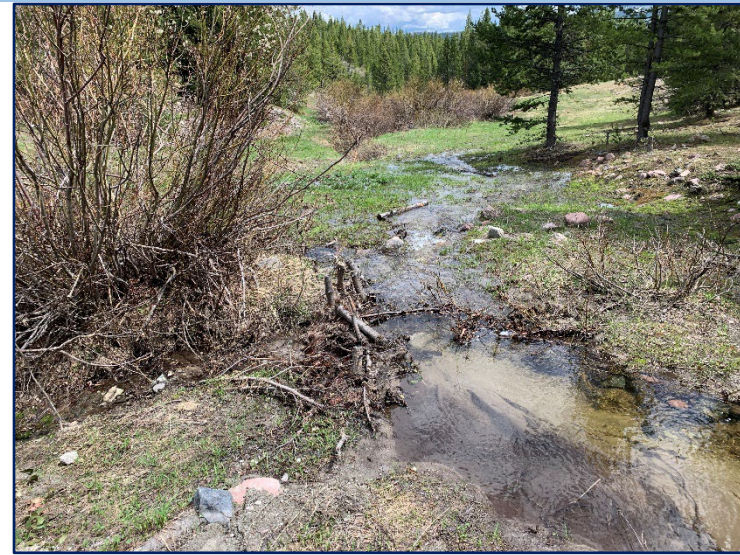
Good floodplain activation and sediment capture in upper reach BDA (spring 2023).

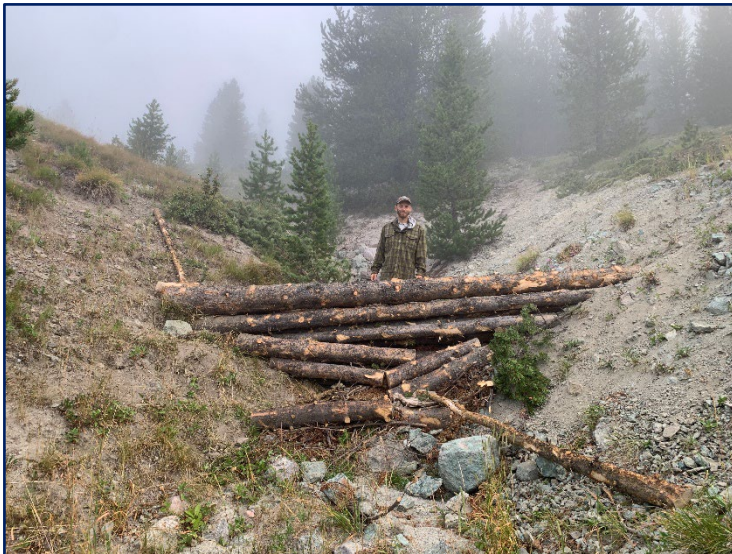
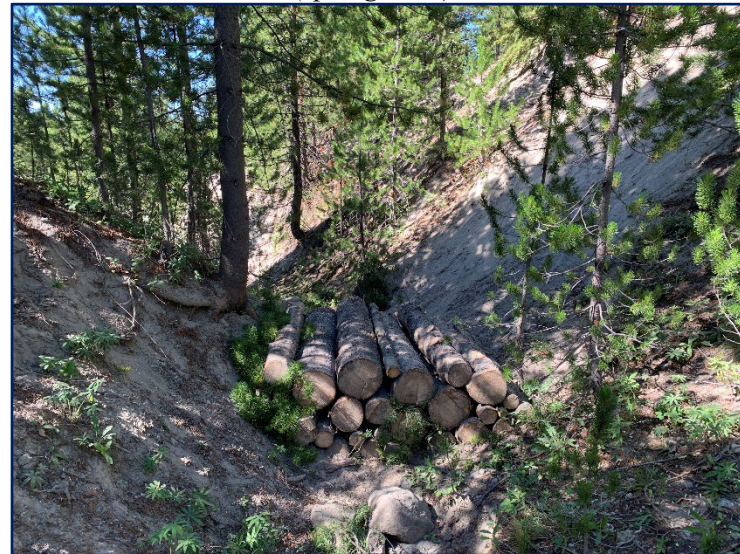
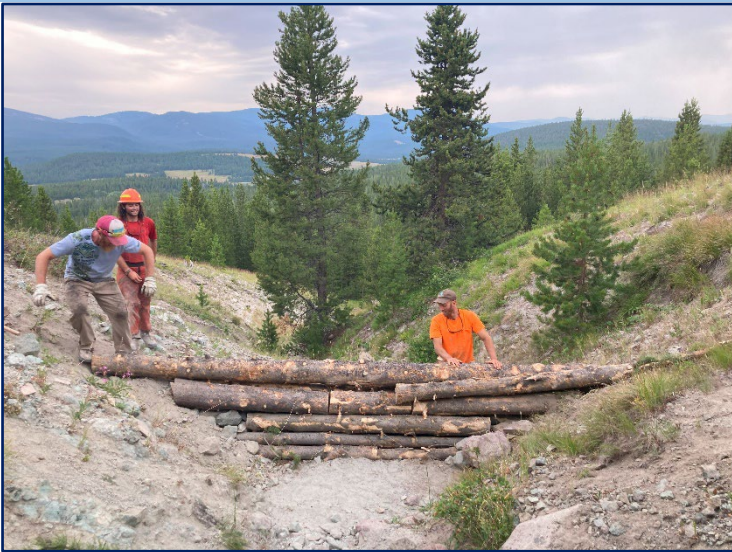
Newly constructed gully check dam (2022).

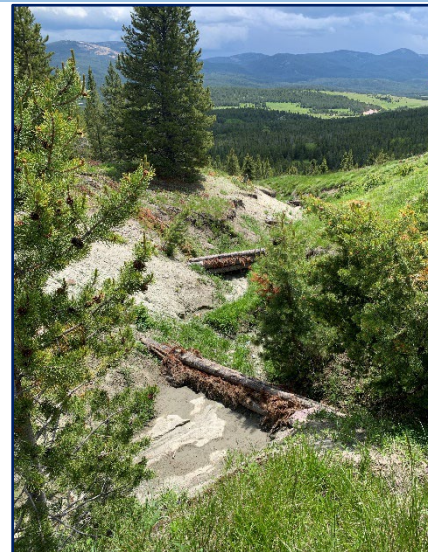
Gully check dam series holding back freshly deposited sediments (2023)

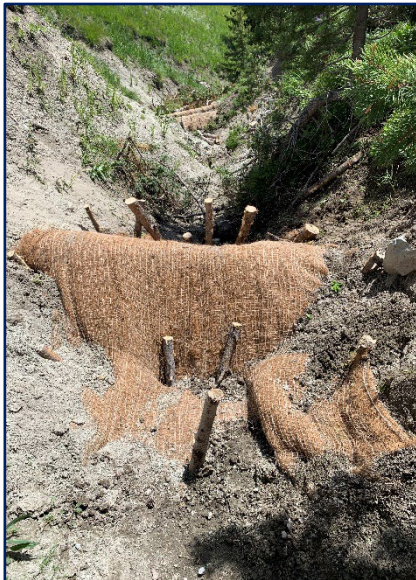
Gully check dam maintenance (2023).

Gully Check Dams: Upland sediments were already being captured behind gully check dam structures, some of which are already at capacity. Watershed Consulting and MCC crews spent a portion of a week (6/26/23-6/30/23) maintaining and fixing 2022 installed gully check dams. Some dams had blowouts and log failures. We incorporated leftover coconut coir fabric to patch blowouts. ALL upland gully check structures have been fixed and strengthened.

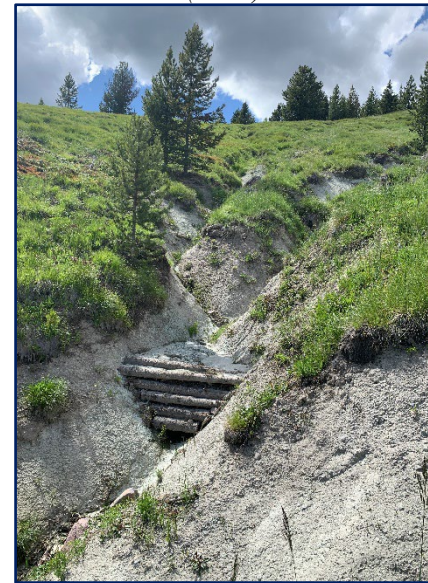
Upper most gully check dam at capacity (2023).

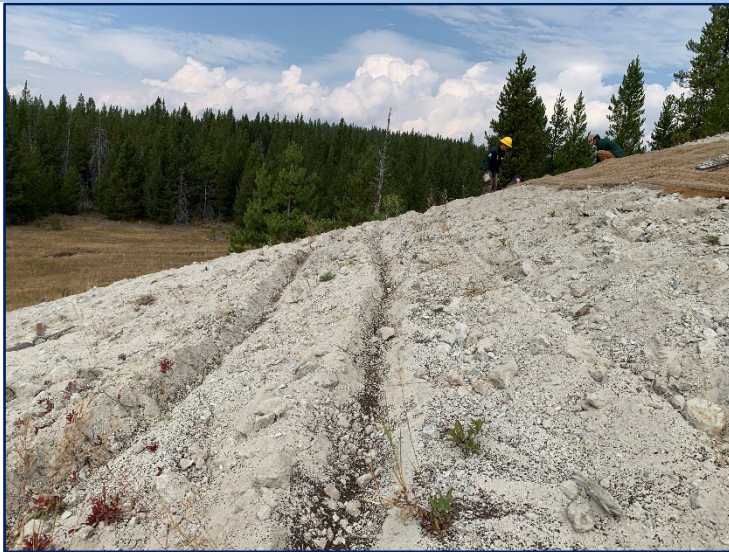
Scarification trenches and fertilizer in "coir band-aid", mid-construction (2022)

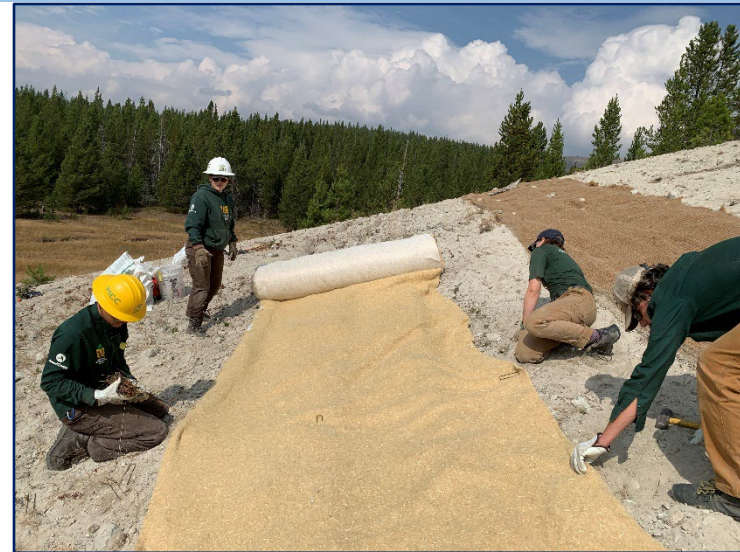
Coir being installed over trenches and fertilizer, mid construction (2022).

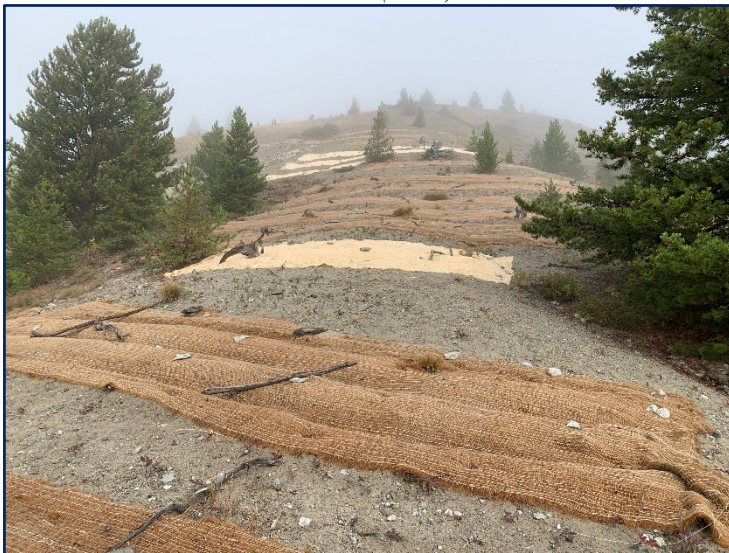
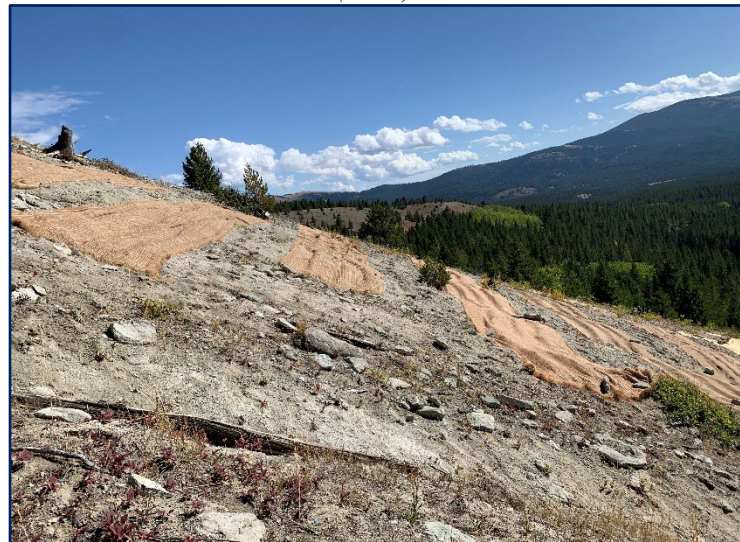
Freshly constructed "coir band-aids" in the uplands (2022).

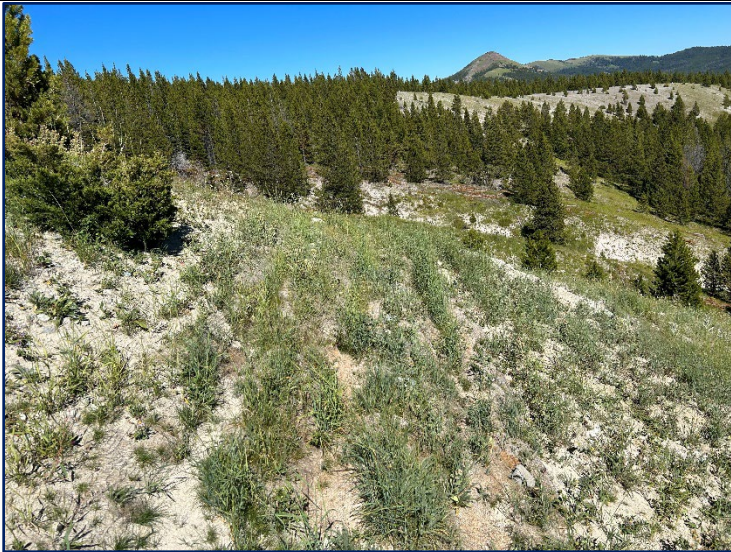
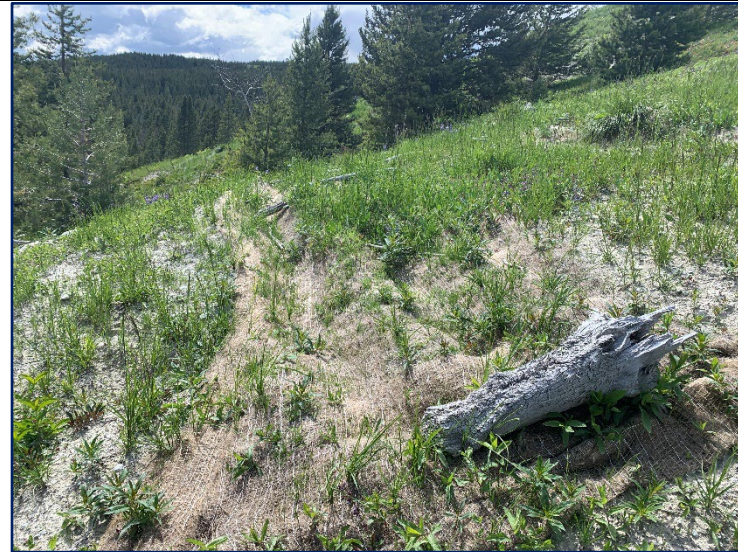
"Coir band-aid" fully vegetated (2023)!

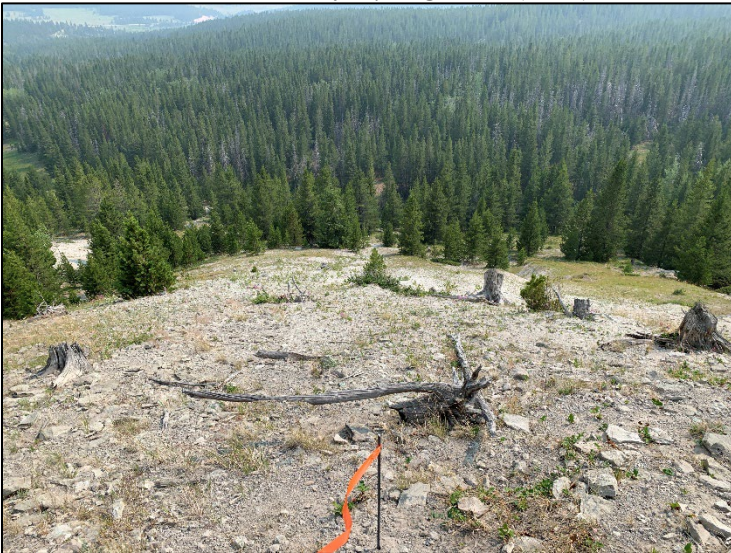
Before photo point (2022).

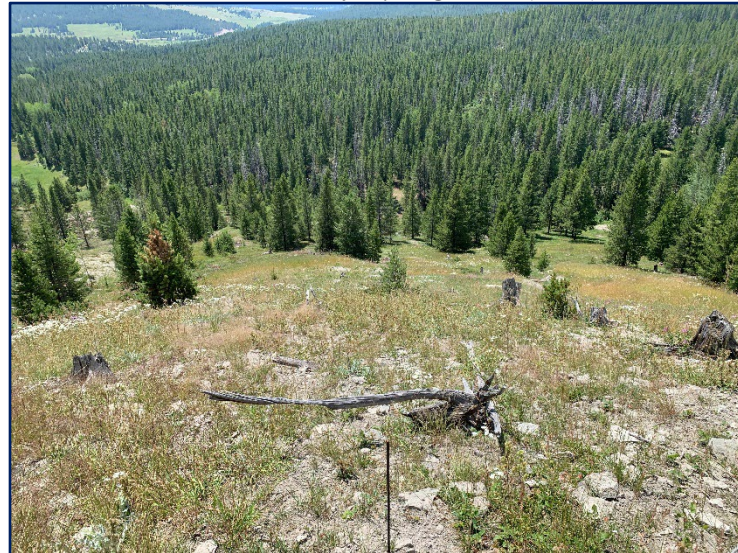
After photo point (2023). Note the clear success of the vegetation treatments!

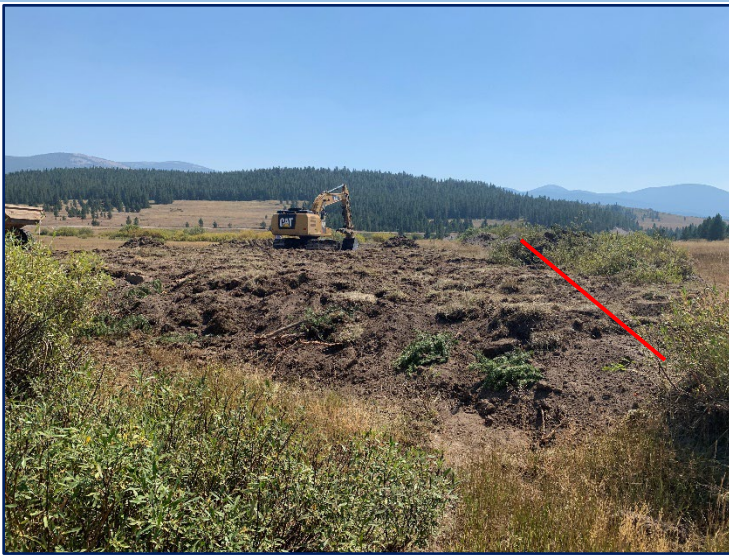
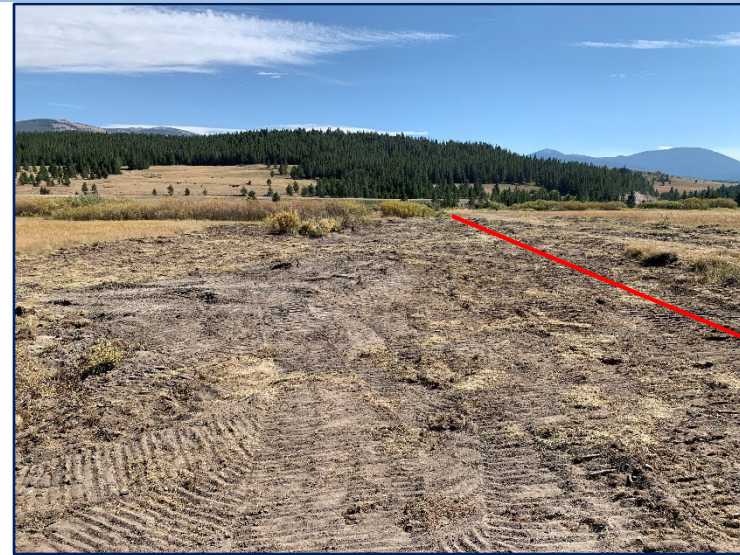
“Stage 0” mid construction (2022). Note: red line signifies where the old channel alignment was.

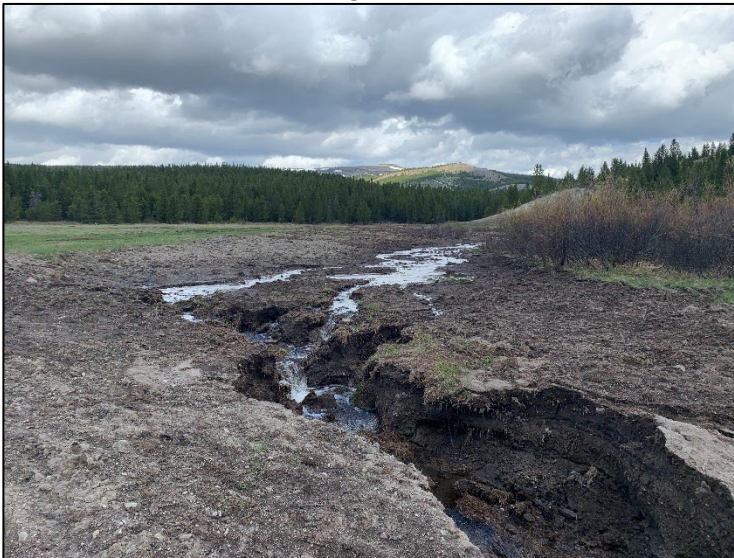
“Stage 0” head cut formation after first runoff (spring, 2023).

Stage 0 Floodplain Reconnection: Mechanized maintenance on the "stage 0" portion of the project (last year's work) was necessary in 2023. A moderately sized head cut formed in the spring of 2023 when water from Oregon Creek failed to rejoin its historic channel and instead followed a reach of low ground into raw earth from 2022 excavation work. The earth was still "raw" and unvegetated, enabling the head cut to work approximately 30 ft upstream. Watershed Consulting repaired the head cut on 6/29/23. Using an excavator, the headcount was filled in to create a swale and armored with willow transplants and harvested sod mats. We also used the excavator to encourage water to flow into the remnant channel using sod mats and minor channel formation.

Lessons Learned: One of the biggest lessons learned was to incorporate more woody/hardened material during the construction of the “Stage 0” portion of the project. During the “cut and fill” process, we utilized adjacent trees and wood to bury and incorporate into the old channel alignment, but not nearly enough. During the spring of 2023, water found its way onto the freshly disturbed fill area and created a substantial head cut in the lower portion of the project. This could potentially have been avoided if the water hit a hardened surface underneath the soil and wasn't allowed to cut down. Furthermore, the head cutting could have been potentially mitigated with a more in-depth survey of the surrounding “finished” ground surface to ensure water was, in fact, going to flow exactly where we wanted. Because the project was a “Stage 0” project in nature, we always had the approach of “let the water find its own path.” In hindsight, we could have taken a few extra steps to ensure the water flowed into the remnant channel as desired. Luckily, we had the budget to fix and follow through with these lessons learned in 2023.

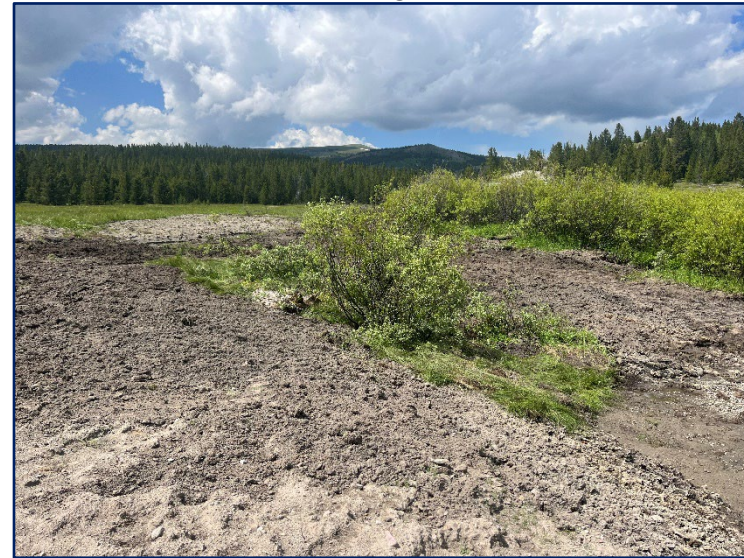
“Stage 0” head cut fix/stabilization (summer,2023)

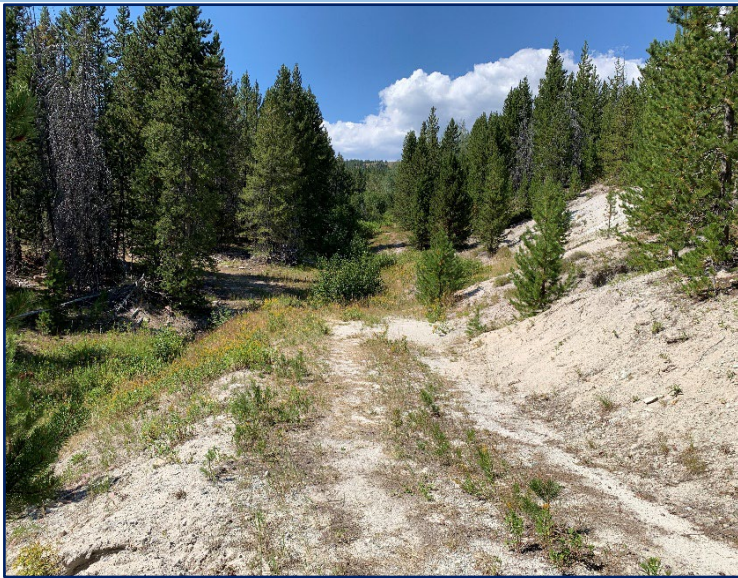
Before photo of road obliteration (2022).

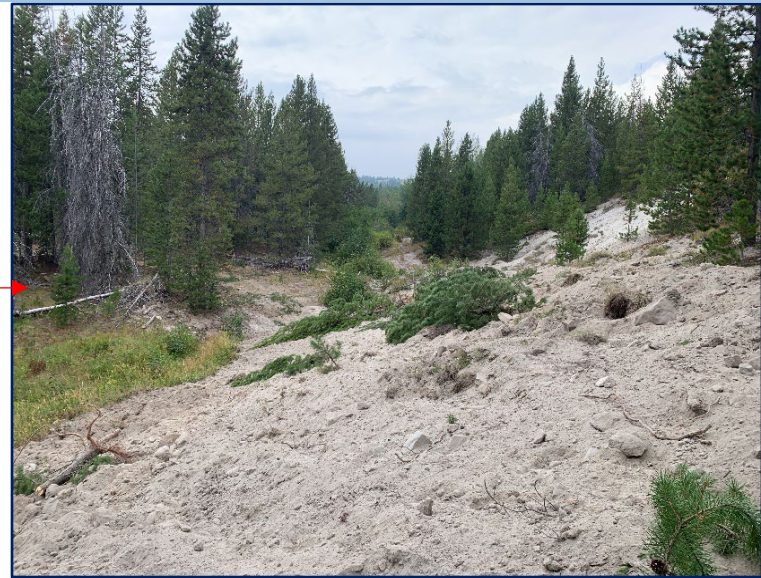
After photo of road obliteration (2022).

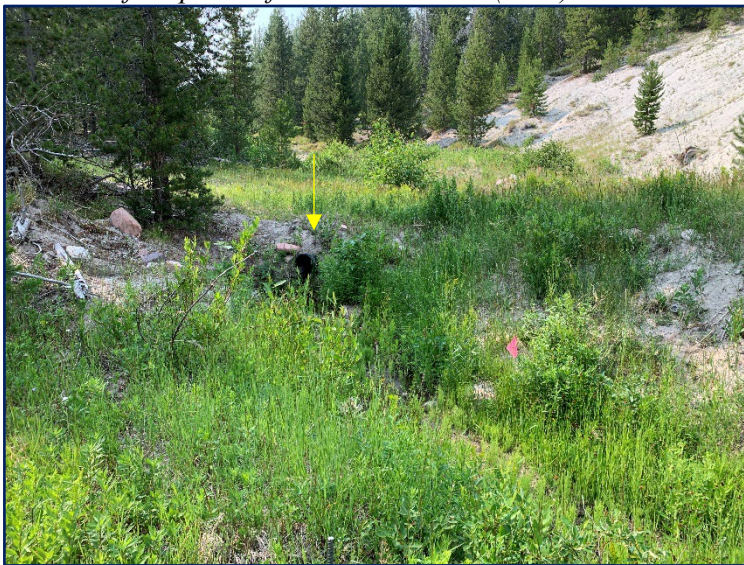
Before photo of perched culvert (2022).

5. *Goal:* Remove a failed culvert, impeding fish passage to approximately .5 miles of Oregon Creek headwaters (yellow dot)
Objective: Pull perched culvert and reconstruct stream channel
Outcome: Removed perched culvert and reconstructed stream channel

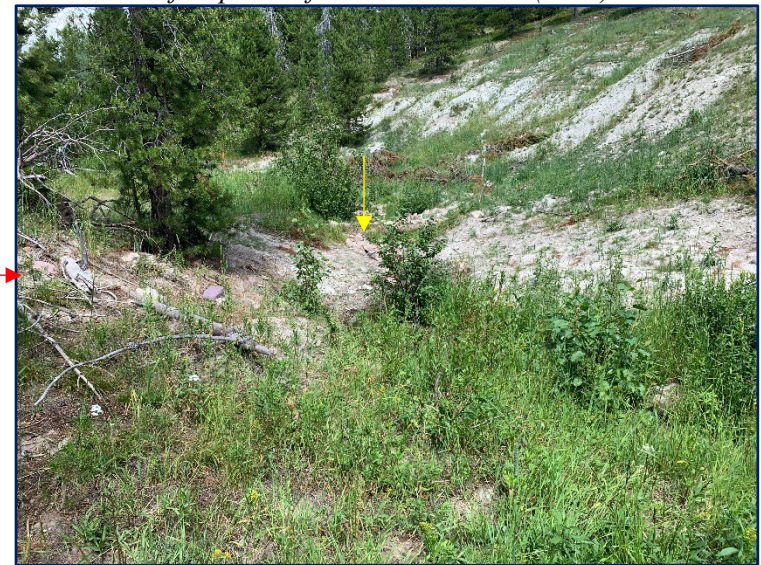
After photo of perched culvert removal (2023).

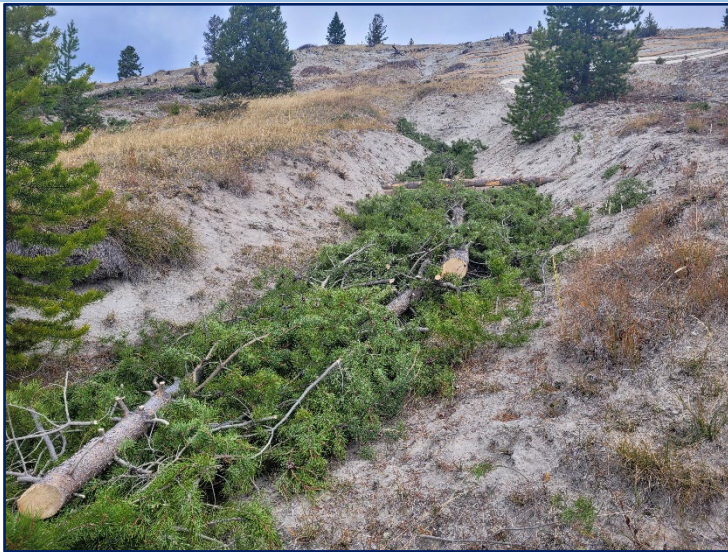
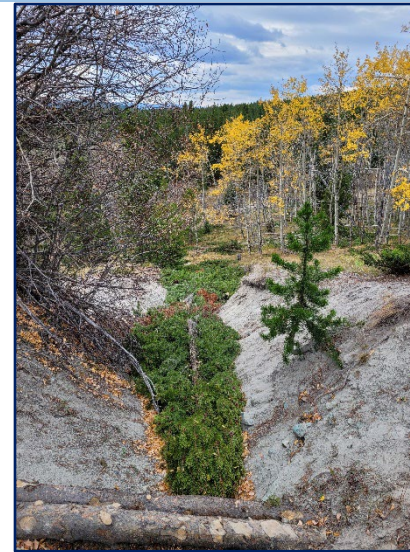
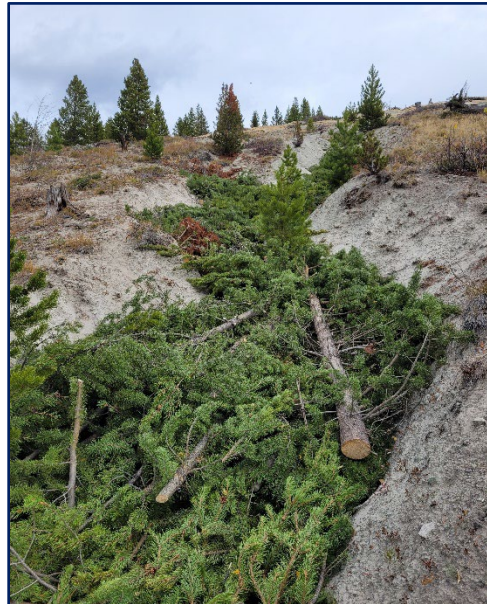
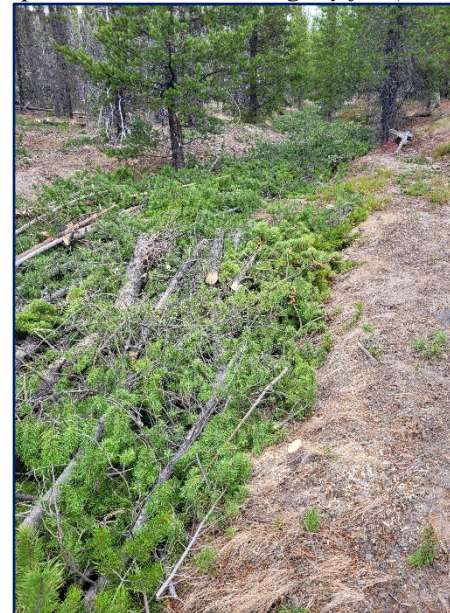
Aspen enhancement and gully fill (2022).

Aspen Enhancement: The aspen enhancement portion of the project is complete. Work was performed from October 19th-21st, 2022. The contractor, Worman Forest Management LLC, thinned conifers (primarily lodgepole pine) within 100 feet of eroded gullies, placing the cut material in the gullies for erosion control. Approximately 8,300 linear feet of gullies were treated and 30 acres were thinned, reducing conifer competition within scattered aspen stands. The thinning only removed trees less than 6 inches DBH.

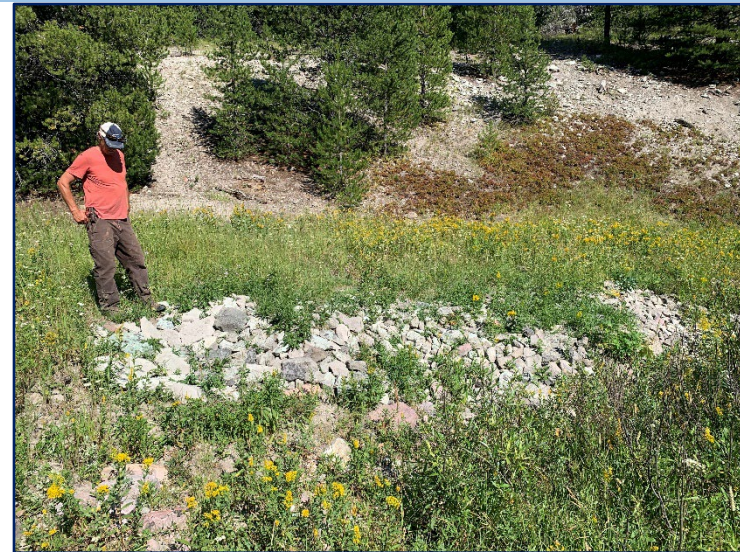
Touring the stream project site with NRDP (2023). Ray Vinkey is inspecting a head cut structure installed in the middle reach in 2022.
