Lower Wise River Stream Corridor Assessment

Final Report

Lower Wise River Stream Corridor Assessment
Final Report

Prepared for the Big Hole Watershed Committee

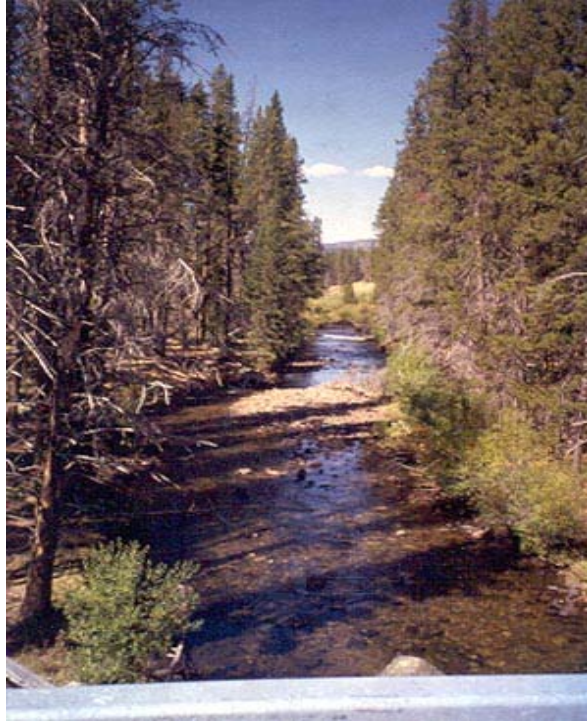
WR 1A - Wise River mainstem located downstream from where Jacobsen Creek and Mono Creek join to form the Wise River.

Much of the upper watershed is characterized by erosive, granitic-based soils. There have been high sediment loads generated from roads, hard rock mining (Elkhorn Creek), livestock grazing, and bank trampling (OEA Associates, 1994). Some of the low-gradient willow bottoms along the upper Wise River are sediment depositional areas. The river channel has responded to the influx of upstream sediment with large point bar development, active bank erosion, and rapid channel migration. Channel incisement was also observed along some of these headwater reaches.

The USFS is aware of the sediment issue and has been actively mitigating some of the major sediment sources. The USFS has the Jacobsen Creek subwatershed listed as a High Restoration Priority watershed and the Wyman Creek subwatershed as an Extreme Restoration Priority watershed (USFS, Big Hole Subbasin Restoration Plan, March 2001). Specific restoration priorities have been identified on Elkhorn Creek (mining), Little Joe Creek (recreational trails or stock impacts), Rabbia Creek (recreational trails or stock impacts), and Crozier Creek (cattle damage to stream beds or banks).

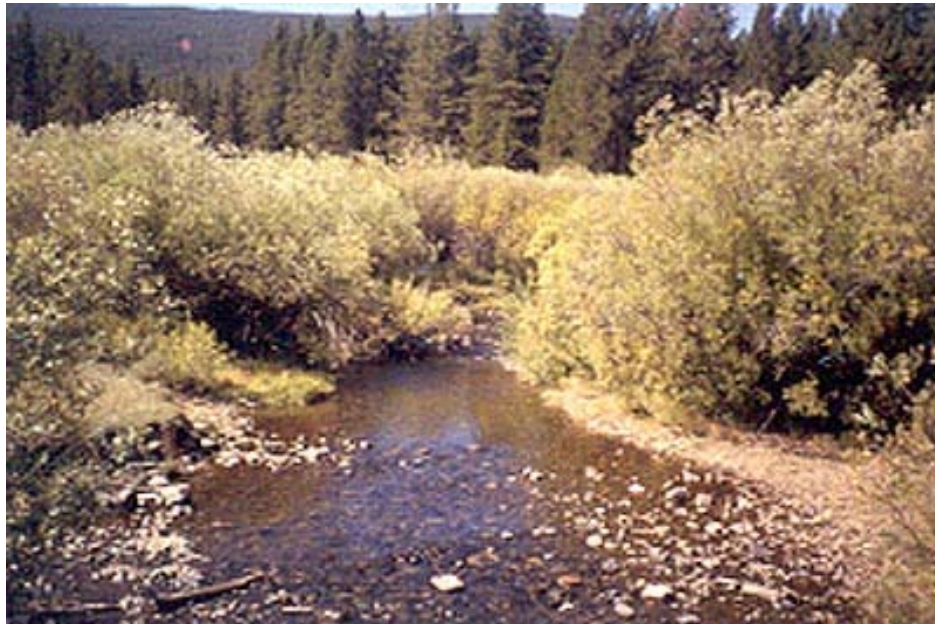
Lacy Creek is the only major tributary entering the Wise River from the west. USFS has rated the upper reaches of Lacy Creek (upstream from Bobcat Creek) as being stable and well functioning. The section of Lacy Creek between Bobcat Creek and the Wise River has been affected by livestock grazing and bank trampling. Bank erosion potential is high and channel stability has been rated fair. Much of this section is dry during the latter part of the summer for unknown reasons. Stream improvement projects on the middle and lower reaches of Lacy Creek are being considered by the USFS.

Lacy Creek upstream from the Wise River (Site LC-1).
This photo is looking downstream from the Lacy Creek Road Bridge.

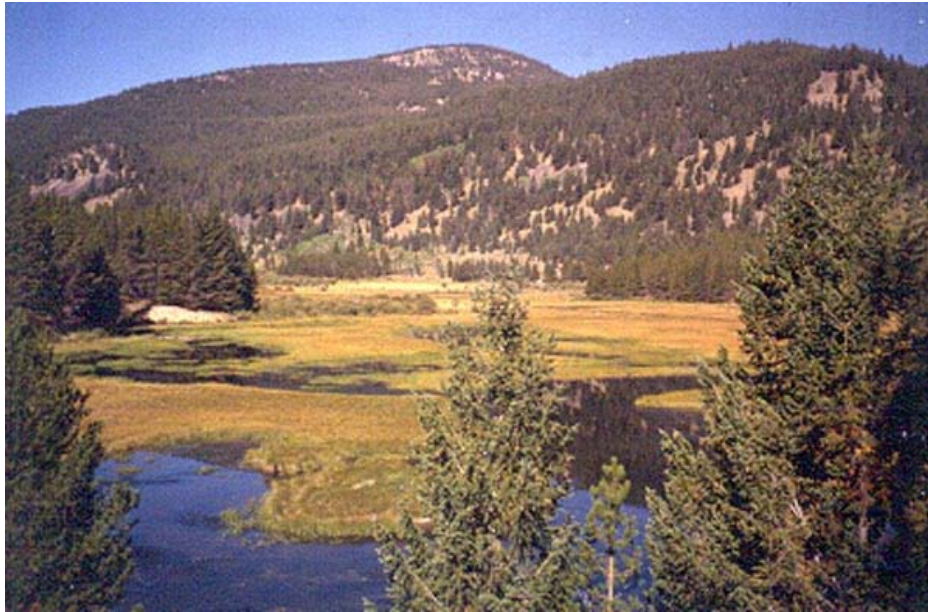
Reach PC-1 This reach extends for approximately two miles upstream from the old MPC dam site. Reach PC-1 scored **77%** on the Riparian Assessment Worksheet.

PC1 - Pattengail Creek looking upstream from the old Montana Power Company dam.

In 1901, the Montana Power Company (MPC) built a dam at a natural constriction of the lower Pattengail Creek valley slightly less than a mile upstream from where Pattengail Creek enters the Wise River. After several years of use, the dam was breached and the company abandoned it. Local ranchers then filled the cut in the dam and used the reservoir to store water for irrigation. In 1927, the dam was overtopped by floodwaters, which washed out the west side of the dam. Severe damage was caused to property downstream. The reservoir covered about 400 acres and extended upstream for nearly two miles.

- Part of this reach had burned about 25 years ago.
- Some willows along the creek and on the floodplain exhibit heavy browse from wildlife (moose) and livestock. Wildlife impacts appear to be greater than livestock. Heavy browsing of shrubs is having adverse impacts on some sections of riparian health and channel stability.

- Noxious Weeds: Canada Thistle observed in the floodplain and adjacent to the ATV trails.

- An expanded assessment would focus on identifying and characterizing significant sources of sediment as natural and/or human-induced sources. Restoration alternatives to reduce the sediment load to Pattengail Creek would be recommended, if and where appropriate.

Set up permanent monitoring transects along Pattengail and Lambrecht Creeks to document long-term trend in riparian health and channel condition.

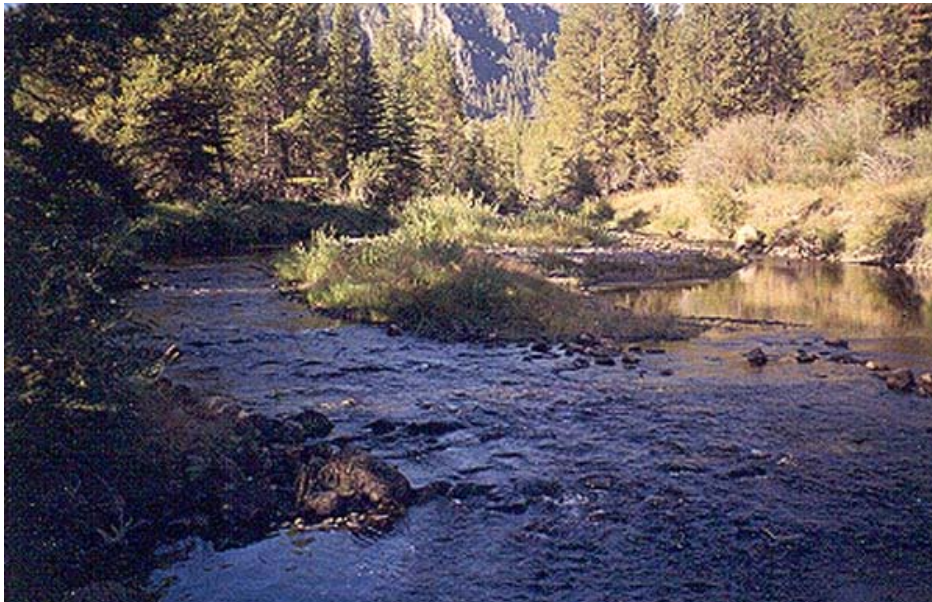
Reach PC-4 This reach extends for about 1 mile from the old MPC dam downstream to where Pattengail Creek enters the Wise River. Reach PC-4 scored **62%** on the Stream Assessment Worksheet.

PC4 - Pattengail Creek located upstream from the Scenic Byway bridge crossing near the confluence with the Wise River.

- This reach has a limited floodplain. Where there is a floodplain (right bank-looking downstream), severe overland scour caused by the surge from the dam washout is still evident. Vegetation has

- The riparian plant community is typically a narrow band of willow and alder (< 20 feet wide) along the channel's edge. Coniferous forest (Lodgepole Pine and/or Douglas Fir) dominates the uplands.
- Browse use on riparian shrubs varies from low use on the lower end of the reach to heavy use closer to the washed-out dam. Browse is primarily attributed to wildlife.
- Noxious weeds: Varying degrees of Oxeye Daisy infestations were found along the creek channel and adjacent floodplain.

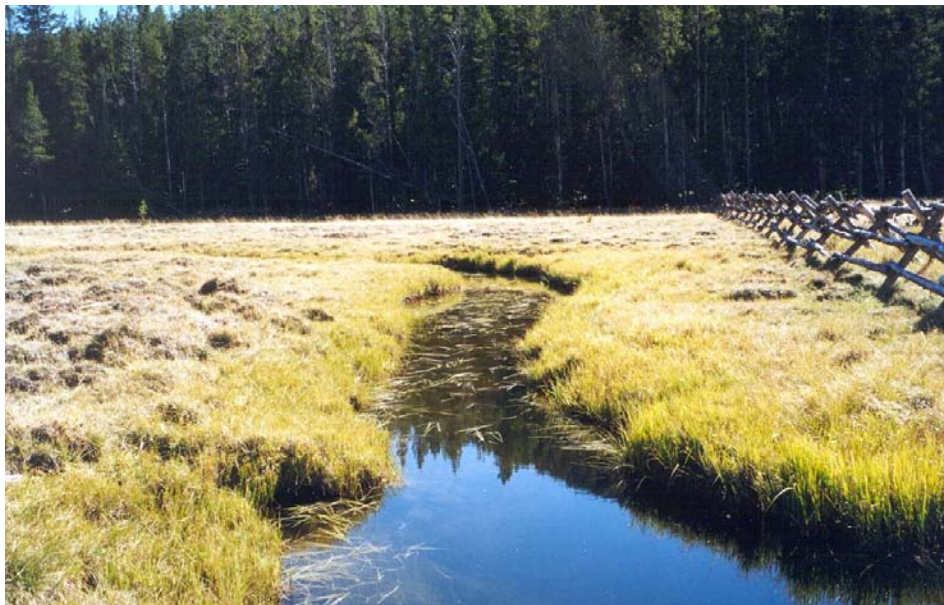
Reach LT-1 Lambrecht Creek at Jerked Prairie. Lambrecht Creek is a tributary that enters Pattengail Creek from the south about 4 miles upstream from the Wise River. Jerked Prairie is a private in-holding located approximately 2 miles upstream from where Lambrecht Creek enters Pattengail Creek. A Riparian Assessment Worksheet was not filled out for this reach.

Lambrecht Creek at Jerked Prairie

- The channel that flows through Jerked Prairie is a low gradient, E5 channel type. The channel is in excellent condition. Width/depth ratio is 3 to 5. This channel type is especially sensitive to heavy grazing pressure and requires careful livestock management.
- The channel downstream from this reach is currently in a USFS grazing allotment. It also is in good condition, but the width/depth ratio of the channel is greater with some bank shear from livestock trampling noted.

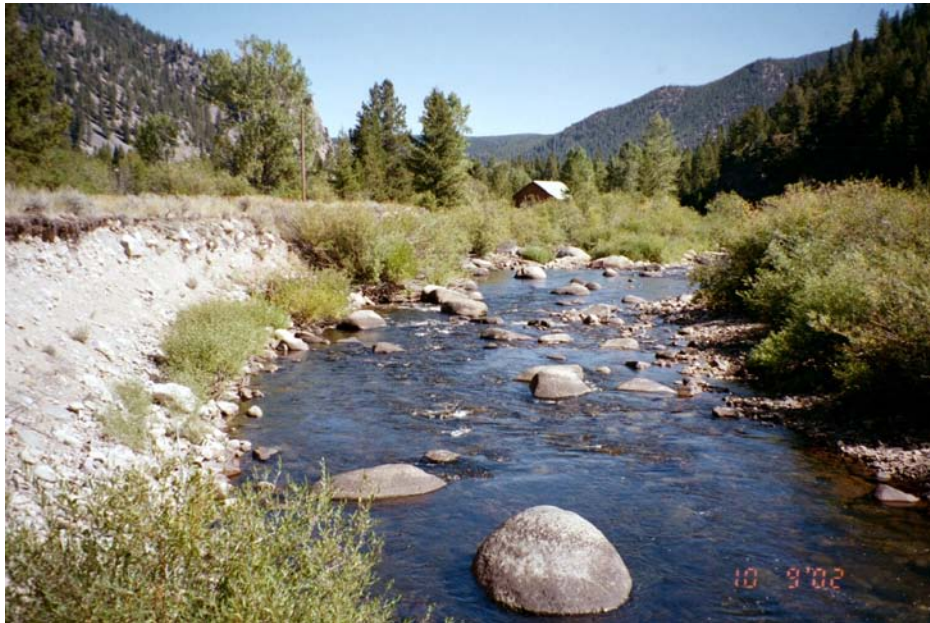
Reach WR-1 Wise River Mainstem - Flying Cloud Ranch Bridge. This reach is located approximately 1.3 miles downstream of where Pattengail Creek enters the Wise River. There is an old gage station about ½ mile downstream. Reach WR-1 scored a **90%** rating on the Stream Assessment Worksheet.

WR1 - Wise River mainstem looking downstream from the Flying Cloud Ranch Bridge.

- The riparian plant community is dominated by willows with scattered Black Cottonwood overstory. The plant community shows excellent age diversity. Smooth brome and timothy grasses are common understory plants.
- Browse on the woody species was estimated to be about 25%, mostly wildlife use. There is little use of this reach by domestic livestock.
- There are scattered Oxeye Daisy infestations throughout the floodplain.

Establish permanent monitoring sites along the Wise River mainstem to determine long-term trends in riparian health and channel conditions.

- Monitoring parameters would be similar to those recommended for Pattengail and Lambrecht Creeks. A long-term monitoring on the lower Wise River would be an important tool for landowners and managers to have when making management decisions that affect long-term forage production and stream corridor health.

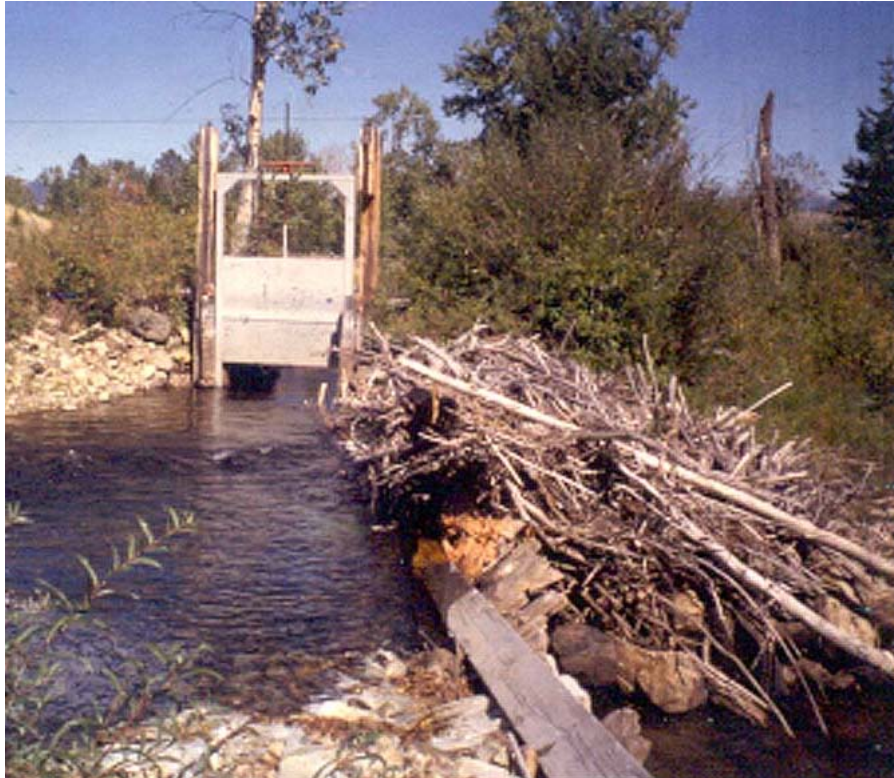
Reach WR-2 Wise River mainstem at the Company Ditch headgate and check structure. The Company Ditch is the largest irrigation ditch in the watershed. The check structure and headgate, located on the west side of the river on a side channel, consists of old wood cribbing, brush, and large rocks. The water is checked up over 3 feet during low flows. The landowner has expressed interest in replacing this check structure with a more efficient and stream friendly structure. A riparian worksheet was not filled out for this reach.

Company Ditch Headgate – Wise River flows from right to left.

The WR-2 and WR-3 reaches are typically used by livestock during the fall and winter, and occasionally in the spring. This part of the river is often used for winter feeding.

Noxious Weeds: Canada Thistle, Oxeye Daisy, and Spotted Knapweed infestations are common along these reaches. There is an active effort to control these weeds by the landowner.

Replace major irrigation check structures on the lower Wise River mainstem.

- Priority check structures provide irrigation water to the Company Ditch and the Truman Ditch. The design of the replacement structures should consider low-cost alternatives. There is an opportunity to take advantage of the abundance of large rock in the near vicinity that could easily be incorporated into the construction of the check structures. The structure design should be fully compatible with natural stream function (narrowing of the channel) and fish passage while still meeting the irrigation water needs of the landowner(s).

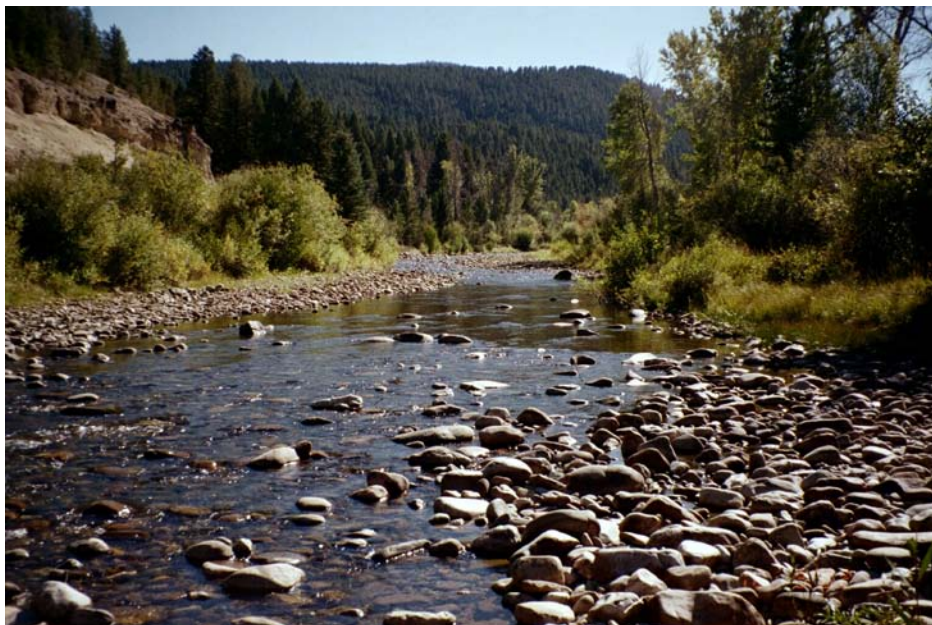
Reach WR-4 Wise River mainstem 1,200 feet upstream from the Swamp Creek confluence and approximately 2 miles upstream from the town of Wise River. Reach WR-4 scored an **85%** rating on the Stream Assessment Worksheet.

WR 4 - Wise River mainstem upstream from the mouth of Swamp Creek.

- The riparian plant community consists primarily of willows, alders, and juniper with scattered Black Cottonwood overstory. There is excellent age diversity. Sedges, Kentucky bluegrass, smooth brome, and timothy are common understory plants.
- Young willow plants show signs of heavy browse, probably from both wildlife and livestock.
- Noxious weed infestations along this reach include Oxeye Daisy and Spotted Knapweed.
