Lower Wise River Assessment Survey and Prioritization

April 23, 2010

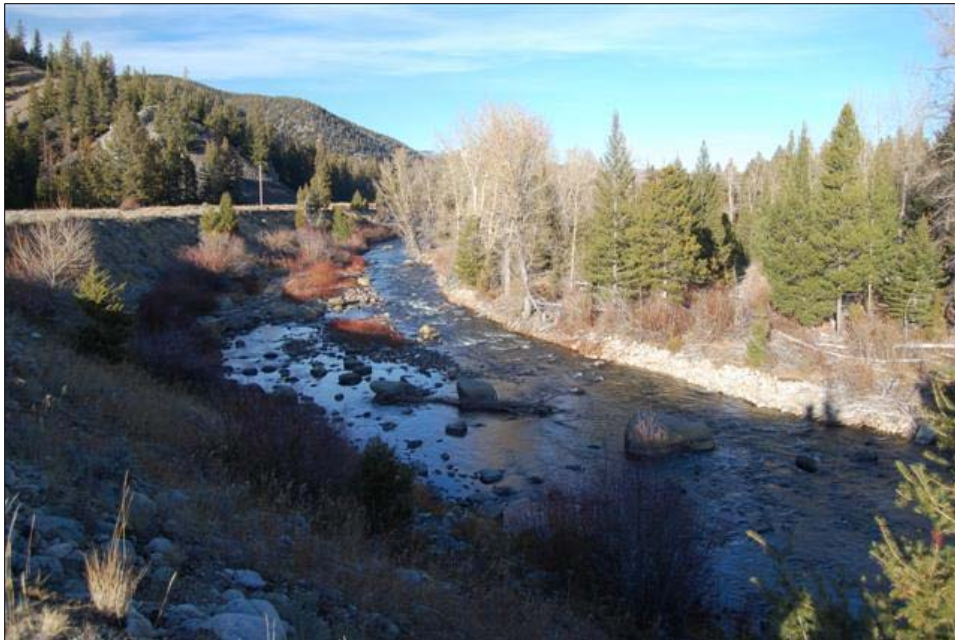
Photo 23. Pleistocene terrace on the left bank; a source of large boulders provides both vertical grade control and lateral bank stabilization, and influences hydraulics at baseflow, a slow water habitat upstream (Map 5, RM 6.90).

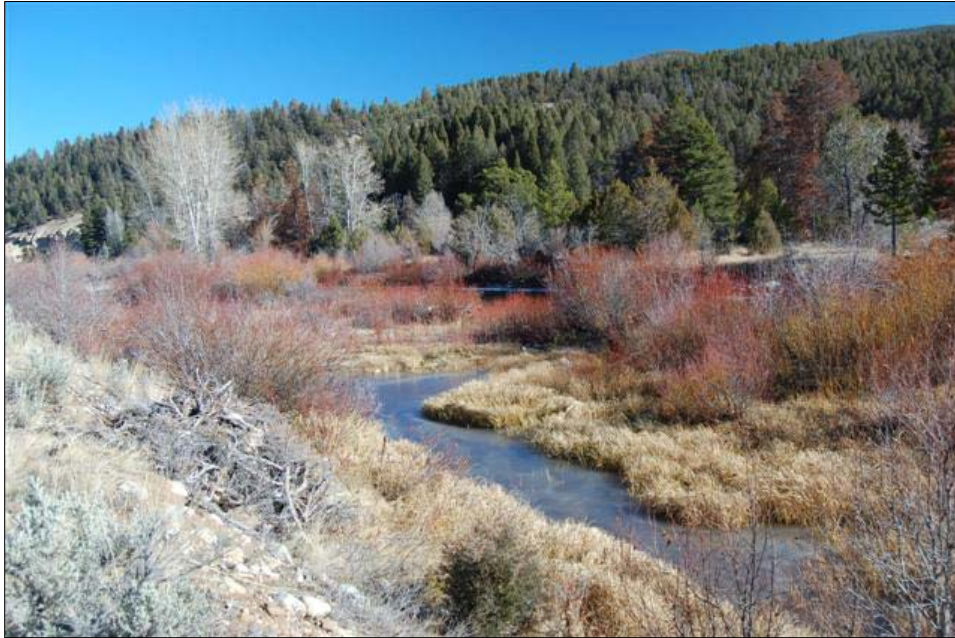
Photo 24. A secondary flood- side channel on the Wise River (Map 3, RM 3.10) provides some limited low velocity refuge and juvenile rearing habitat. Brookies and 20- inch plus brown trout were observed spawning in vicinity of the side-main channel confluence (11/2/09).

MT FWP personnel indicate seasonal use and distribution of resident and non-resident trout and grayling populations throughout the Wise River are not well understood (J. Olsen, personal comm.). Nonetheless, future head gate diversion structure improvements and replacement should consider the ability to retrofit or provide some kind of fish screen or fish passage mechanisms for the future.

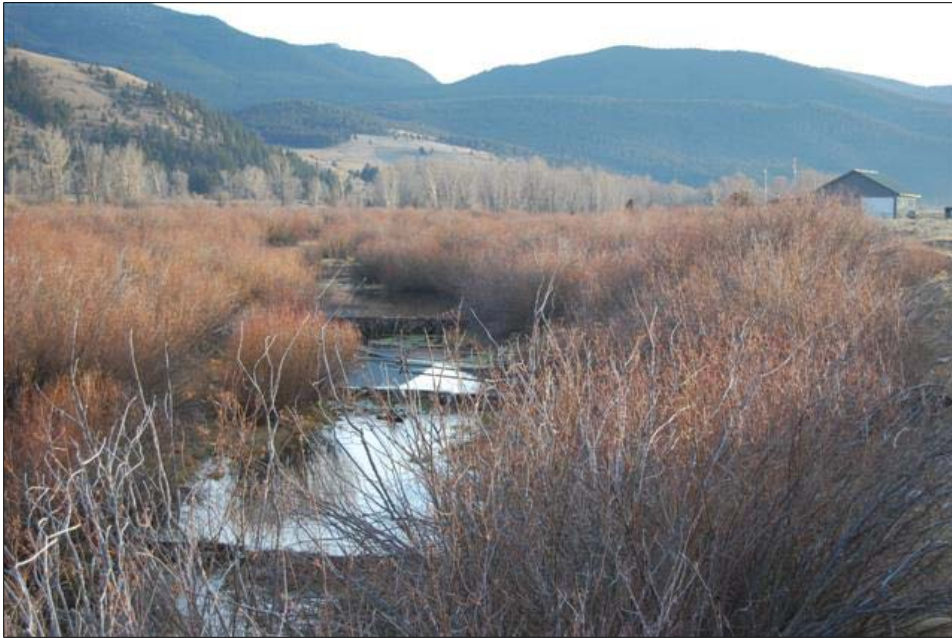
Photo 25. Looking upstream at series of beaver dams near origin of Smart Creek below bench southwest of town, Wise River corridor (Map 2).

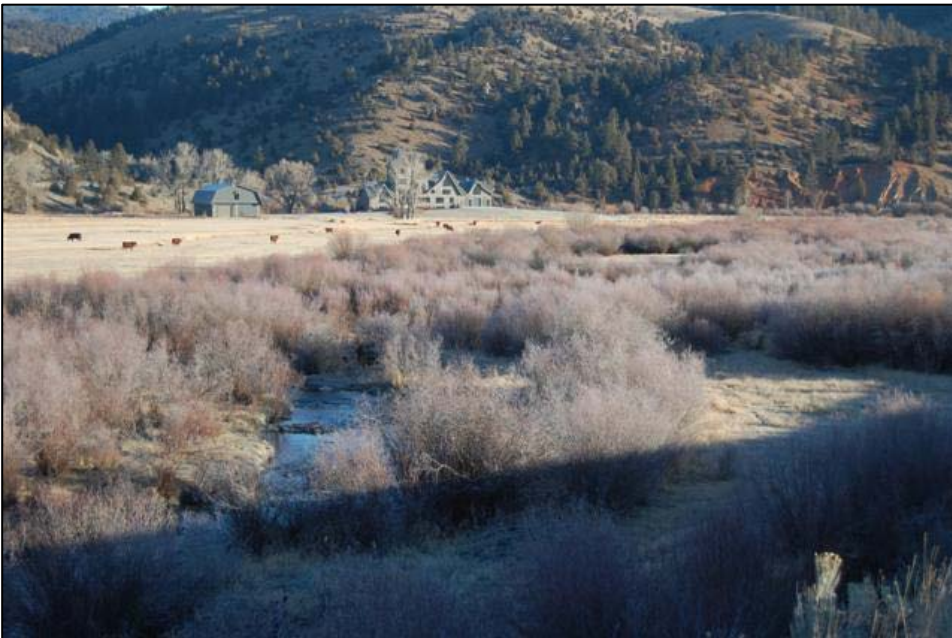
Photo 26. Looking down valley at PKR spring creek tributary and broad willow riparian corridor, approximately 0.5 miles upstream from Big Hole River confluence.

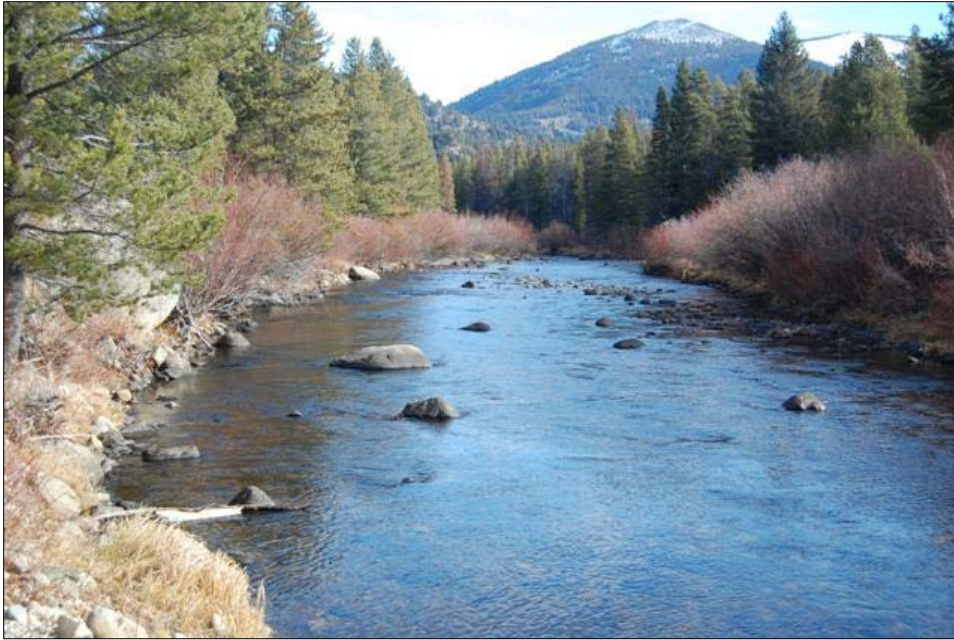
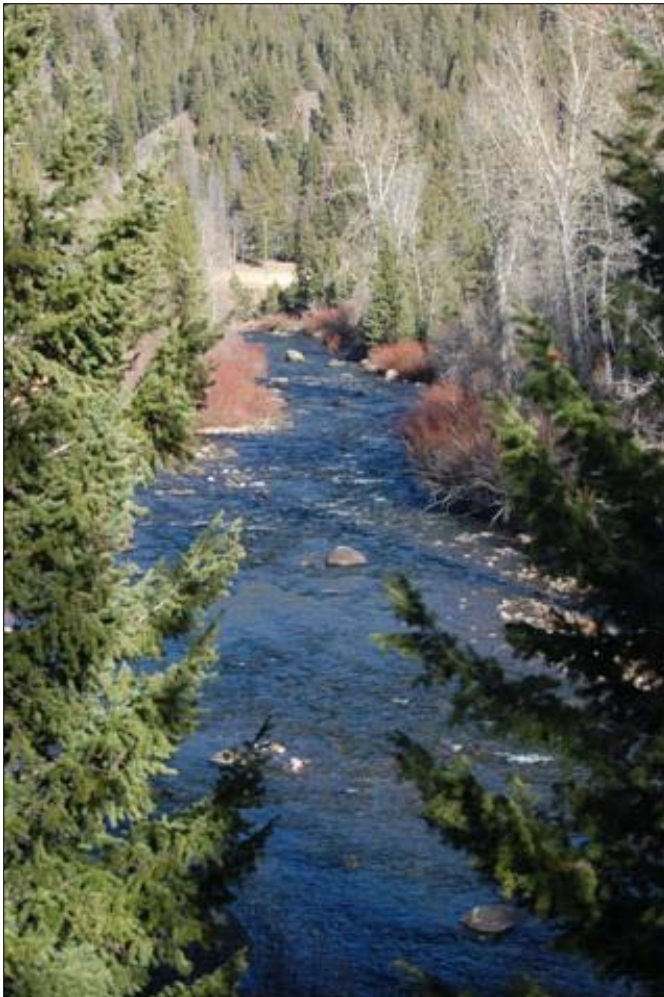
Photos 27 and 28. Typical stable channel configuration, moderately entrenched with coarse bank materials and bed armor, a fringe of willow, and lodge pole pine and Douglas fir along the floodplain-terrace bottom.
