# Anaconda Smelter NPL Site Mount Haggin Uplands (RDU 15)

## Remedy and Restoration Work Plan

PREPARED BY:  
MONTANA DEPARTMENT OF JUSTICE  
NATURAL RESOURCE DAMAGE PROGRAM

MAY 2018

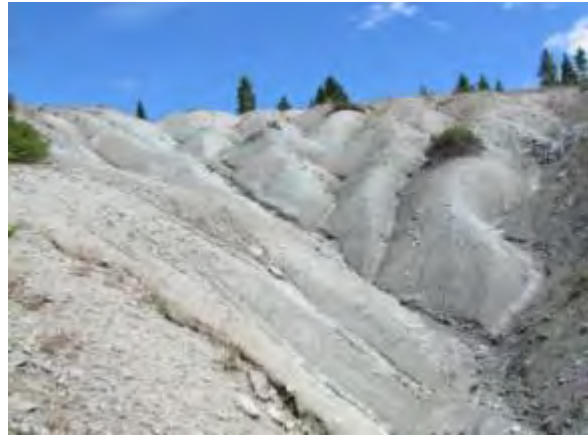
*Figure 7. Typical conditions in the uplands. Dozens of small rills easily transport volcanic material and form increasingly deeper gullies.*

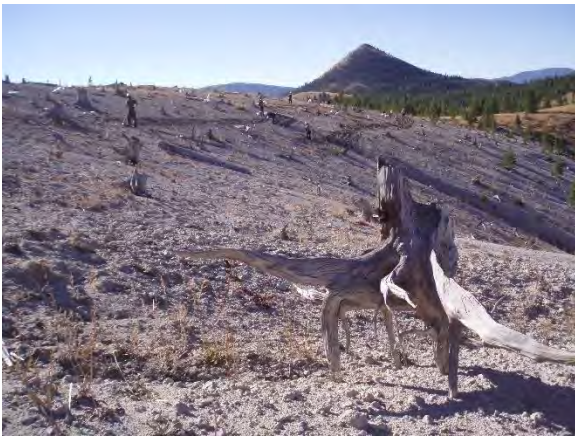
*Figure 9. Typical upland conditions on volcanic soils. Root system of tree shows where original soil level was and the degree of erosion. Trees likely cut around 1900.*

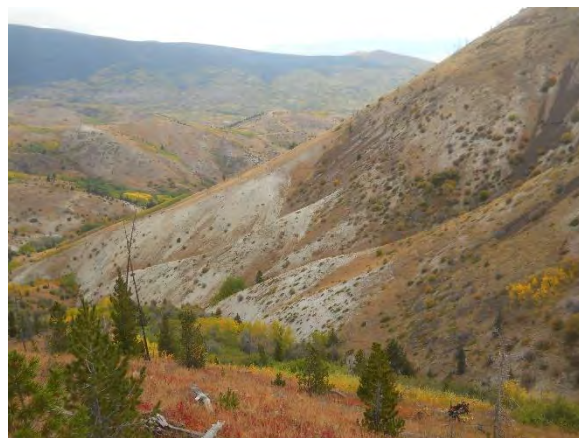
*Figure 10. Looking north into Joyner Gulch. Mix of natural revegetation conditions and erosion typical of the broader landscape.*

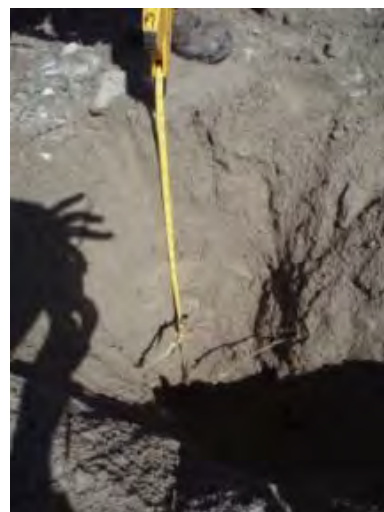
*Figure 12. Soil pit in California Creek sediment plume. Lack of a visible soil horizon to depth of 26" shows lack of soil formation.*

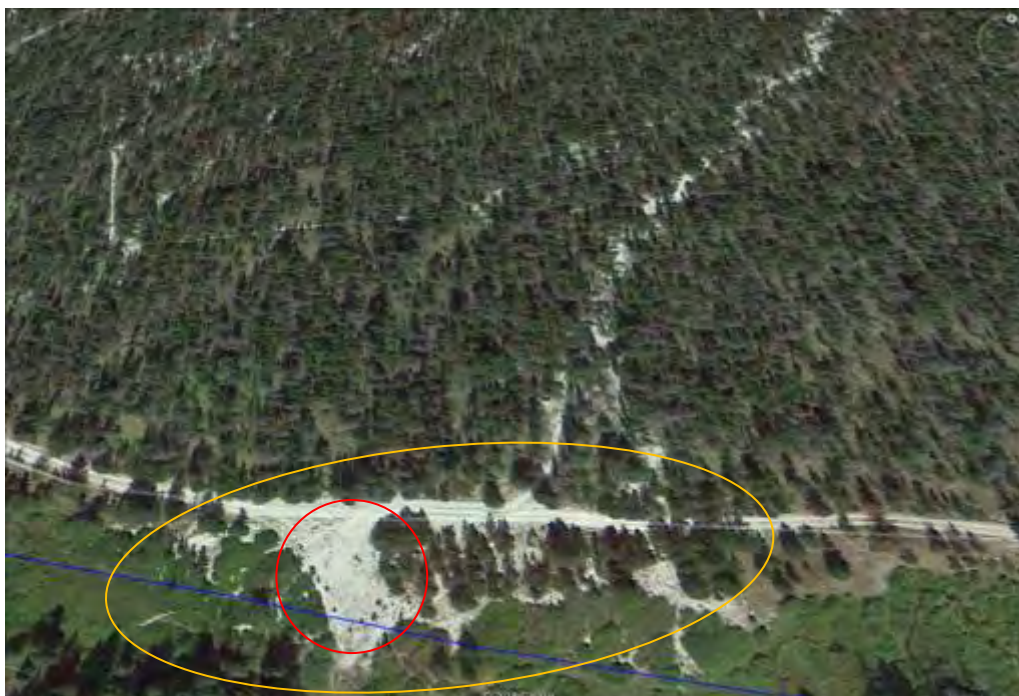
*Figure 13. Sediment plume and gully above California creek. The more active plume area shown in the red circle and the historic plume shown in the orange and the contributing gullies were treated by NRDP and DEQ in 2014.*

The riparian areas and floodplains of the RRA are built, for a large part, upon sediment deposits originating from bare upland slopes. Sediment plumes are visible from aerial photographs where gullies lose gradient and have deposited tons of sediment across the toe of the slope, into the floodplain and riparian areas. These sediment plumes are in differing stages of natural recovery depending on their proximity to the major gullies in the system. Soil pits dug in both active plume areas as well as revegetated floodplain areas show uniform layers of volcanic tuff material down to 2 feet (**Figure 12**). In some areas, where sediment loading from uphill gullies has diminished over time or been dispersed over the landscape, native seed sources have established and riparian and upland plant communities are returning, as shown in **Figure 13**. In the plume areas that see regular delivery of fresh sediment, vegetation is scarce.

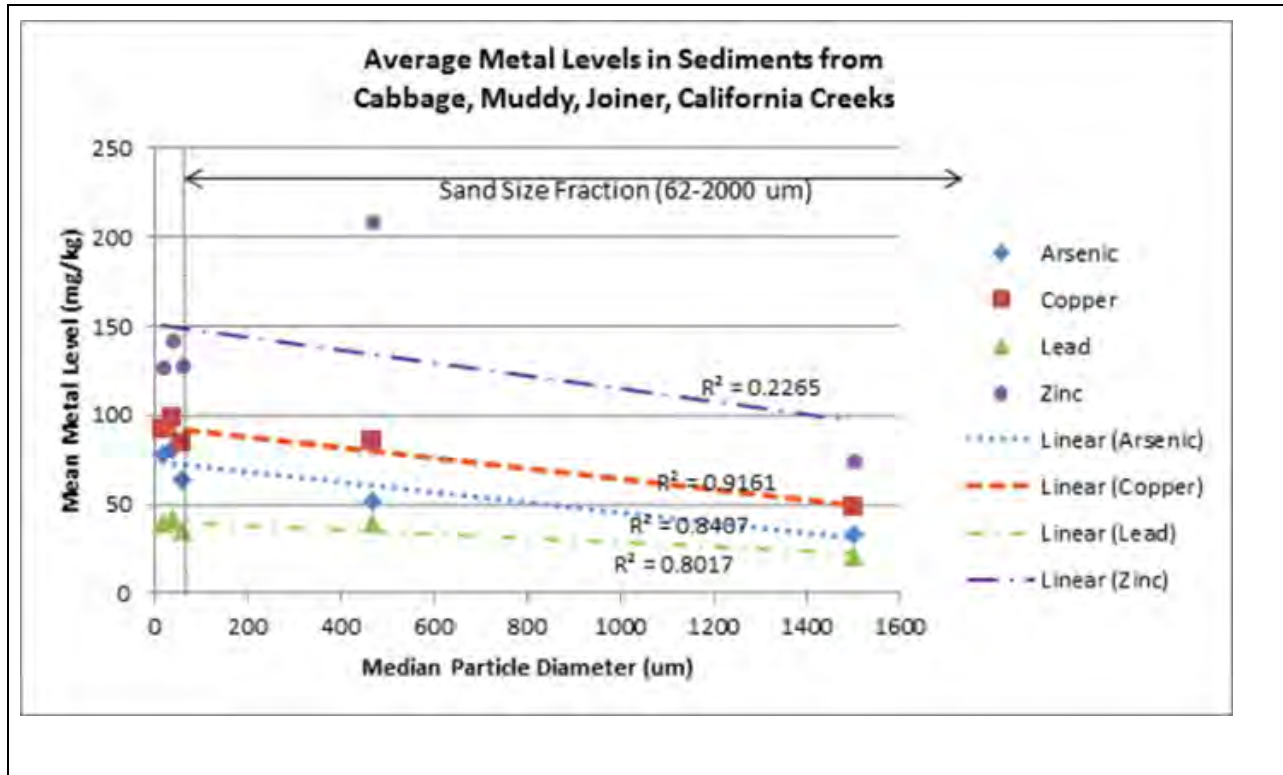
Figure 18. Average metal levels in RRA drainages by median particle size

Additional soils analysis work by ARCO between 2014 and 2016 provides a more nuanced understanding of the relationship between soils and metals on the landscape (see ARCO, 2017). The graphic shown in **Figure 18** illustrates that metals concentrations increase with decreasing soil particle size. These finer-textured soils are typically located on the landscape in valley bottoms and lower gradient areas, alongside streams. These are typically the areas where natural revegetation is occurring the most rapidly across the RRA. Conversely, bare and highly erosive slopes, while covering a larger percentage of the landscape, typically transport fewer metals to waterways. ARCO’s findings state, “the largest potential source of arsenic and metals to surface waters is soil

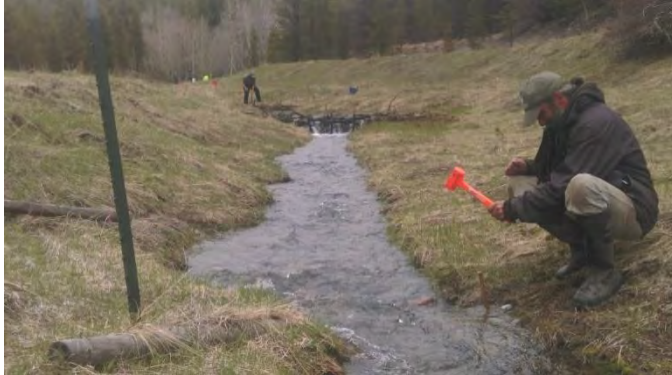
*Installing willow stakes below beaver analog structure in May 2016 (above) and in June 2015 (right) in California Creek*

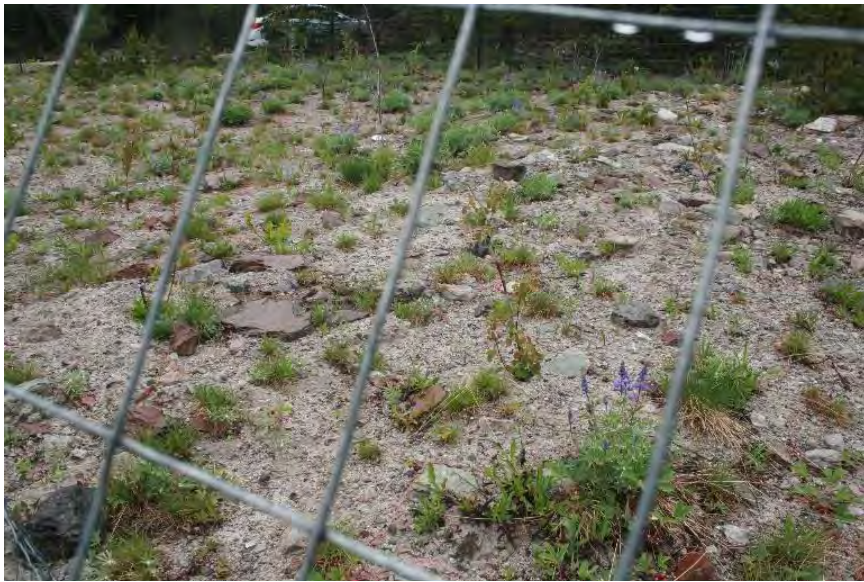
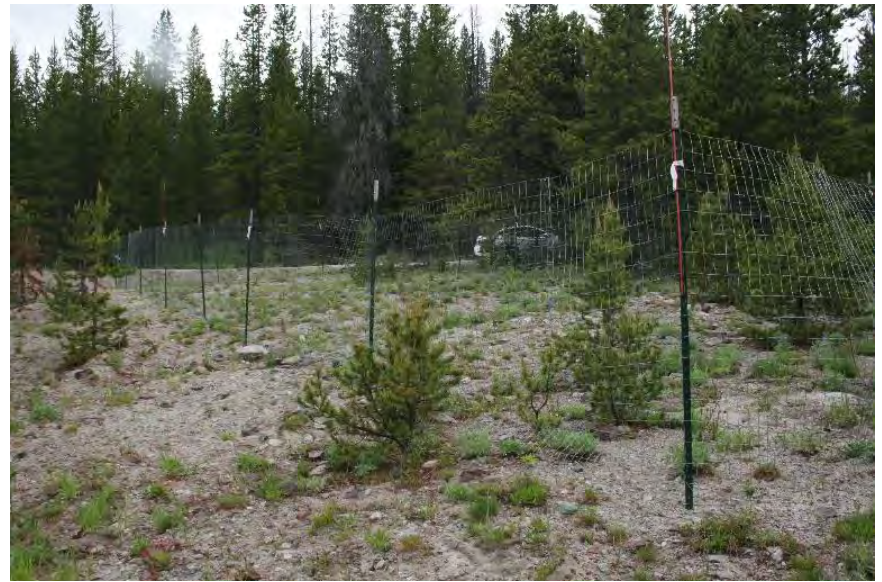
*May, 2014, snowmelt from gully crosses California Creek road and adds to sediment plume (left); June, 2016 beginning of vegetation establishment after installation of culvert gully plugs and container plants (right)*

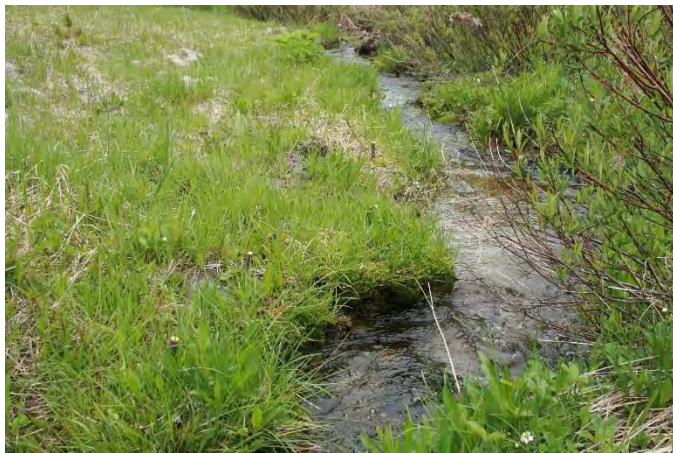
*Vegetation establishment in a California Creek plume area (June, 2016)*

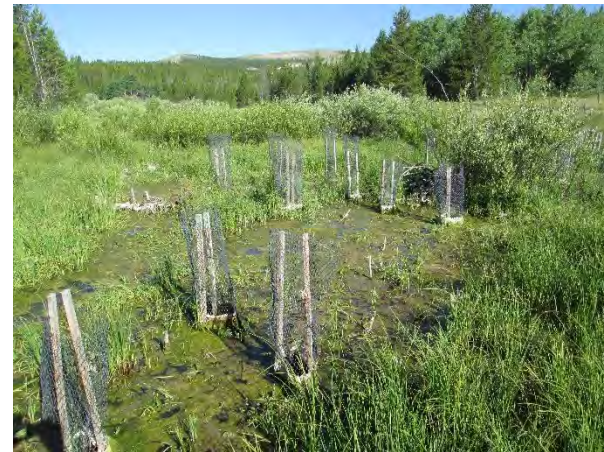
*Willow stakes along stream in California Creek (June, 2016)*

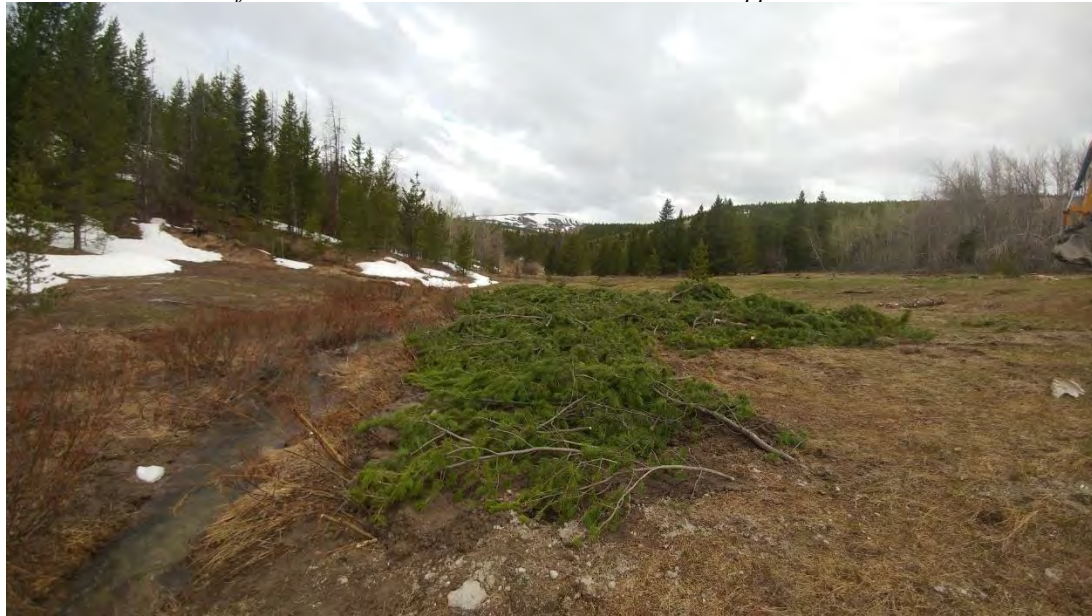
*Installation of willow brush trench in California Creek. Disturbed soil was seeded and capped with brush to minimize soil loss (October 2016)*

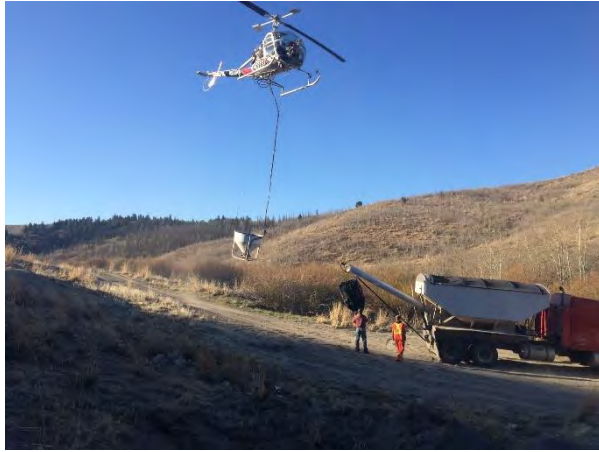
*SSR- 1b, aerial fertilization operation, 2016*

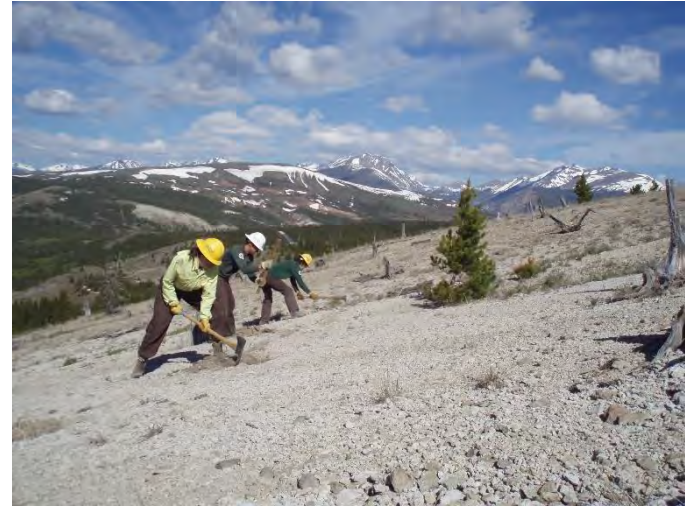
*SSR-1c Upland vegetation enhancement by MCC crew, June 2014*

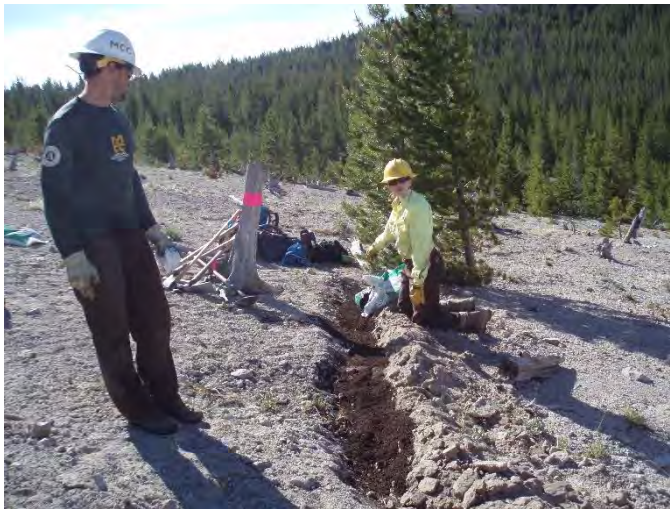
*Compost soil amendment in trench*

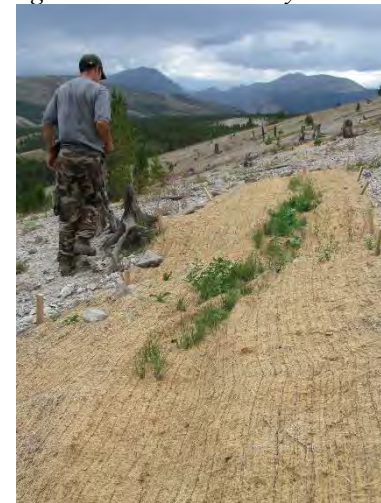
*May, 2015 early results from trenching vegetation enhancement trials*

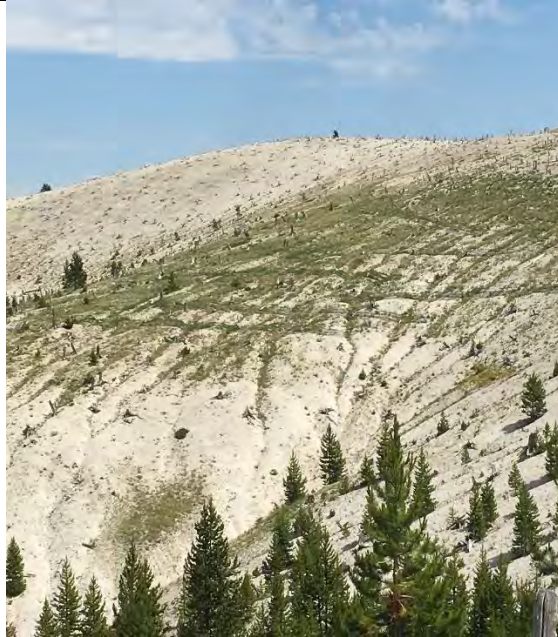
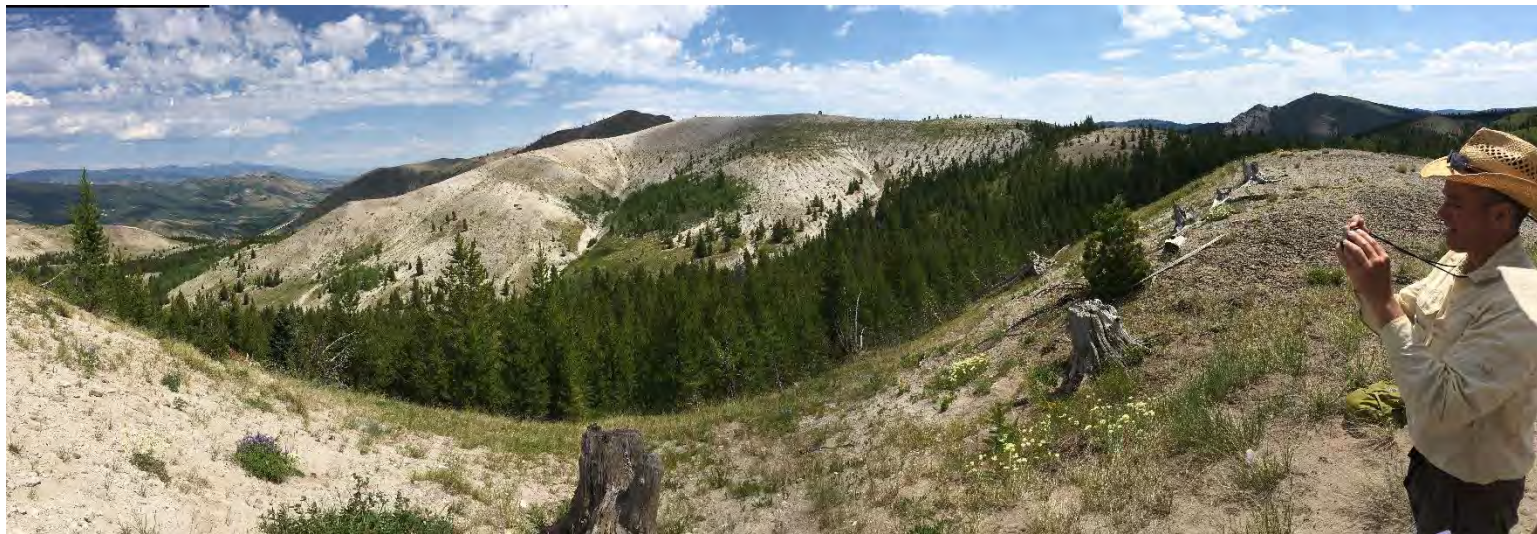
*Joyner Gulch polygon treated with SSR-1c, 2000lb/acre organic fertilizer and erosion control fabric*

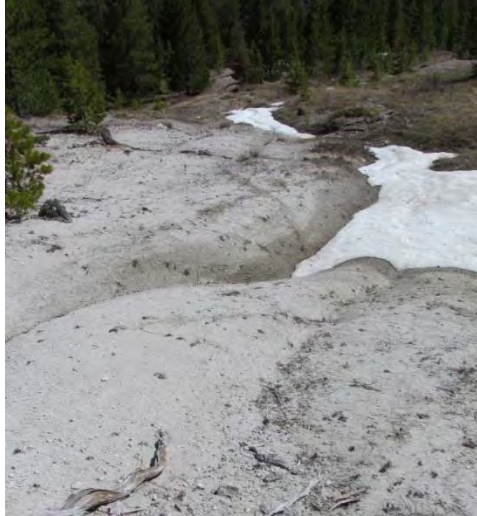
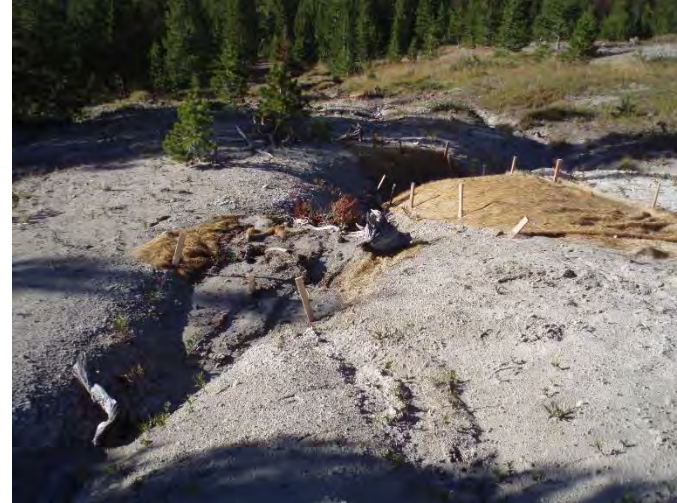
*Figure 24. SSR-2a Rill Treatment examples*

*Rill treatments high in bare area high above California Creek. Before and after (above) showing sediment catchment. Structures below (left) filled and sediment cut around soft bank. Filled structure (below right) provided germination substrate for native seed to establish.*

SSR-2 activities involve the installation of grade control and sediment retention BMPs in the gullies and stream systems of the RRAs. Functionally, these structures serve to capture sediment in erosive gully pathways, which decreases erosive bank slope lengths, decreases erosive energy and also establishes more suitable seed germination substrate in the areas of captured fines behind structures. Captured sediment is a priority outcome for remedy and restoration work, as some of these sediments hold contaminants of concern. A summary of SSR-2 completed work is provided in **Table 8**. In the California Creek watershed, significant funding was provided by Montana DEQ to address stream sediments in that drainage. Efforts were taken to calculate captured sediment in SSR-2 structures in that drainage, results of which are shown in **Table 9**. That table also shows volumes and Tons captured per unit of treated area, numbers which were used to estimate total sediment captured across the RRA, which is shown in **Figure 22**. A map of completed SSR-2 work is provided in **Figure 23**<sup>20</sup> and images of installed structures are shown in **Figure 24**, **Figure 25**, **Figure 26**, and **Figure 27**.

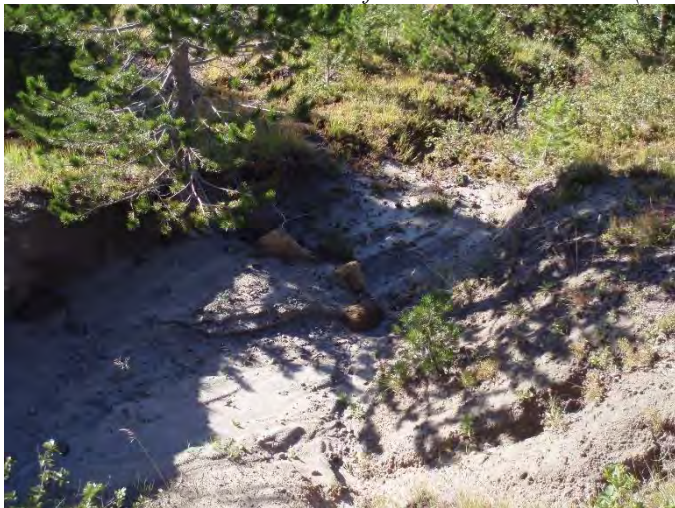
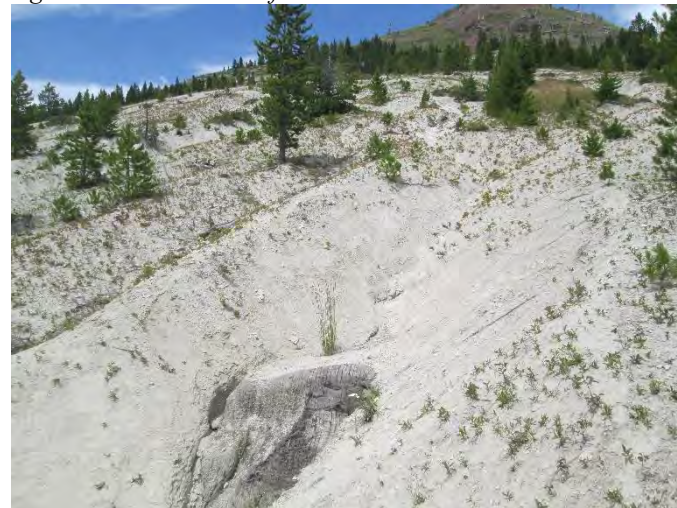
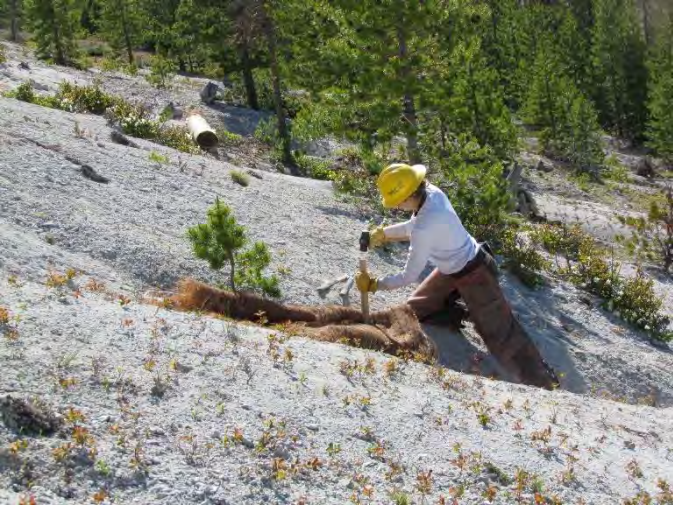
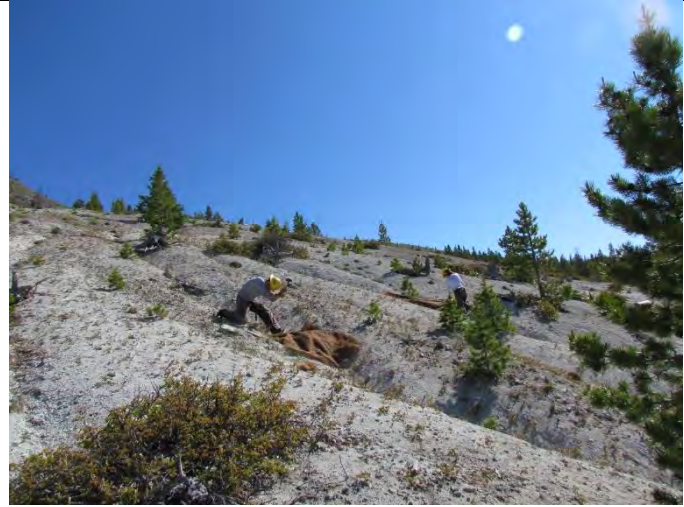
*Rill treatment structures installed by MCC crews, June 2014*

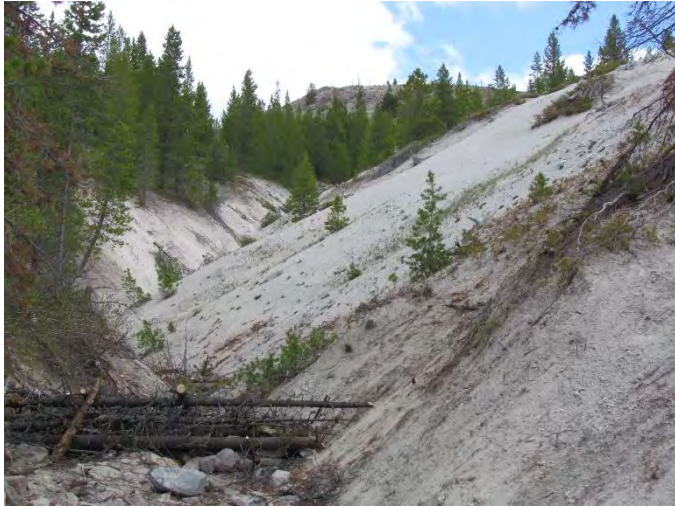
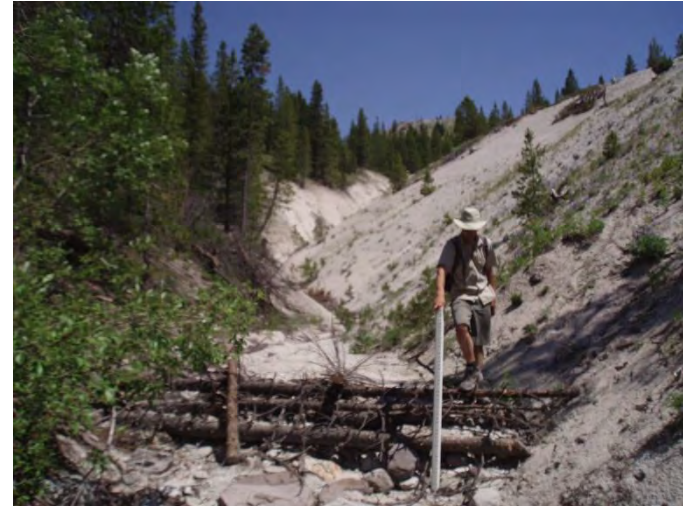
*Figure 25. SSR-2d (Gully BMP structures) examples*

*(Above) Structure installed by MCC June, 2014 (left) and completely filled, July, 2015(right)*

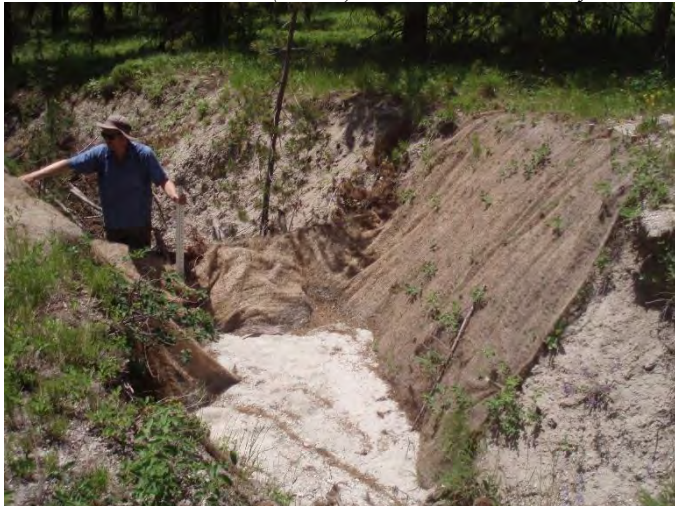
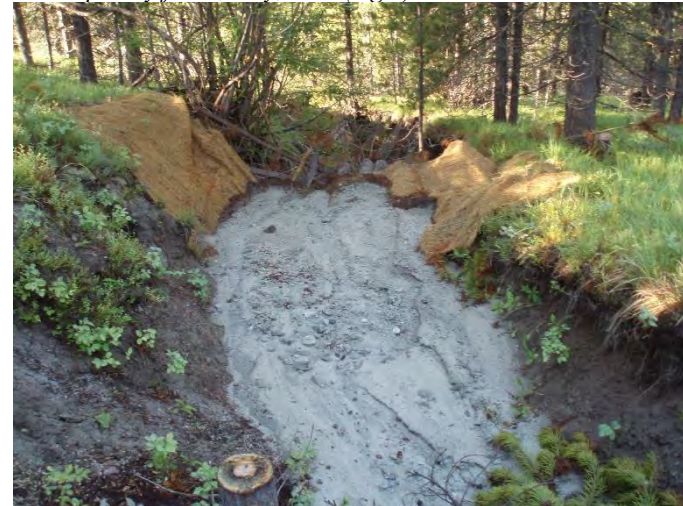
*Gully structures using coir fabric after 1 year of sediment delivery in upper California Creek*

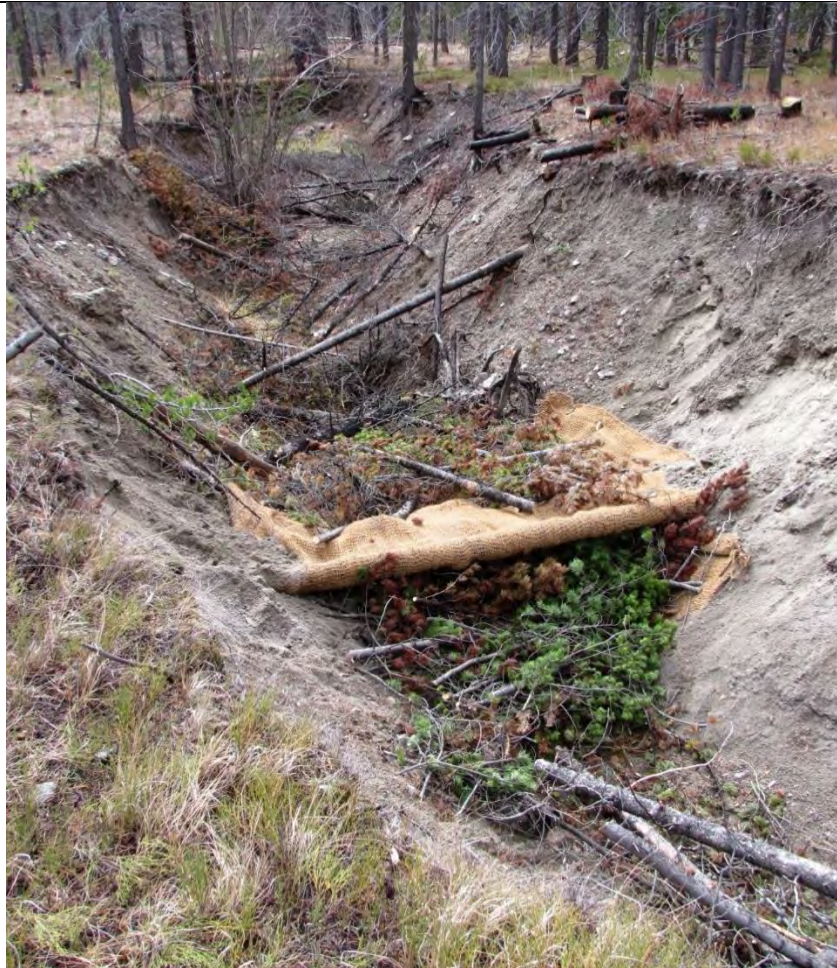
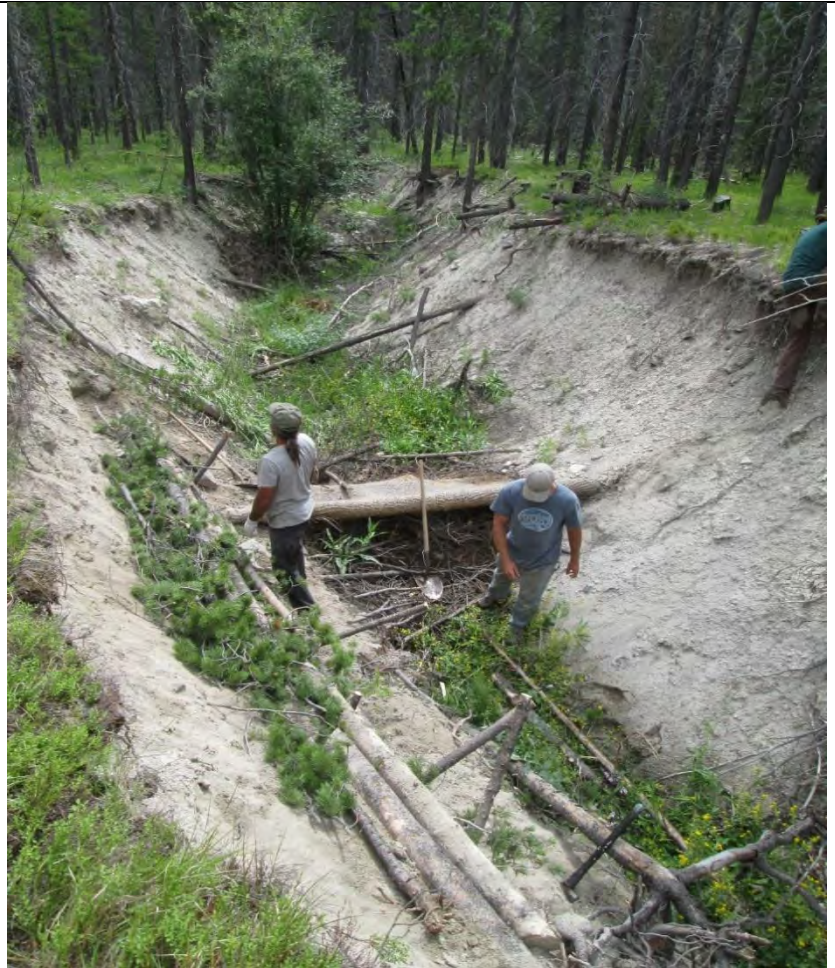
*Coir-lined fabric in gully above California Creek taken in Fall 2015 (left) and Spring 2016 (right). This gully captured overland flow and gully structures below held back water and promoted vegetation establishment previously non-existent. Bank slope lengths also reduced from slash filters.*

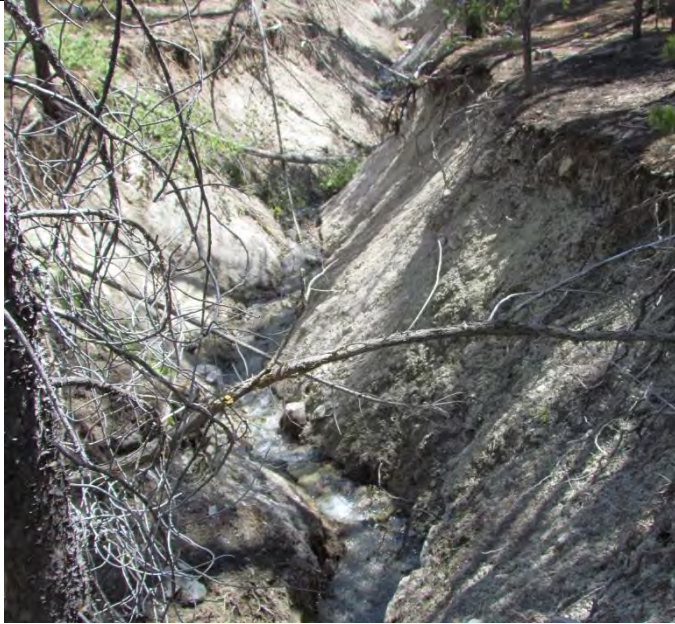
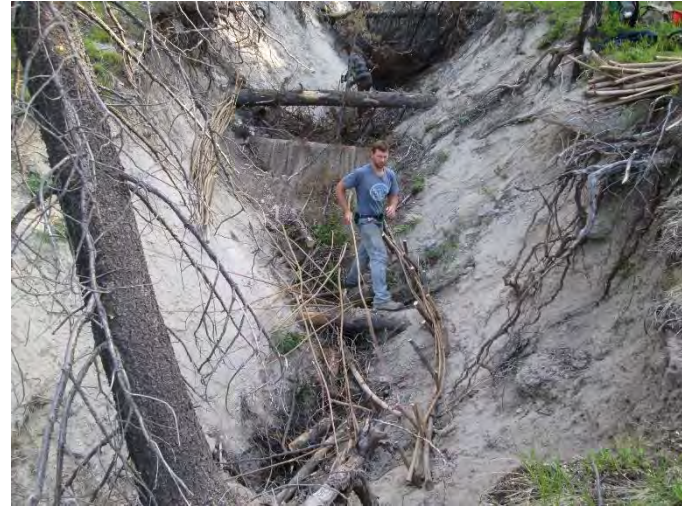
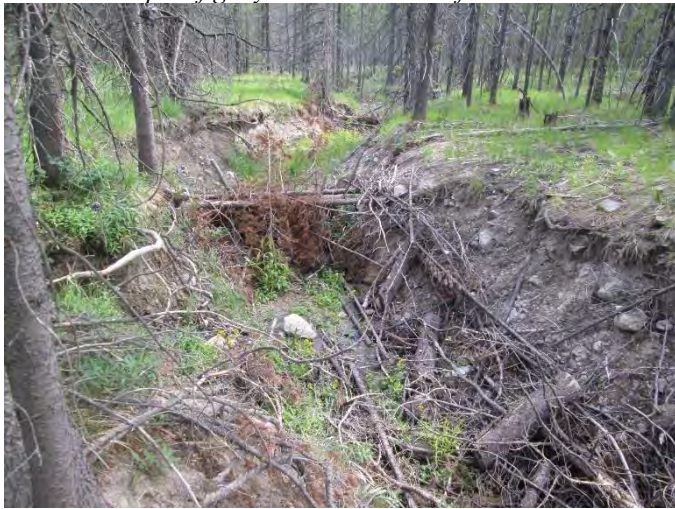
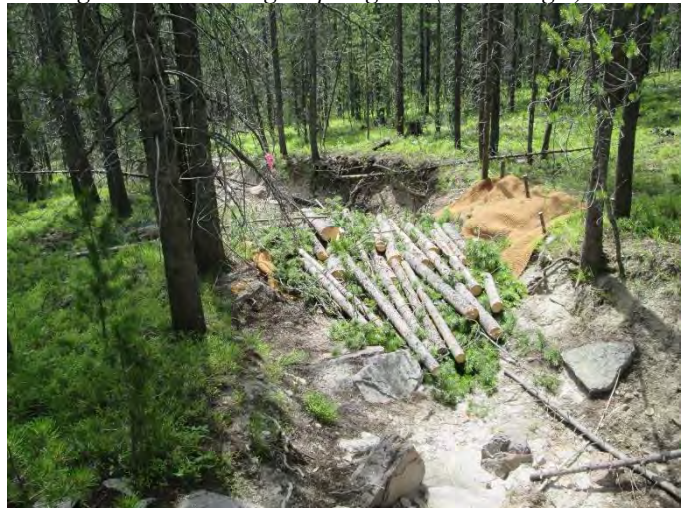
*Example of gully structures. Some filled structures were re-visited in 2016 and gullies were brought up to grade (bottom right).*

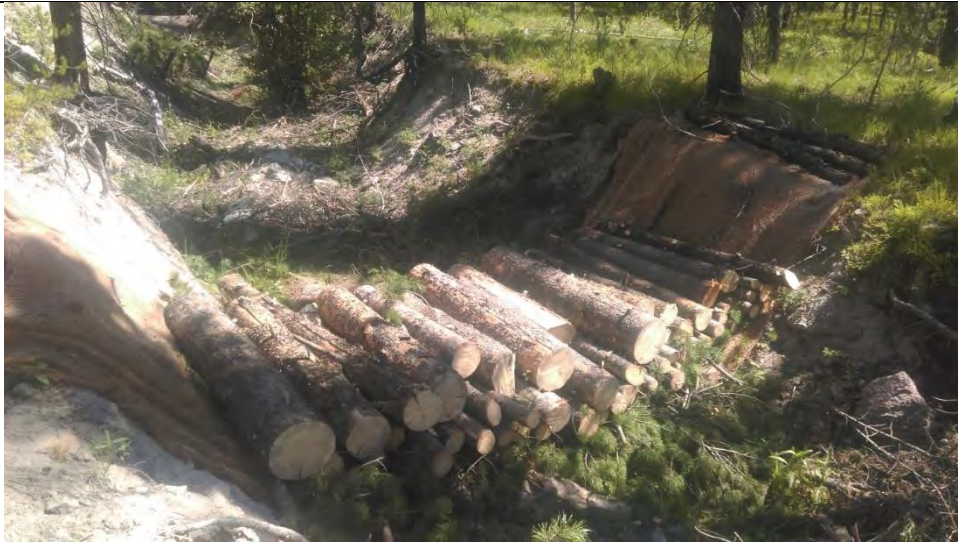
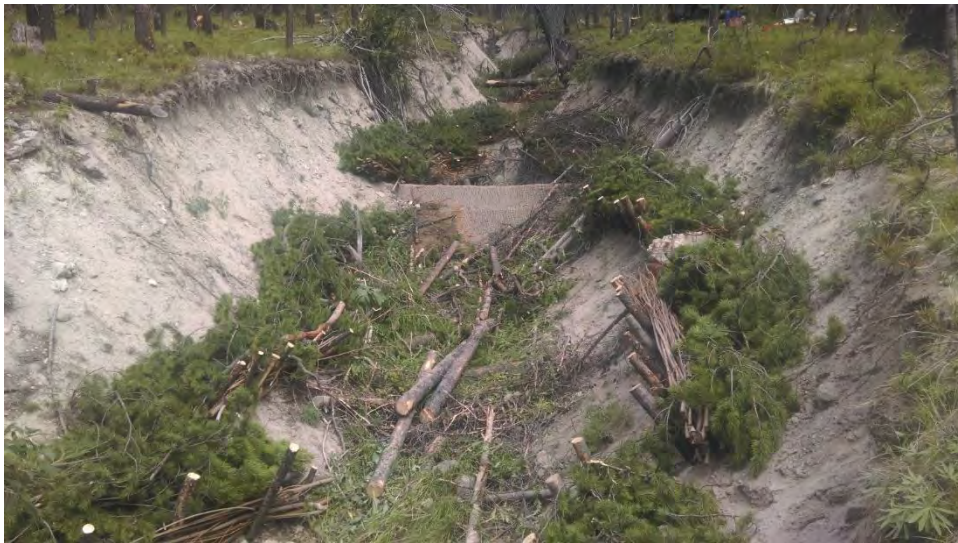
*Example of enhanced SSR-2d structure previously filled (above) and SSR-2c slash filters in gully bottom and bank walls (below)*

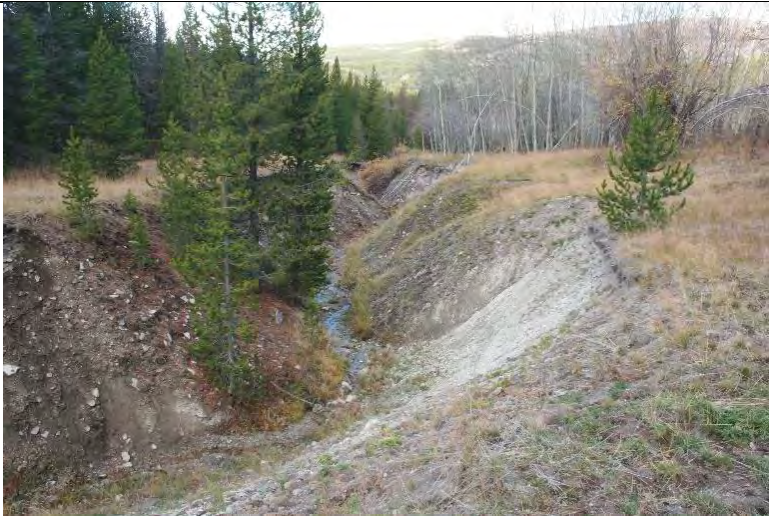
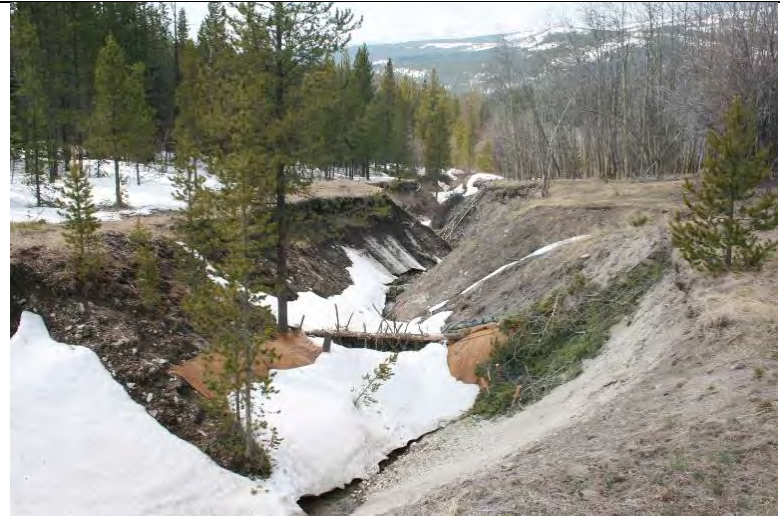
*SSR-2d structure progression in 2014 (top left), Spring 2015 (top right), June 2017 (bottom)*

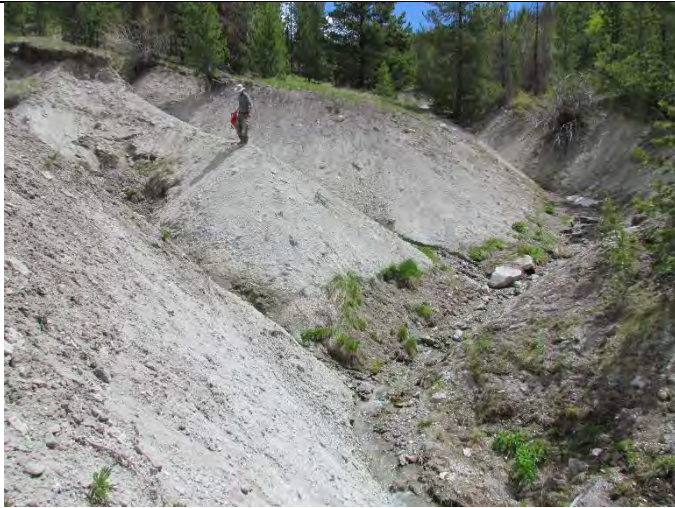
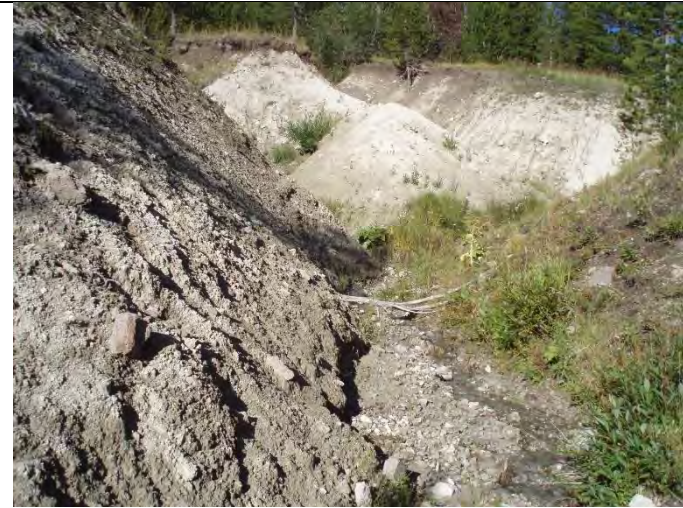
*SSR-2d structure before (top) during (bottom left) and immediately after installation in 2014 and one year later with some sediment catchment (bottom right)*

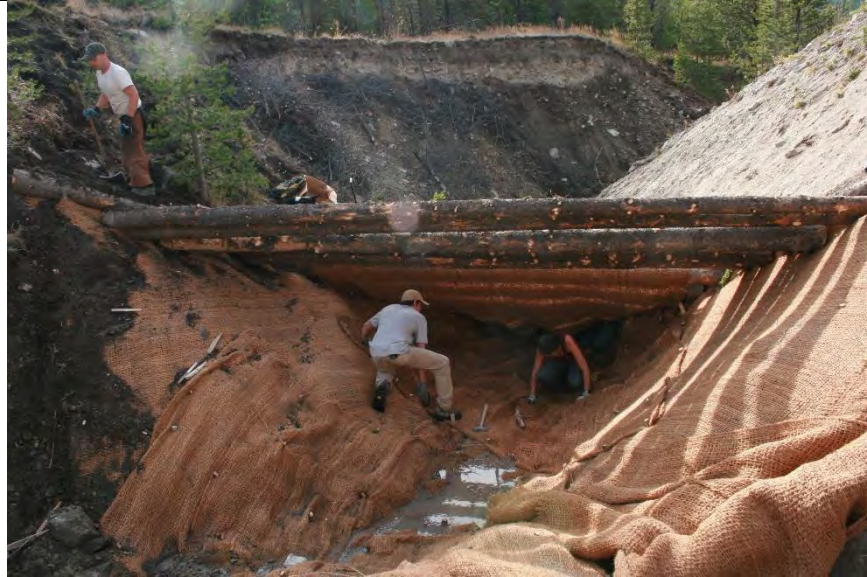
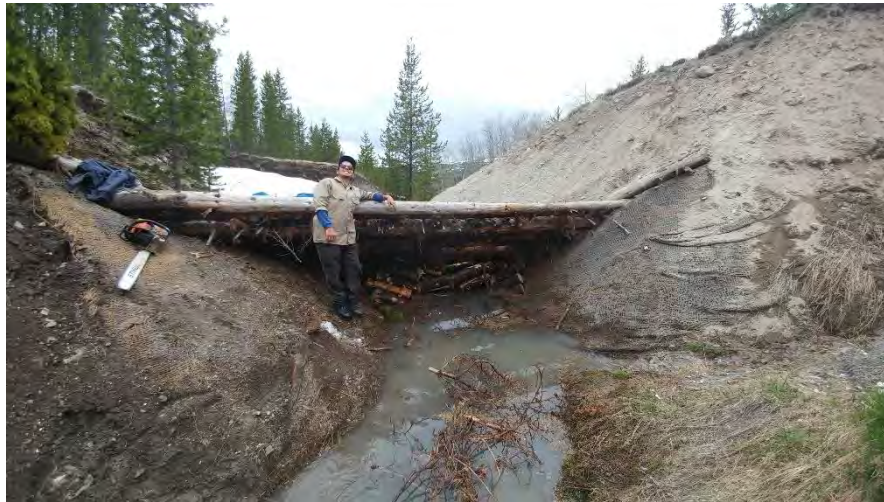
*SSR-2d structure during construction in 2014 (above) and after enhancement in 2017 (below)*

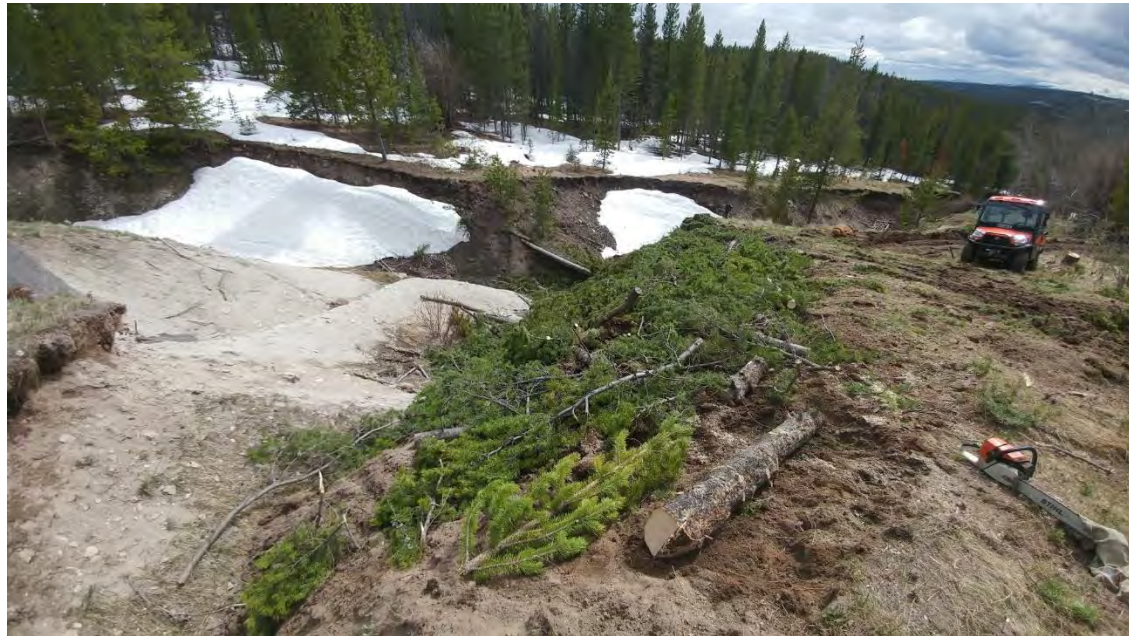
*Mechanized enhancement to eroding banks in 2017, including deposition of erosion into existing structures*

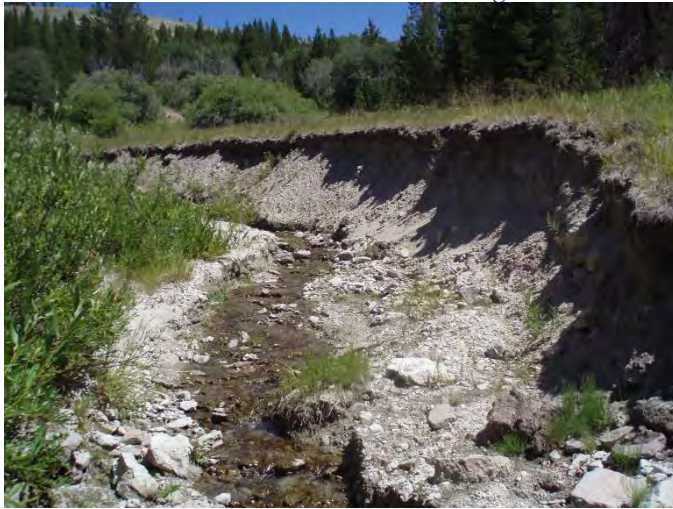
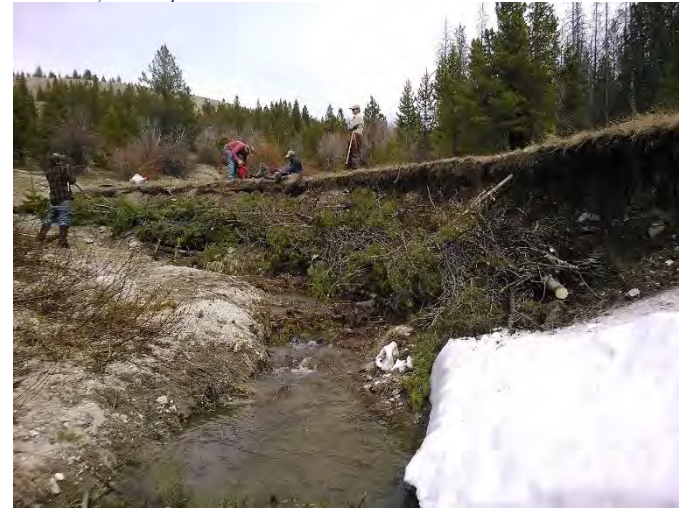
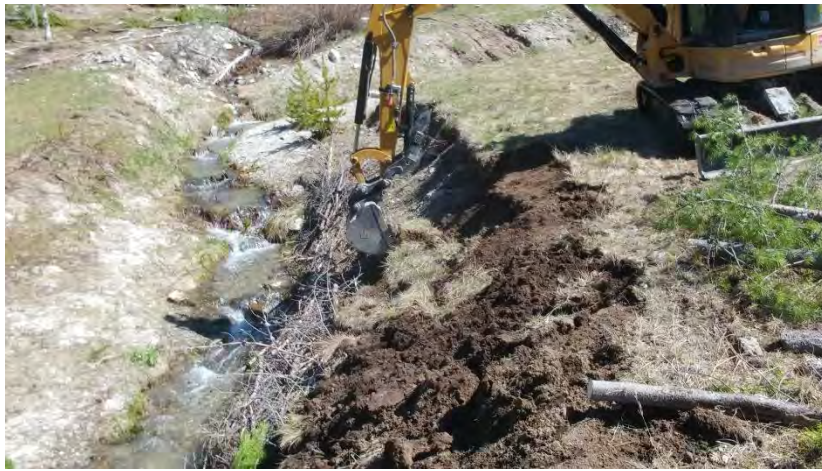
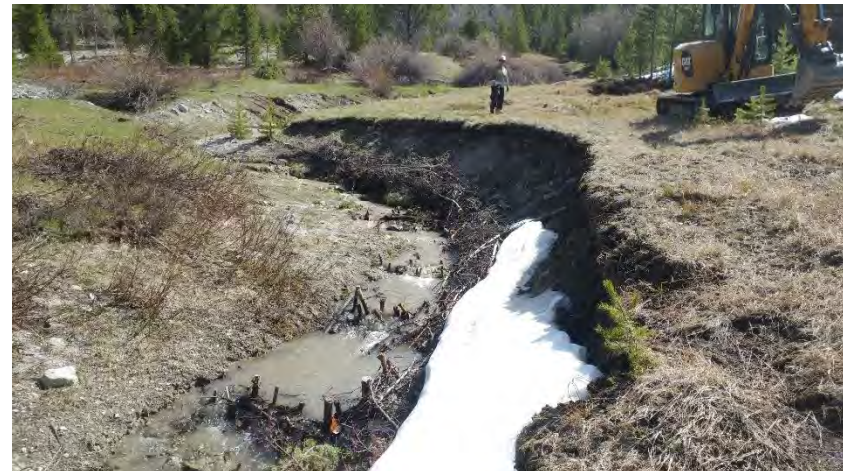
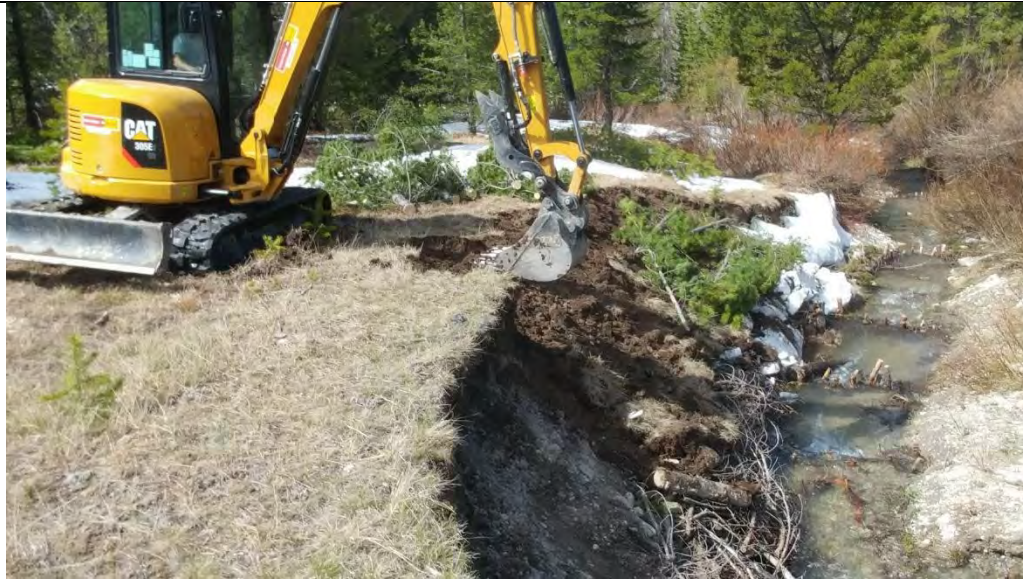
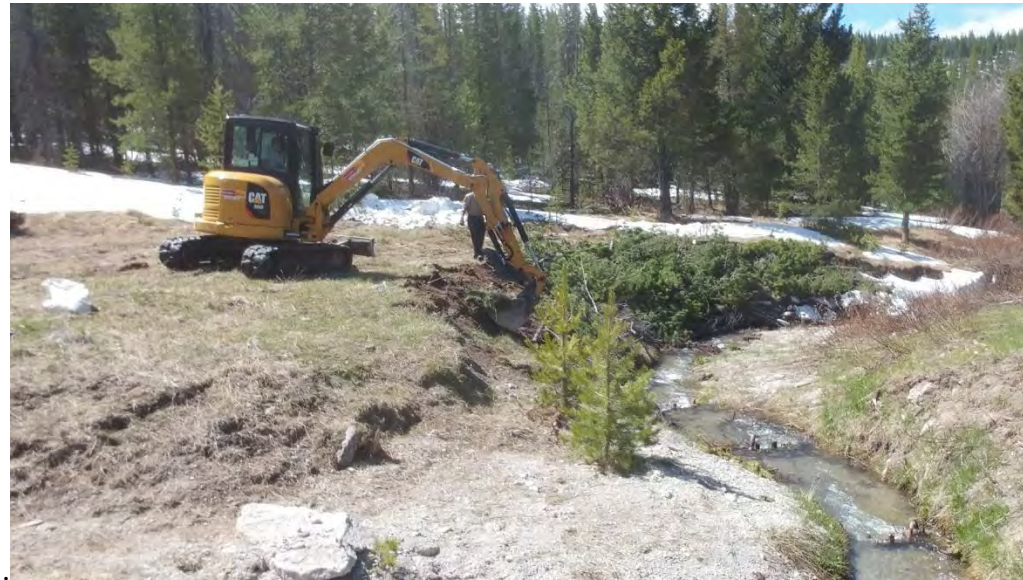
*Figure 26. SSR-2e (Anchored brush bundles) examples*

*Example of brush bundle installation and mechanical enhancement in California Creek: Summer 2013 (top left); Spring 2015 (top right); Spring 2017 (bottom and next page)*
