# Anaconda Smelter NPL Site Mount Haggin Uplands (RDU 15)

## Remedy and Restoration Work Plan

PREPARED BY:  
MONTANA DEPARTMENT OF JUSTICE  
NATURAL RESOURCE DAMAGE PROGRAM

MAY 2018

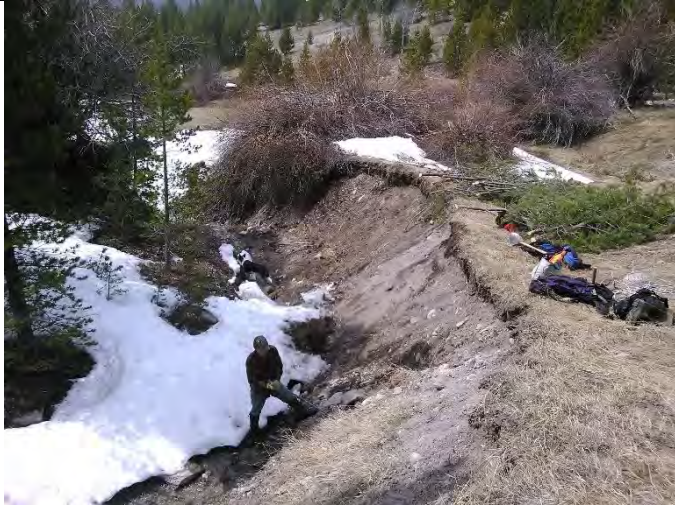
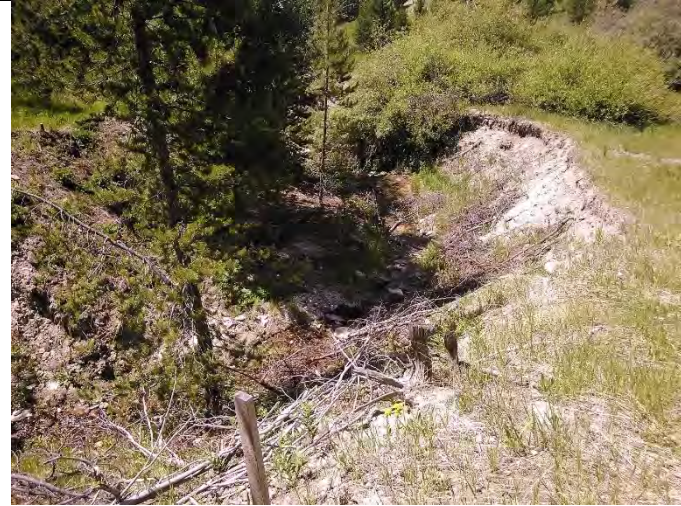
*Anchored brush bundles examples before and after installation*

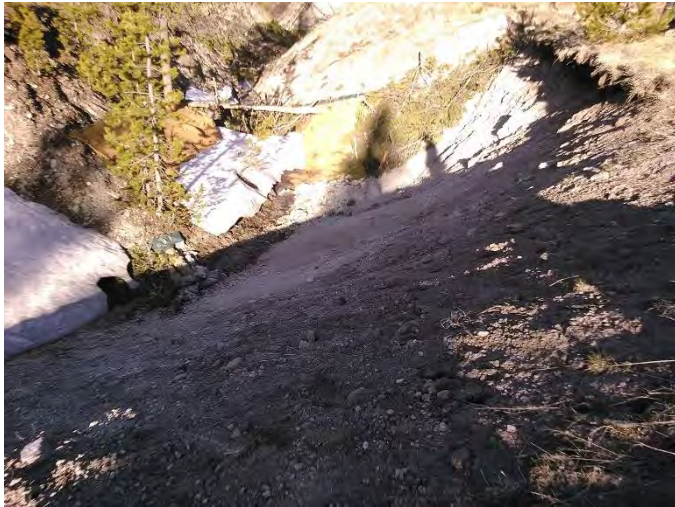
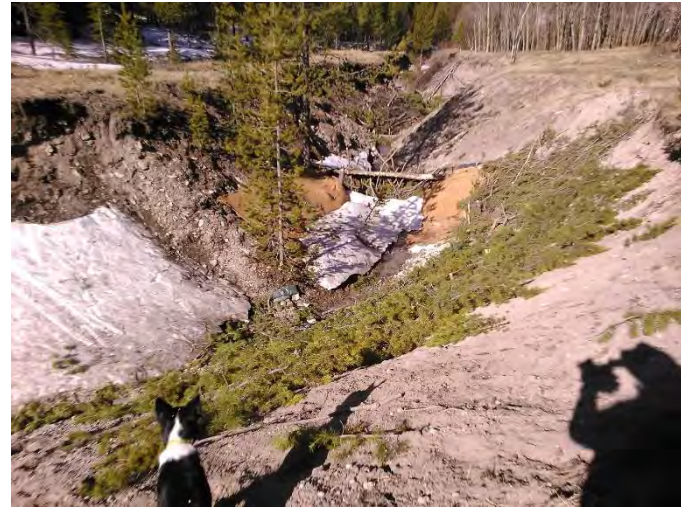
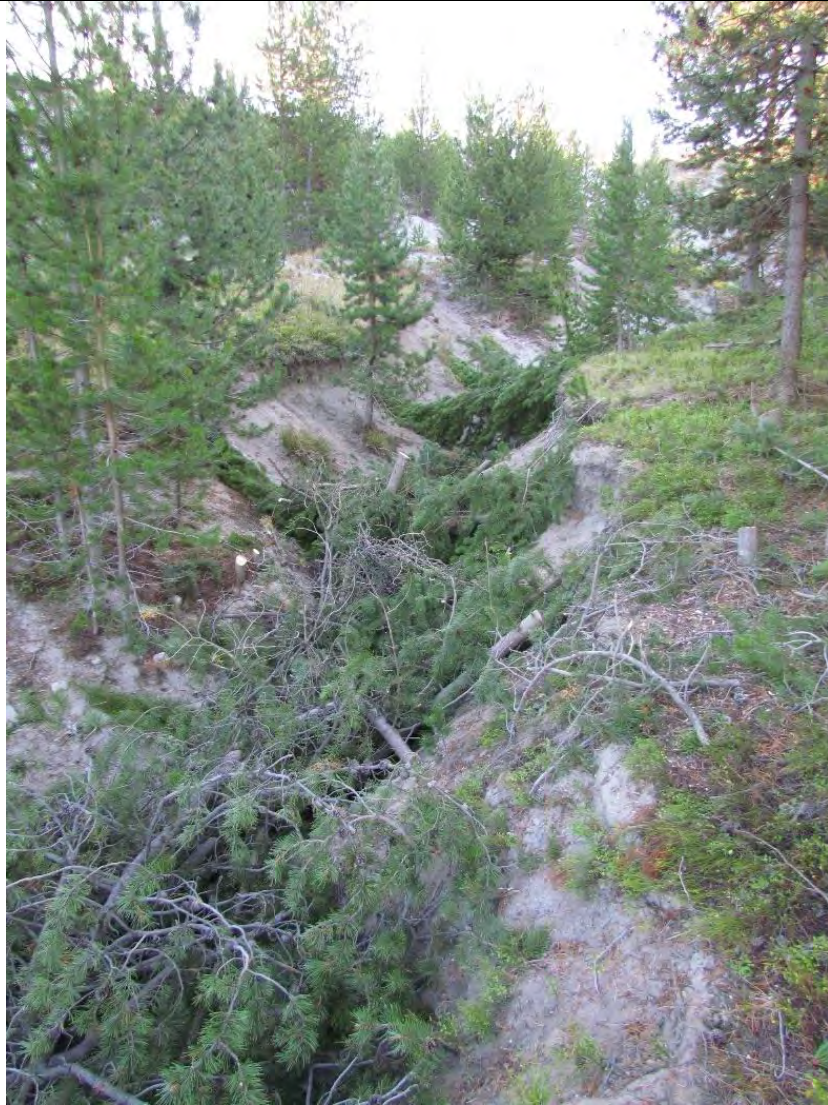
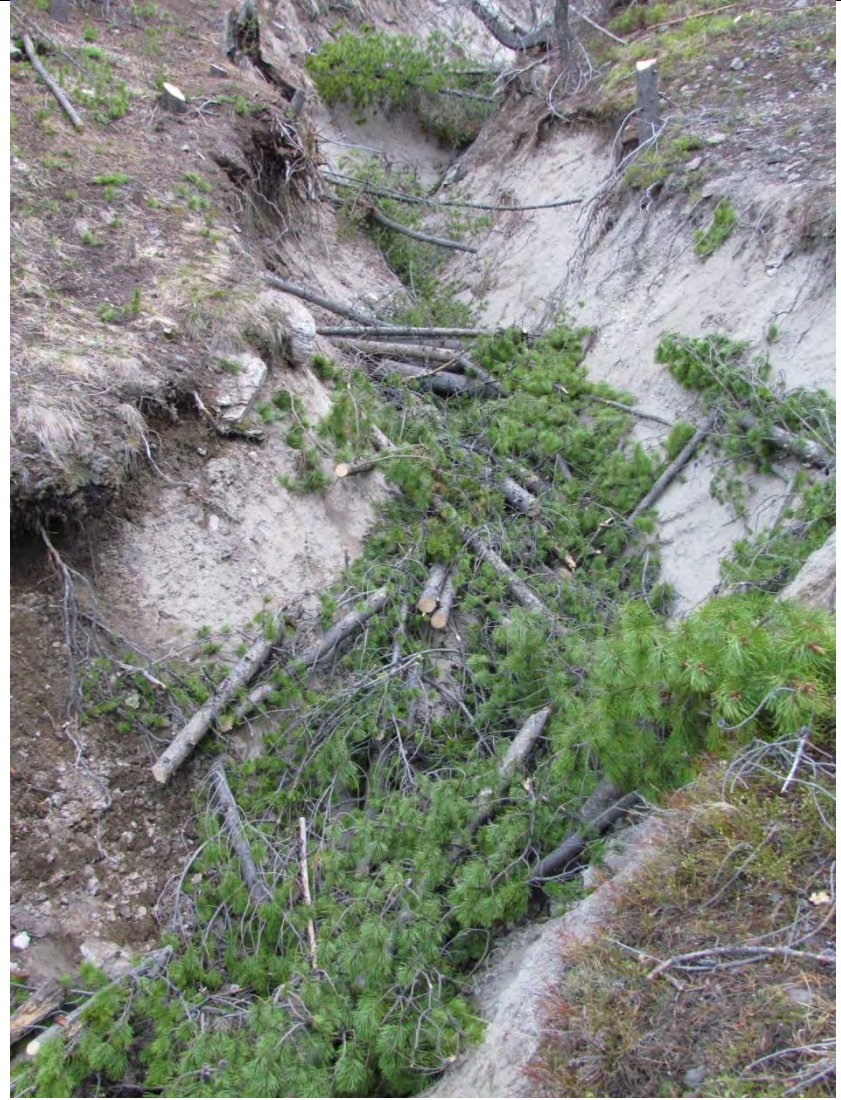
*Gully slash filters in gullies above California Creek soon after installation in 2014*

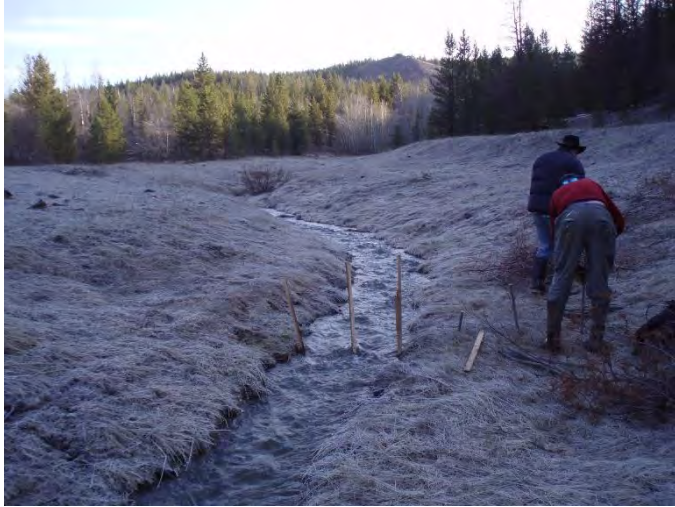
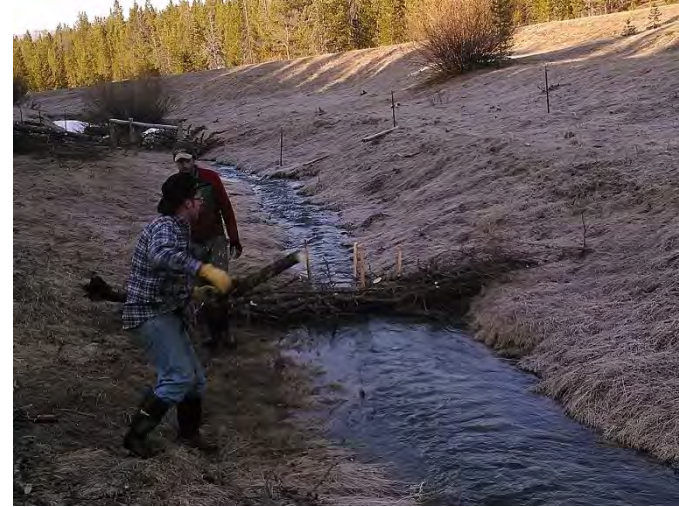
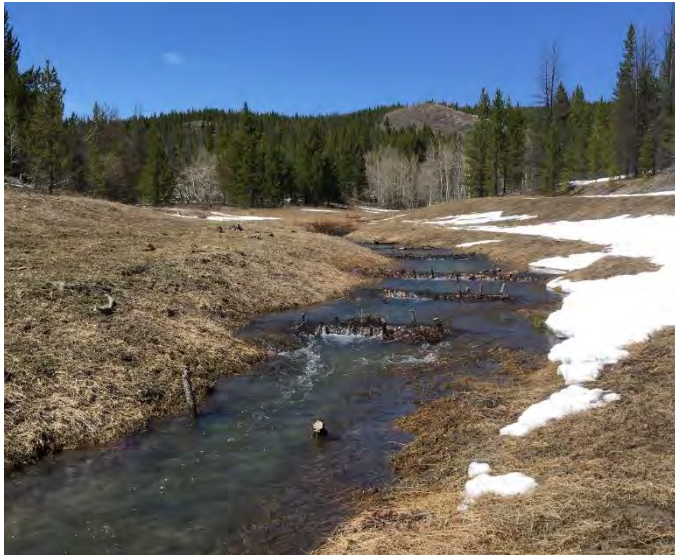
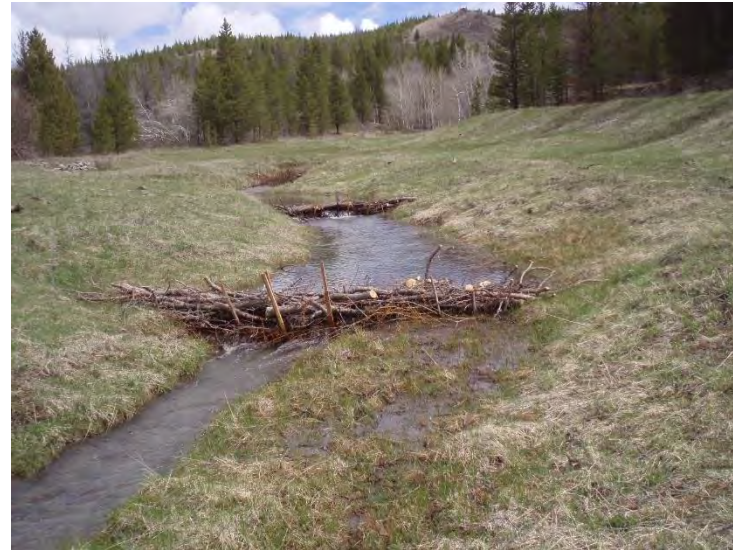
*Figure 27. SSR-2b (Beaver Mimicry structures) examples*

*Progress of a beaver mimicry structure over time: Spring 2015 (top); Spring 2016 (bottom right); Spring 2017 (bottom left)*

SSR-2 activities involve the installation of grade control and sediment retention BMPs in the gullies and stream systems of the RRAs. Functionally, these structures serve to capture sediment in erosive gully pathways, which decreases erosive bank slope lengths, decreases erosive energy and also establishes more suitable seed germination substrate in the areas of captured fines behind structures. Captured sediment is a priority outcome for remedy and restoration work, as some of these sediments hold contaminants of concern. A summary of SSR-2 completed work is provided in **Table 8**. In the California Creek watershed, significant funding was provided by Montana DEQ to address stream sediments in that drainage. Efforts were taken to calculate captured sediment in SSR-2 structures in that drainage, results of which are shown in **Table 9**. That table also shows volumes and Tons captured per unit of treated area, numbers which were used to estimate total sediment captured across the RRA, which is shown in **Figure 22**. A map of completed SSR-2 work is provided in **Figure 23**<sup>20</sup> and images of installed structures are shown in **Figure 24**, **Figure 25**, **Figure 26**, and **Figure 27**.

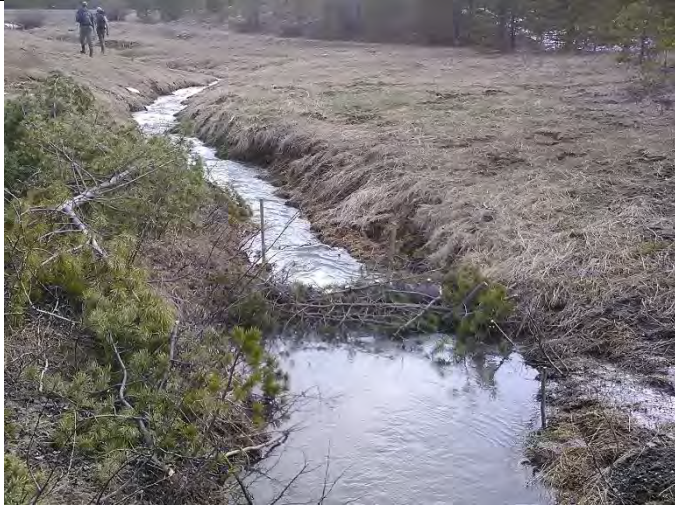
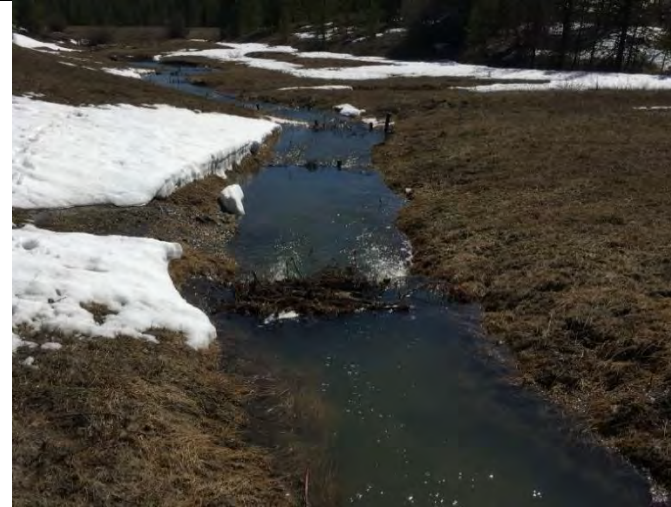
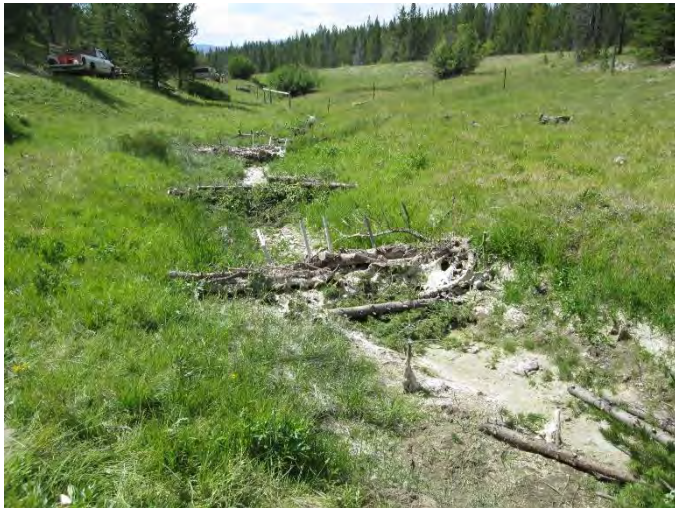
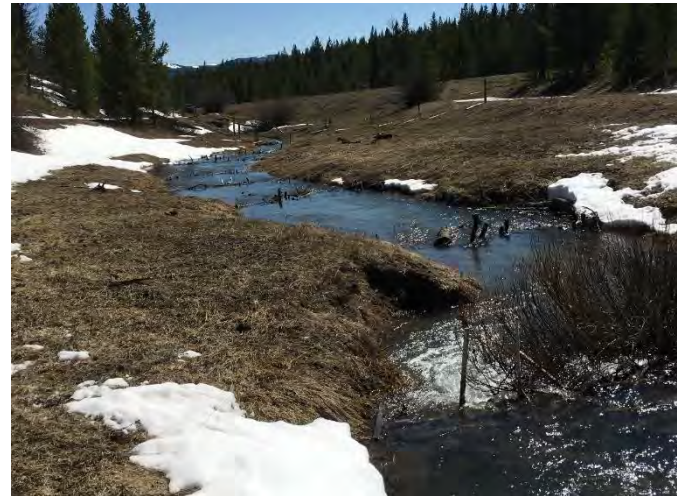
*Progress of a beaver mimicry structure over time: Spring 2015 (top left); Spring 2017 (top right); and in another area just downstream in Summer 2016 after enhancements to filled structures (bottom left); and Spring 2017 (bottom right)*

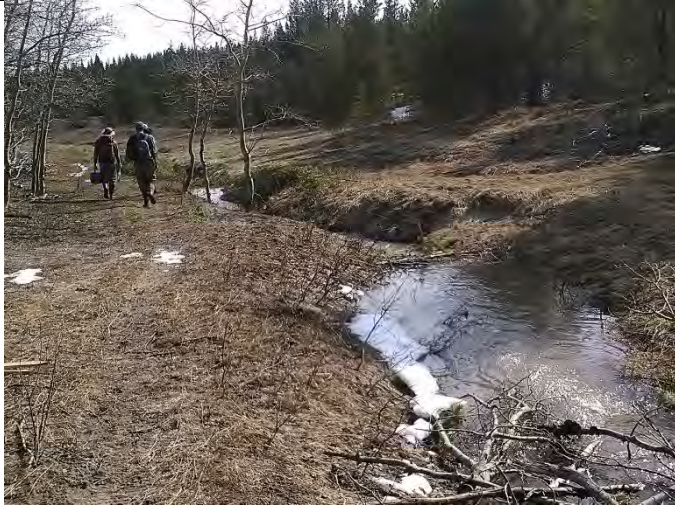
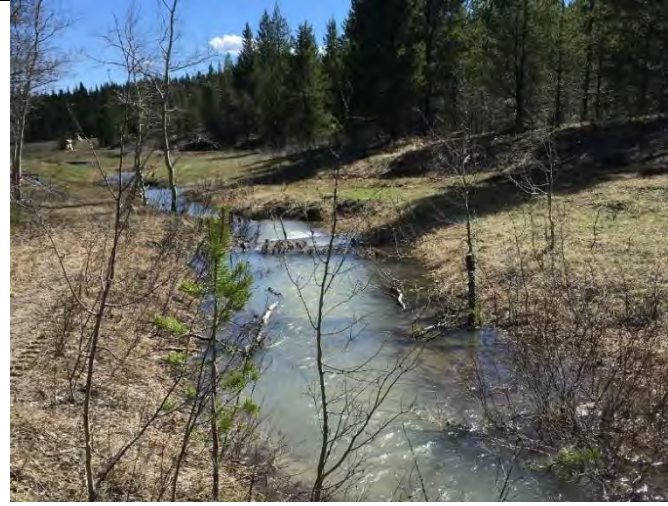
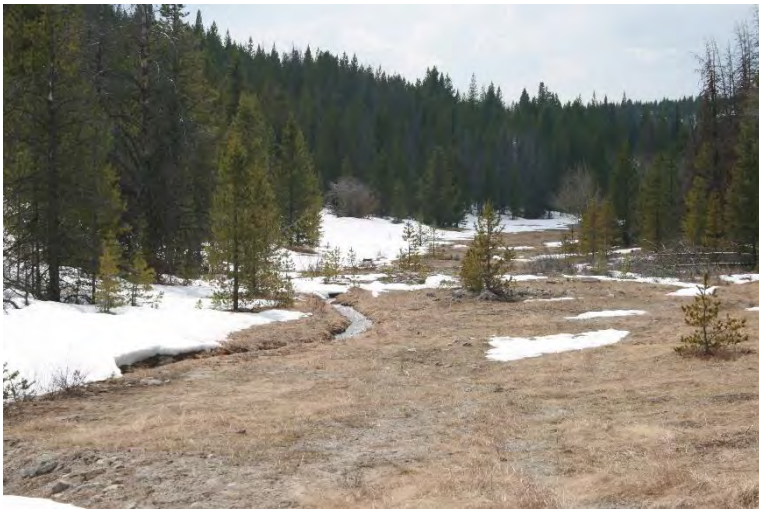
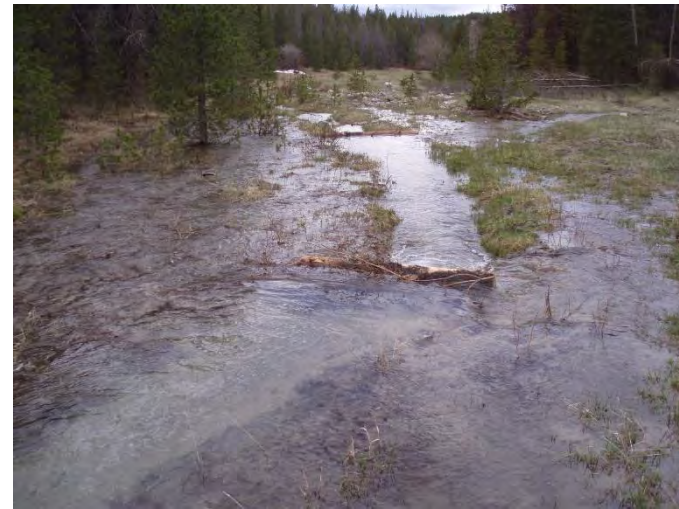
*Progress of a beaver mimicry structure over time (top): Spring 2015 (left); Spring 2017 (right)  
Progress of beaver mimicry structure over time (bottom): Spring 2015 (left); Spring 2017 (right)*

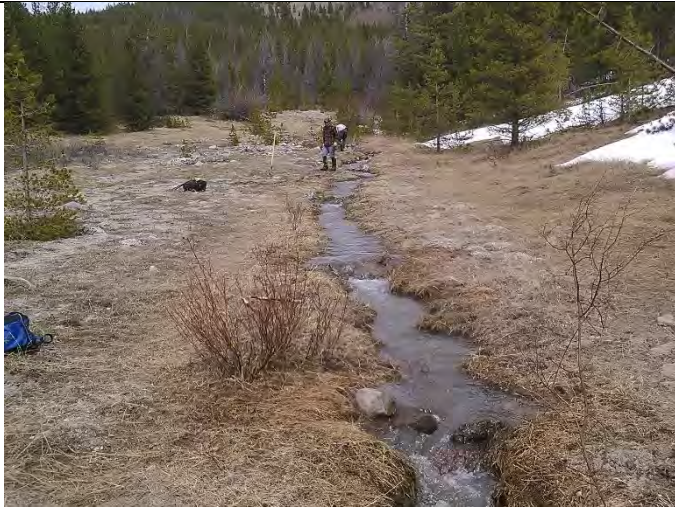
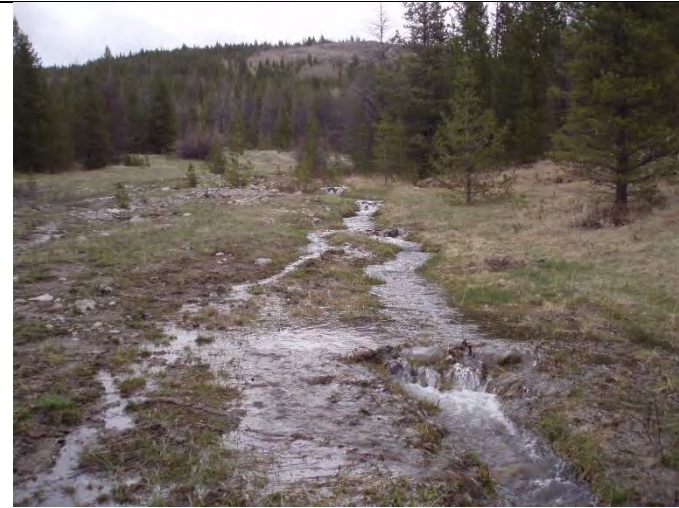
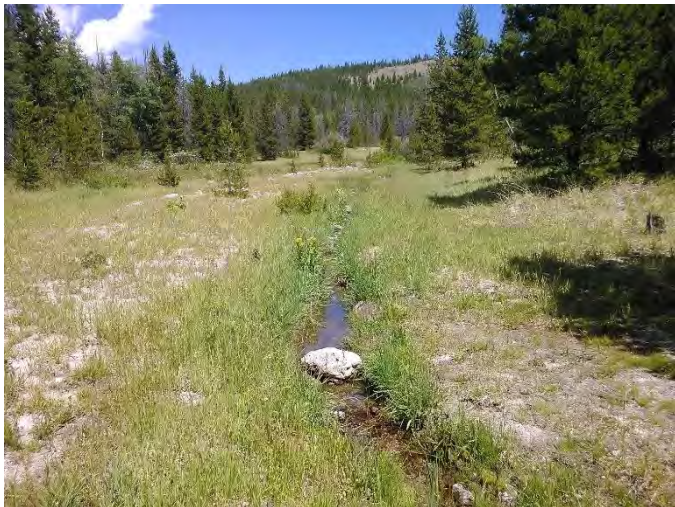
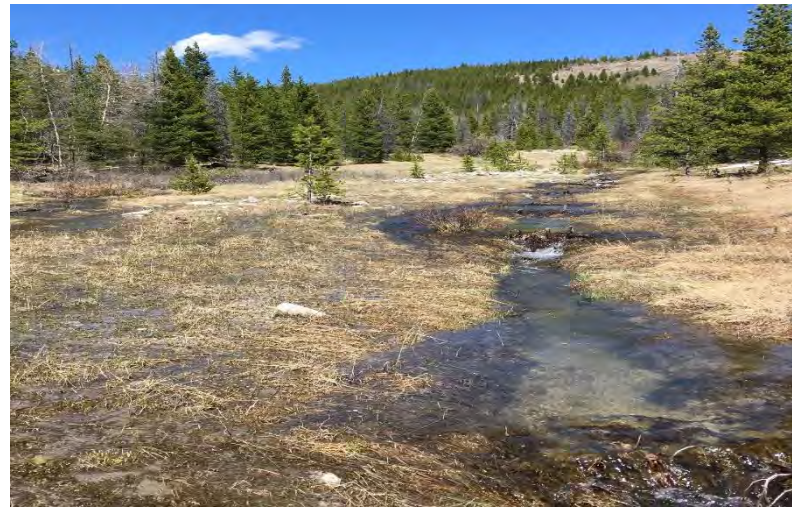
*Progress of a beaver mimicry structure over time: Spring 2015 (top left); Spring 2016 (top right); Summer 2016 (bottom left); Spring 2017 (bottom right)*

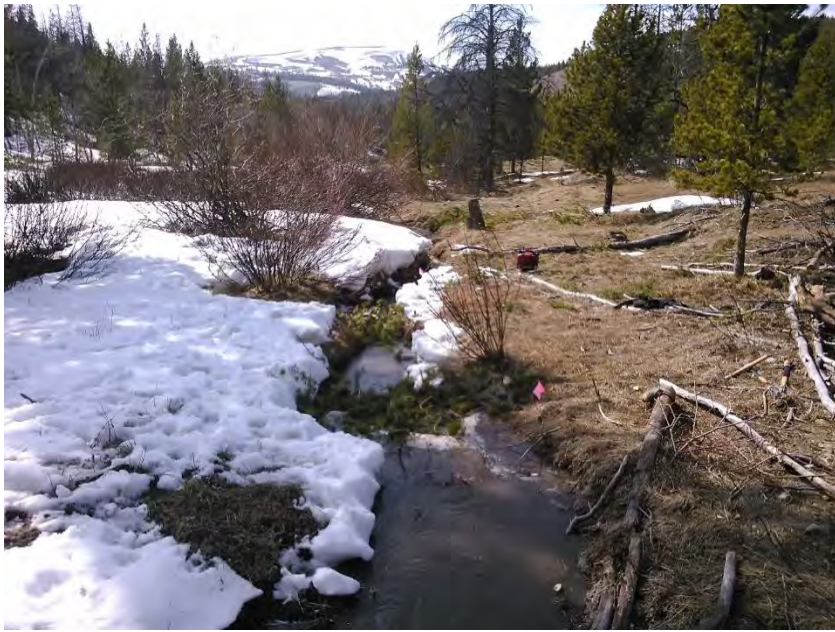
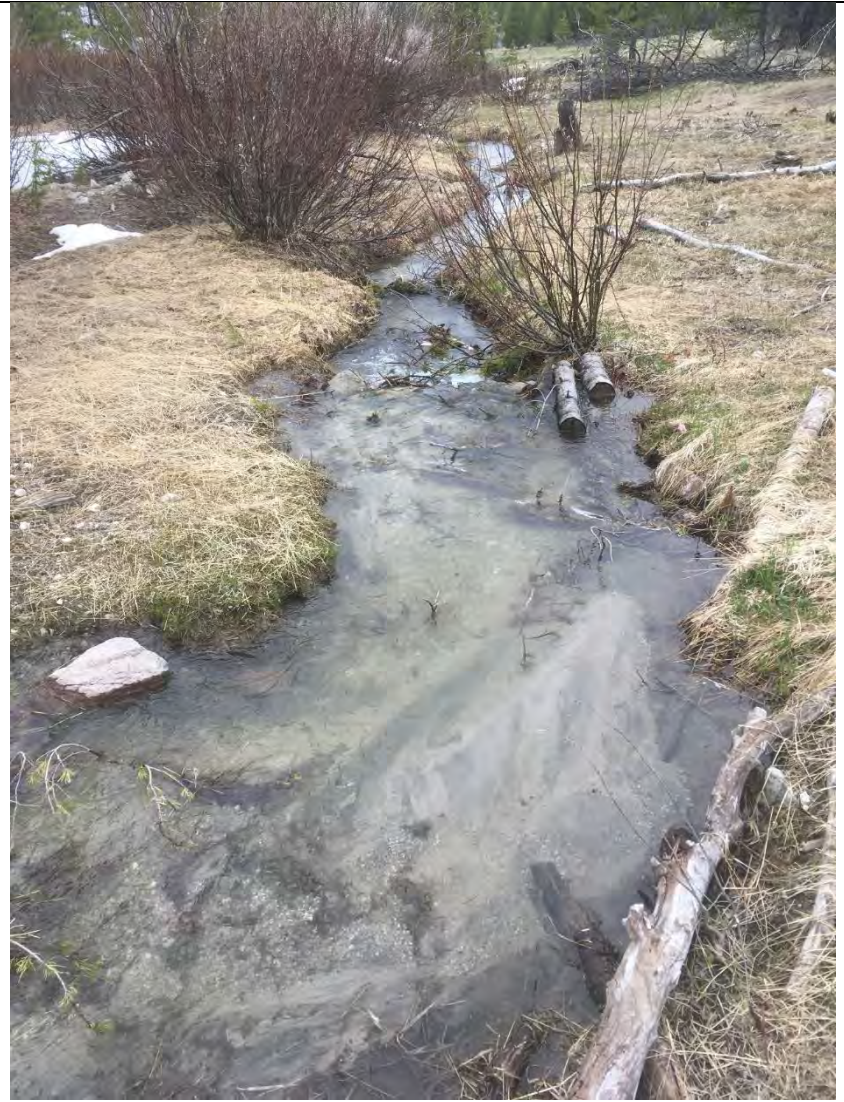
*Sediment catchment from beaver mimicry structure installed in incised reach of California Creek in 2015 (above) and in Spring 2016 (right)*

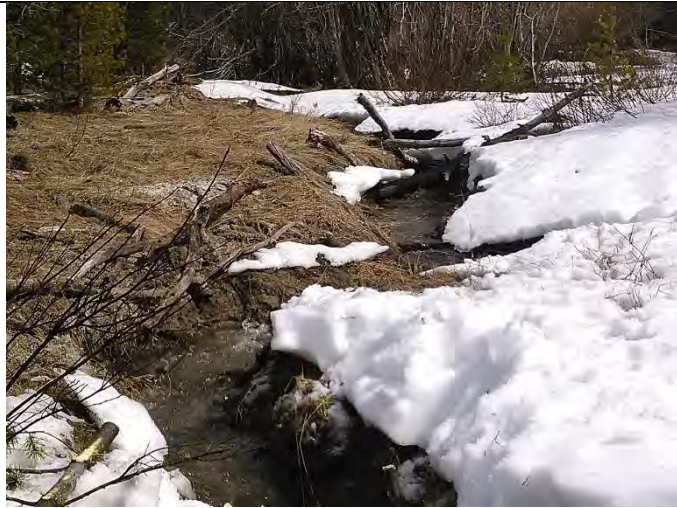
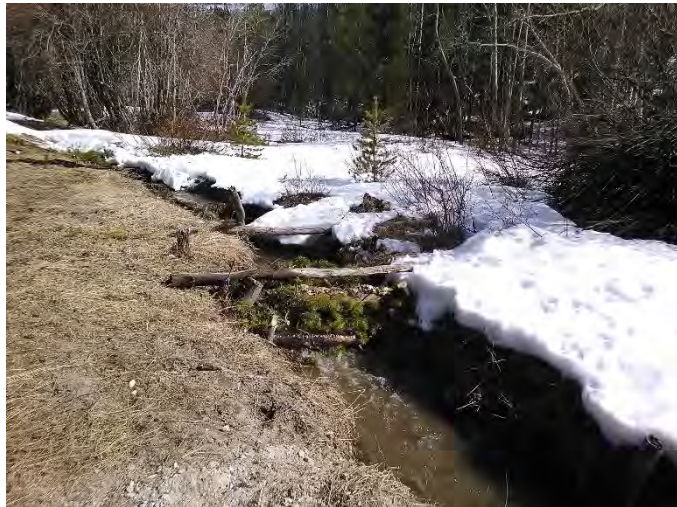
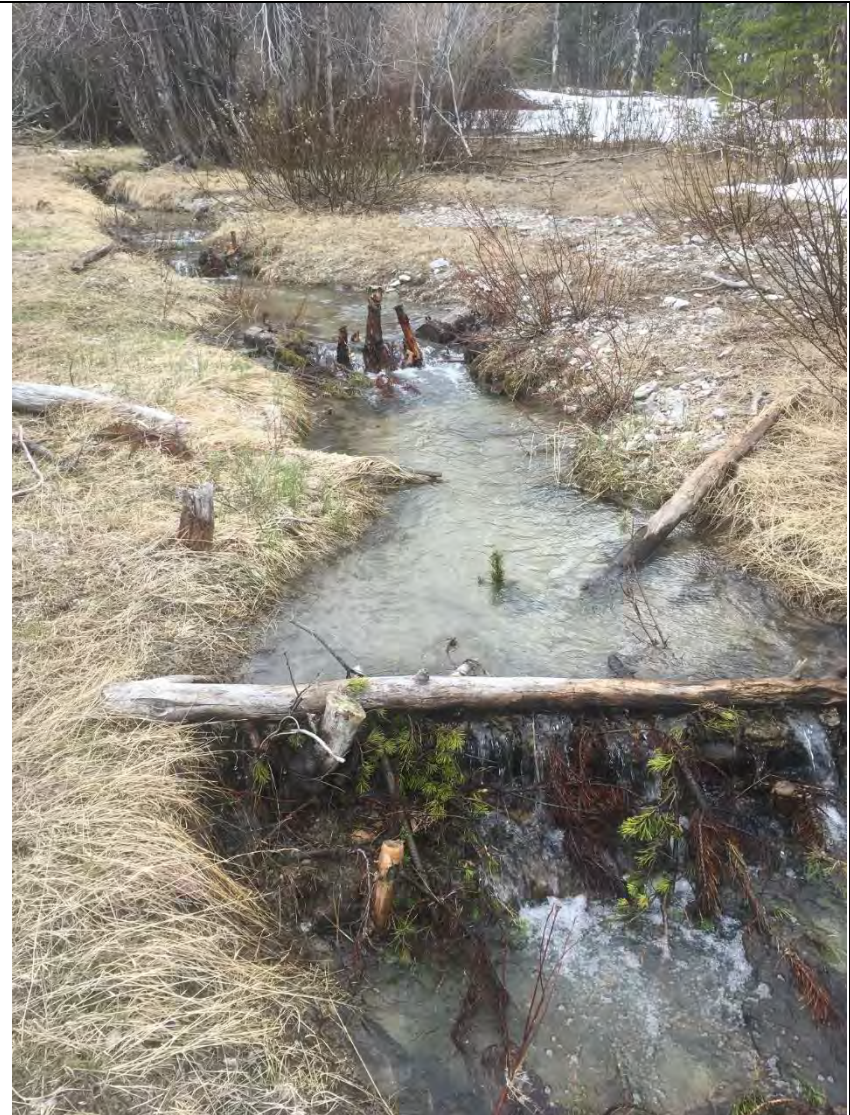
*Progress of a beaver mimicry structure in California Creek from installation in Spring 2015 (left) and in Spring 2016 (right)*

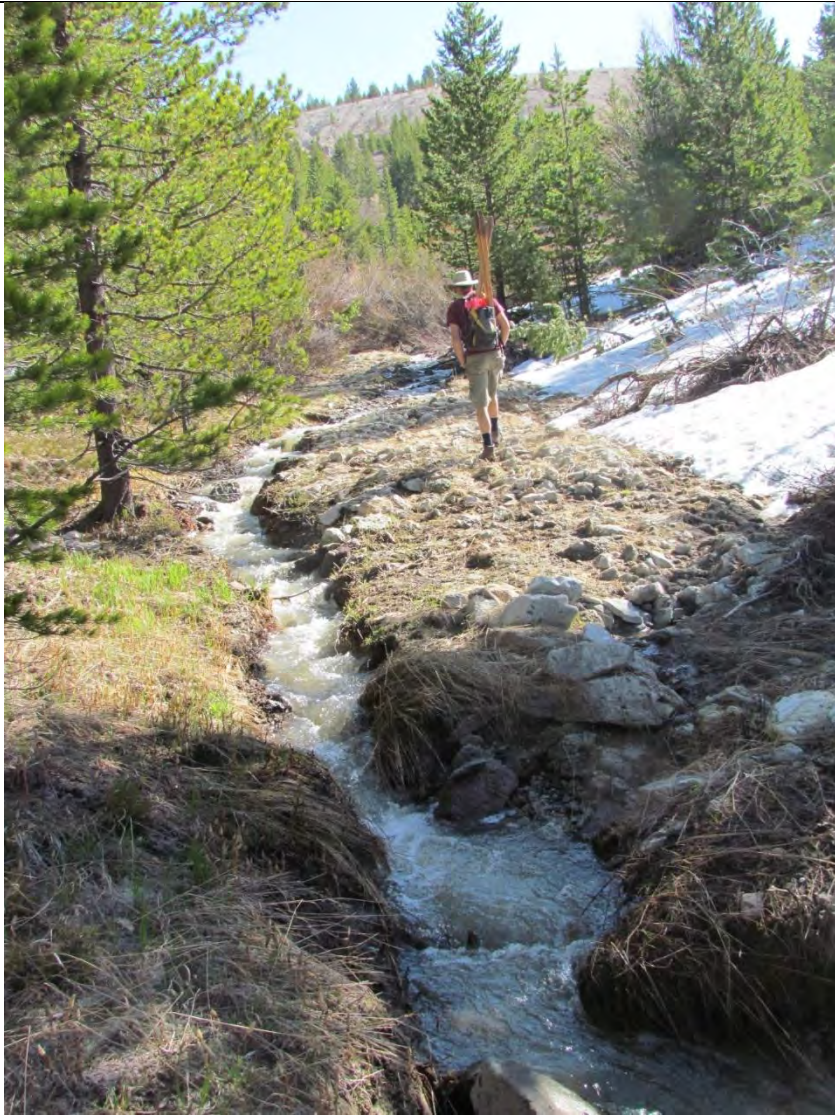
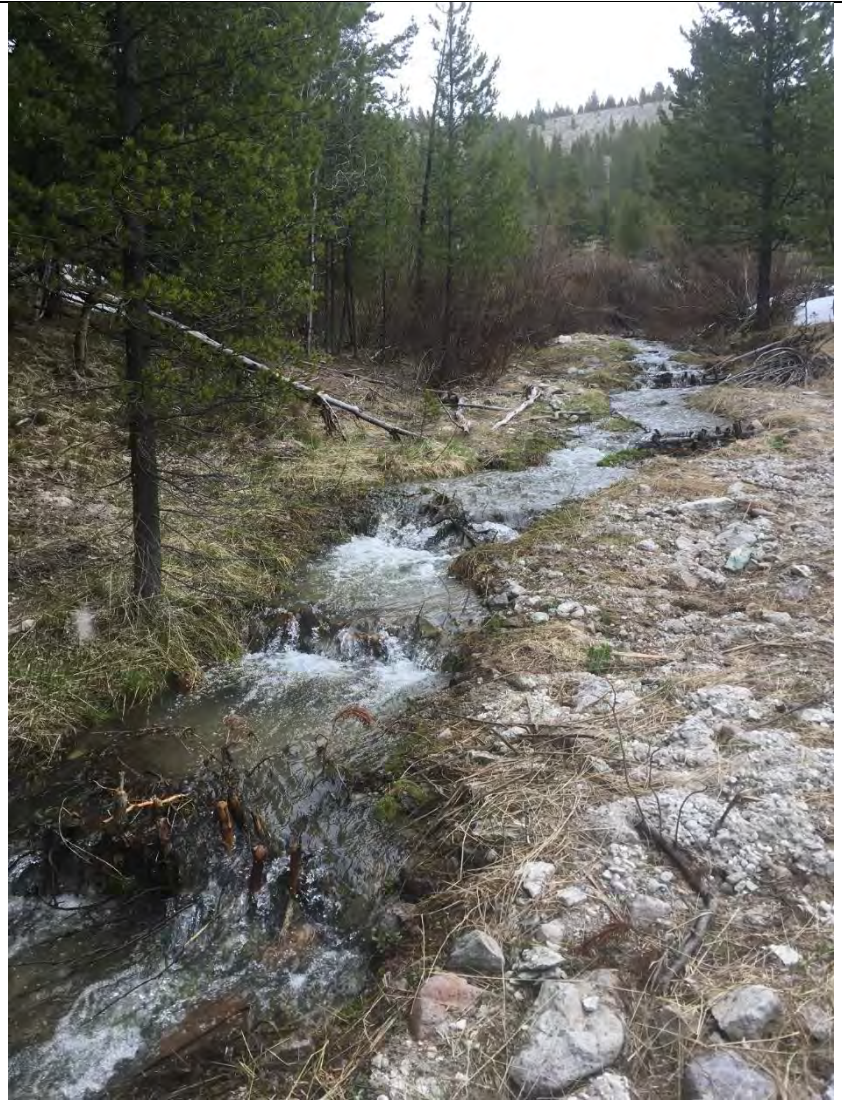
*Progress of a beaver mimicry structure in California Creek from installation in Spring 2014 (left) and in Spring 2017 (right)*

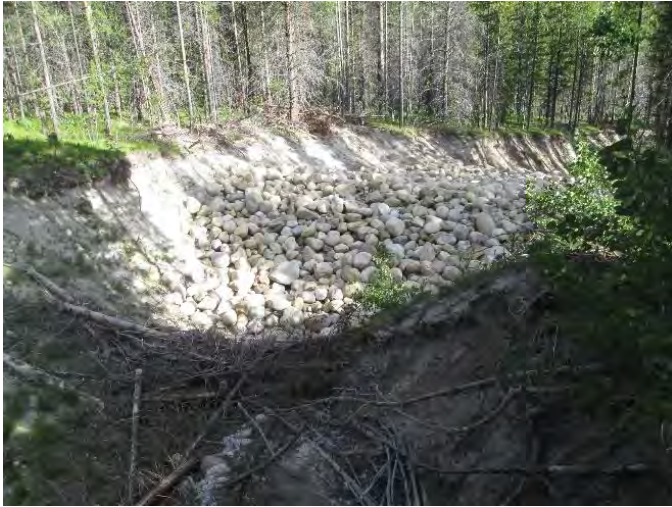
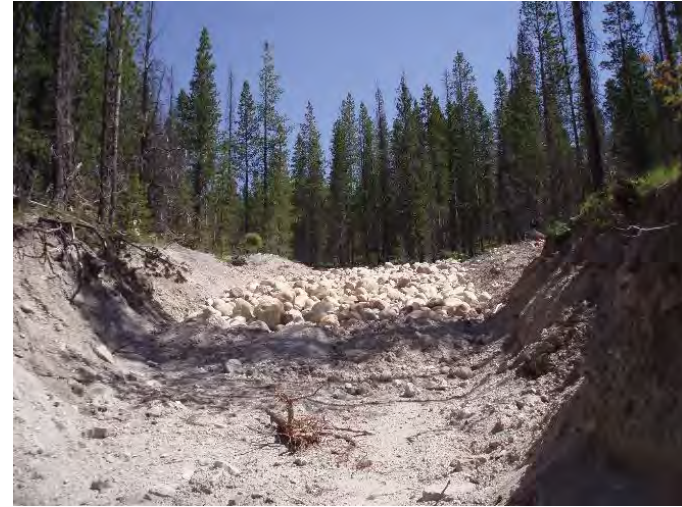
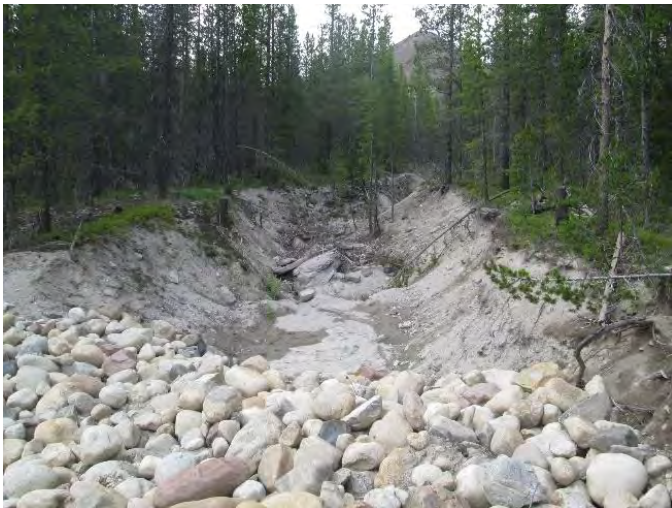
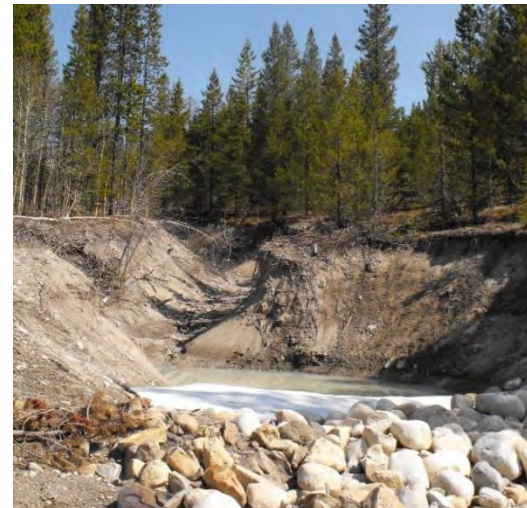
*Figure 29. SSR-3d Engineered Rock Check Dams*

*Engineered rock structures installed by NRDP in two gullies above California Creek.  
Images (top row) looking upstream at structures from below and looking upstream at structures from above (bottom row)*

This work includes more aggressive, mechanized approaches to sediment reduction. The techniques accomplish similar functions to those described for SSR-2 techniques above but mechanized practices necessarily involve some impacts to the landscape. All vehicle access areas are reclaimed after work is completed and seeded with native species mix. Weed control is always included with SSR-3 activities to avoid incursions from equipment. Summary of all SSR-3 work is shown in **Table 10** below. A visual summary of completed SSR-3 work is shown in **Figure 28** and images of work completed are shown in **Figure 29** and **Figure 30**.

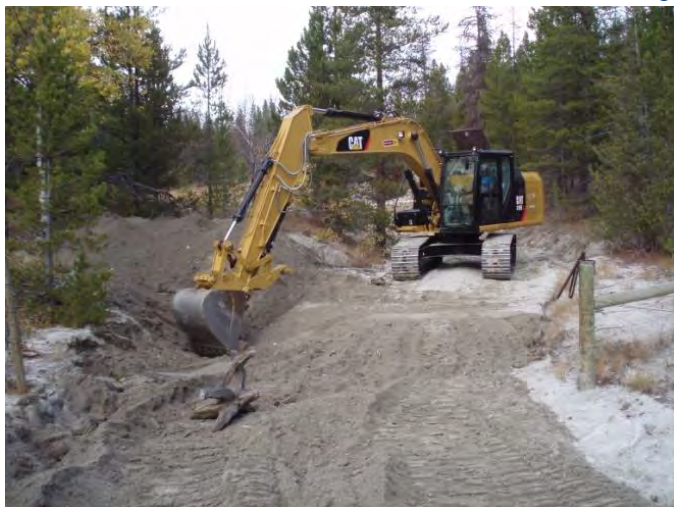
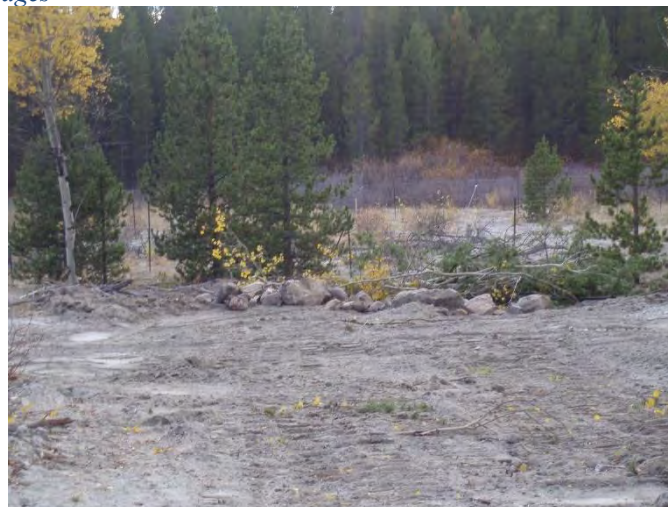
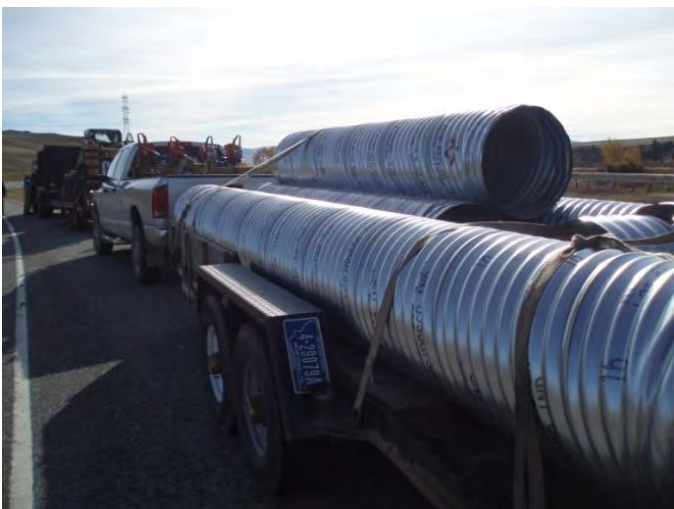
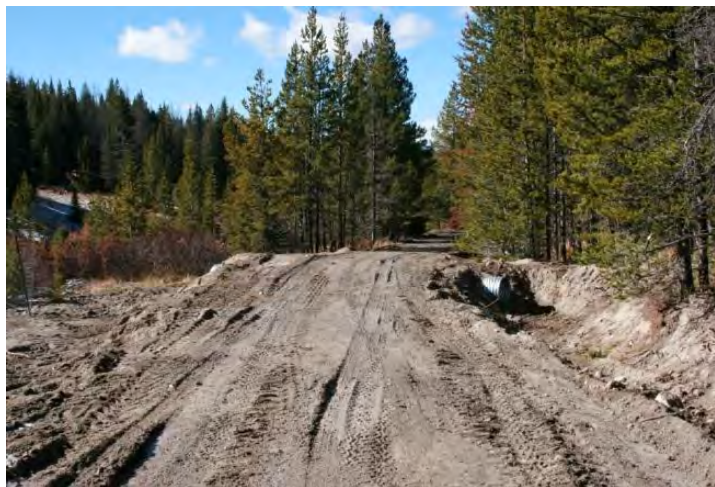
*Figure 30. Road Work Images*

*Digging catchment beside plume area (top left) and view across road where large rill used to cross (top right) in California Creek.  
Road work area 3 (below) right showing ditch and culvert crossing*

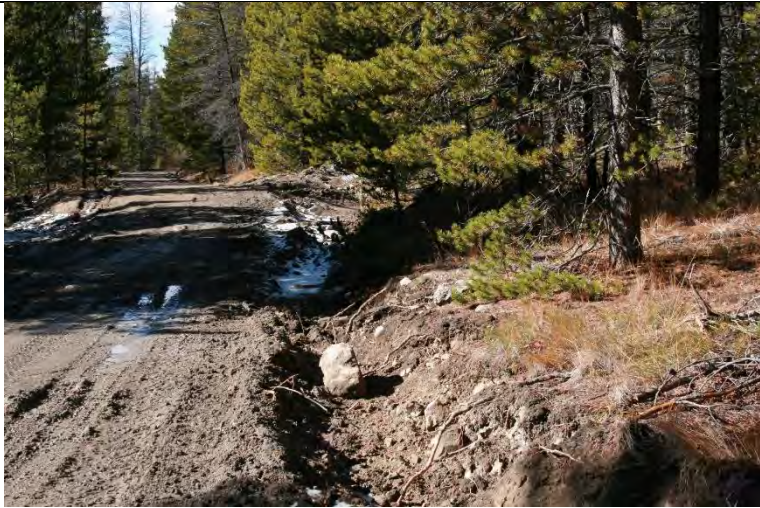
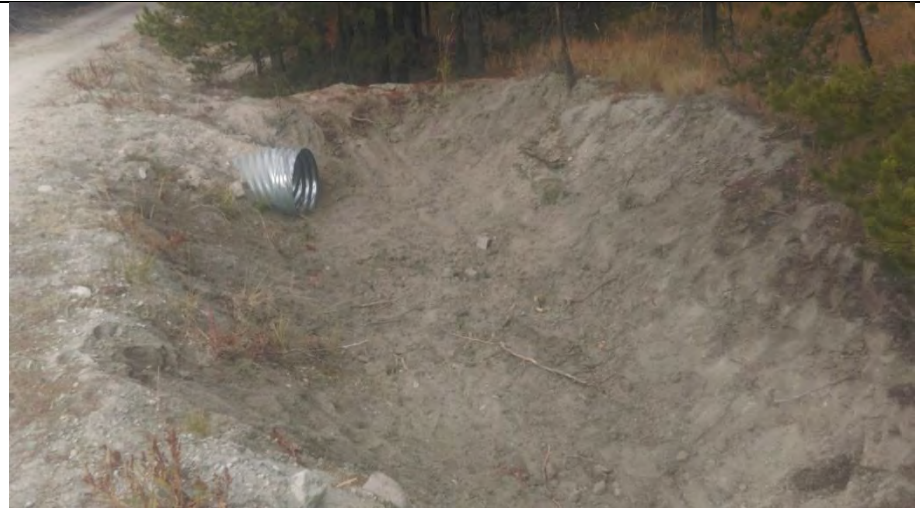
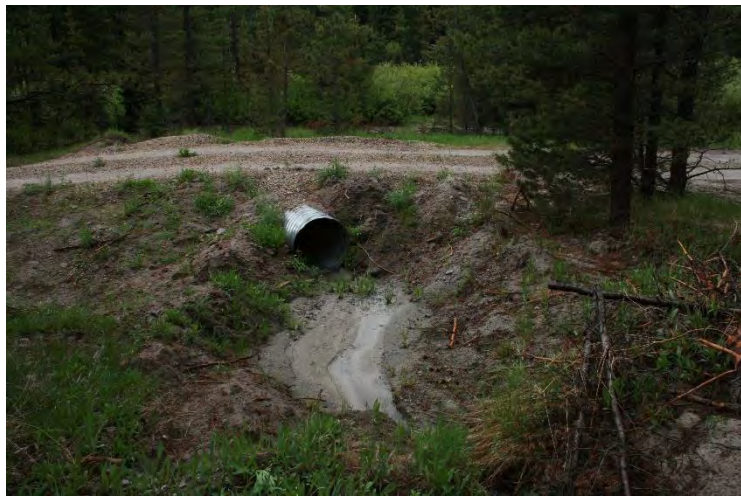
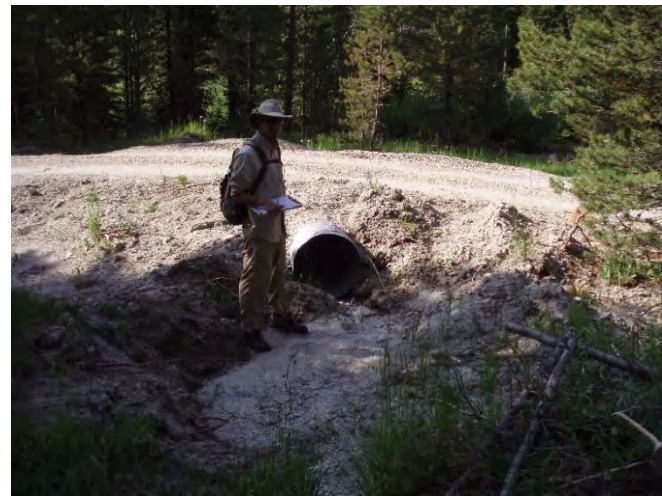
*Road work area in California Creek (above) showing ditch and catchment basin.  
Another road work area (below) with sediment deposition from 2015 (left) and 2016 (right) spring flows*

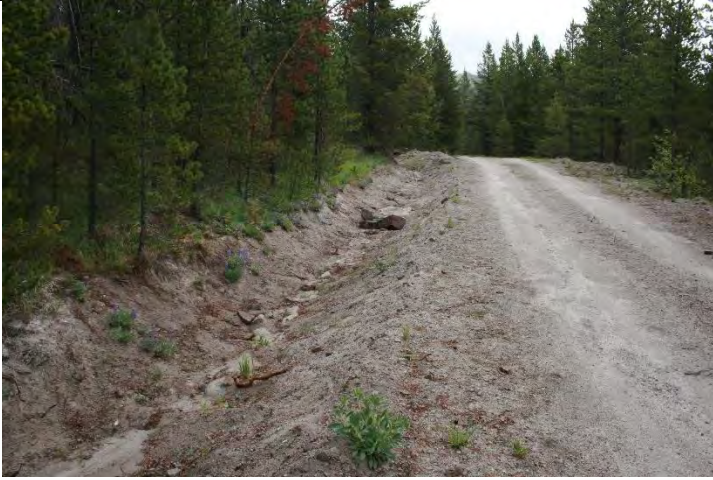
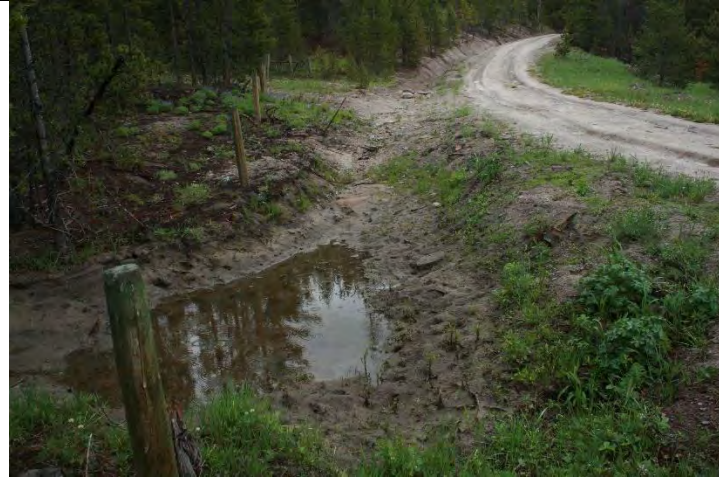
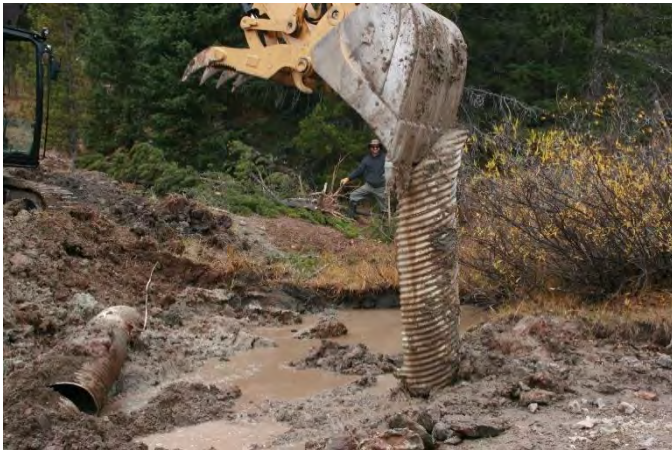
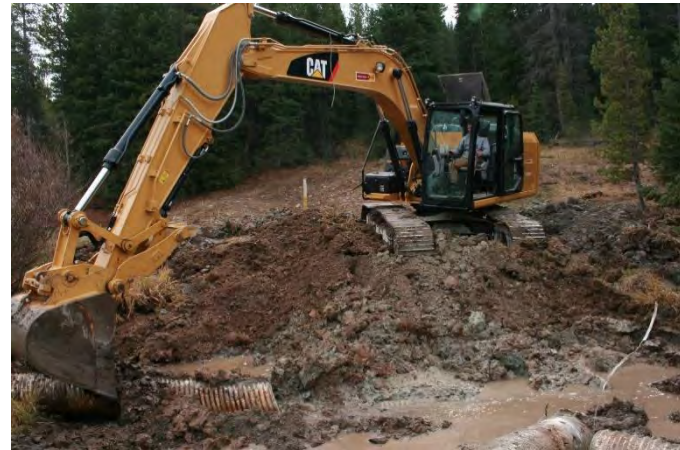
*Road work area (above) with improved roadside drainage and expanded catchment area at base. Culvert remains plugged and will be addressed by MFWP in the future. Culvert removal from stream in California Creek shown below and on next page*

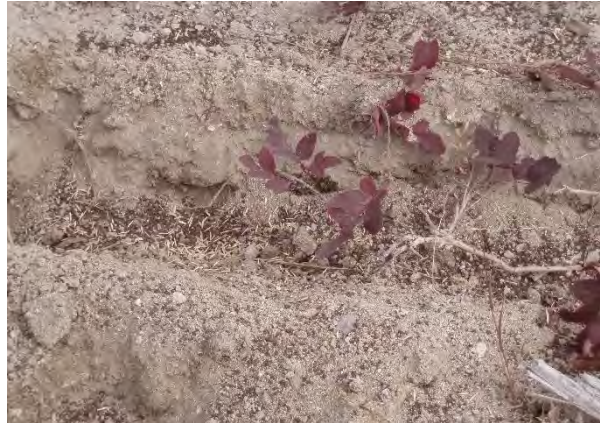
*Broadcast seed and inorganic fertilizer visible alongside established Berberis repens in the Mt. Haggin Uplands.*

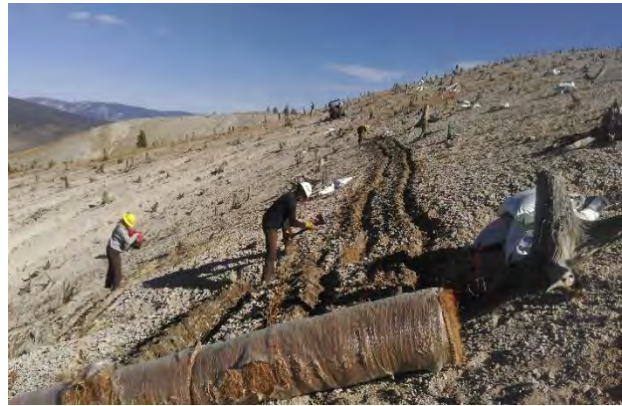
*Seeded and fertilized micro-swales (trenches) are installed before being covered by coconut coir erosion fabric and fastened with stakes and woody debris in Joyner Gulch*

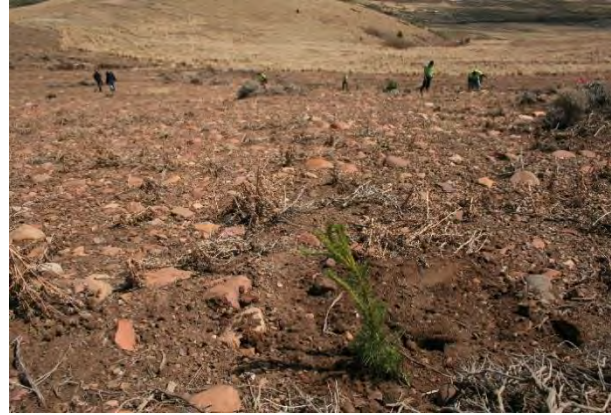
*Woody vegetation establishment is a crucial step towards the end goal of the Mt. Haggin restoration efforts. Above, Pinus contorta saplings being planted at the Stucky Ridge site.*

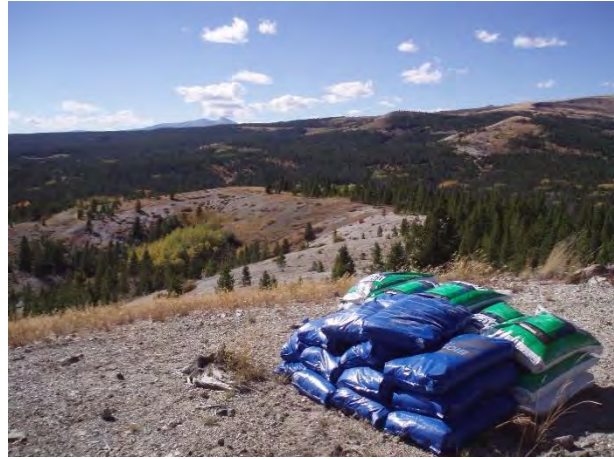
*Two forms of bagged fertilizer, – one organic, the other inorganic – are staged on a ridgeline via helicopter or ATV*

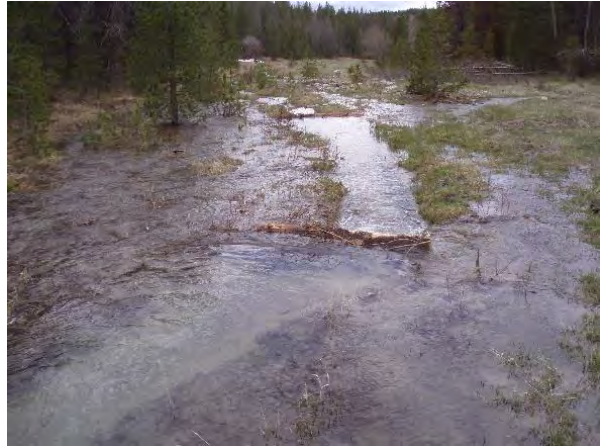
*In-stream beaver dam analogues (BDAs) successfully stopping sediment transport and reactivating floodplain in previously incised creek system in the Mt. Haggin WMA*

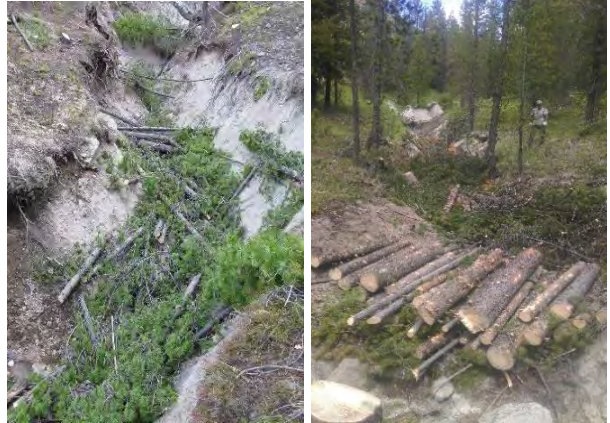
*Two examples of slash filters utilizing forest thinning byproducts to capture sediment and fill erosion gullies.*

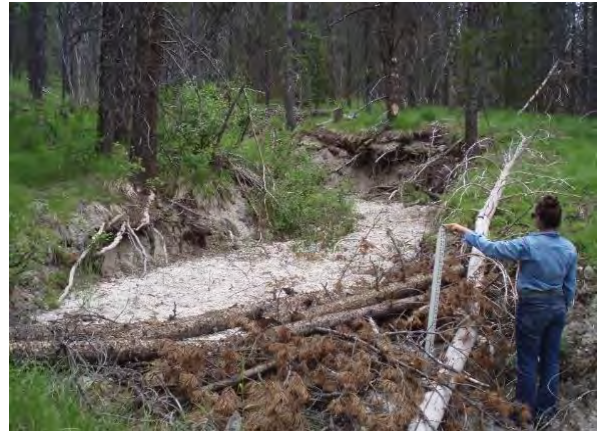
*A log and slash check dam that filled with sediment over the course of one year in the Mt. Haggin WMA*

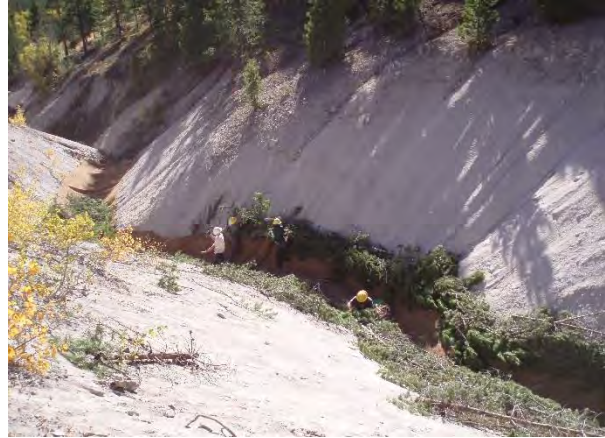
*Brush bundles being installed in a large erosion gully in the Mt. Haggin WMA*
