# Anaconda Smelter NPL Site Mount Haggin Uplands (RDU 15)

## Remedy and Restoration Work Plan

PREPARED BY:  
MONTANA DEPARTMENT OF JUSTICE  
NATURAL RESOURCE DAMAGE PROGRAM

MAY 2018

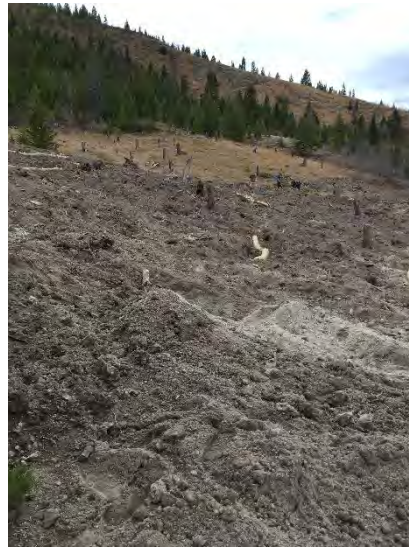
*Several acres of slope pitting and roughening adds microtopography which improves water retention, planting success, and soil stability; Stucky Ridge*

Slope pitting and roughening utilizes heavy equipment to increase microtopography on steep slopes in an attempt to reduce overland sheeting, increase water retention and infiltration, promote seed germination and planting success, and reduce soil mobility. Pits can be large, from 3-8 feet from pit bottom to top of pile. Microtopography provides ideal settings for fertilization retention, seed germination and success, and snow and rainwater collection and infiltration.

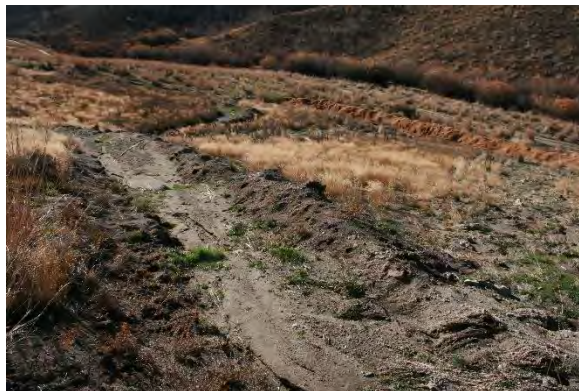
*A newly constructed earthen sediment basin with broadcast seed and erosion fabric, prior woody shrub plantings; Cabbage Gulch*

Earthen sediment retention basins are swales dug across contour that catch overland sediment flows. Filled basins become terraces with improved conditions for natural revegetation, including seed germination and moisture retention. These are constructed with an excavator or skid steer- as older swales fill, newer ones are constructed upstream.

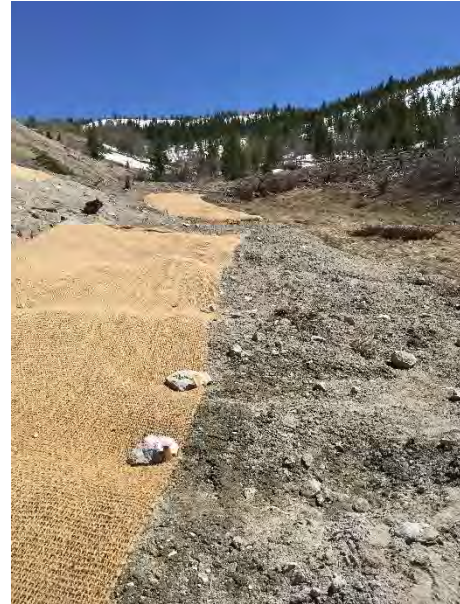
*Filled gully matches existing slope angle. Stream here was redirected to old channel through sedge mat at new low point in valley*

Gullies are filled by pushing material from surrounding areas and creating even grades throughout the landscape to reduce channelization and overland sheeting. Additional SSR treatments are incorporated to minimize soil mobility and promote water infiltration. Check structures ensure water does not re-cut old channel.

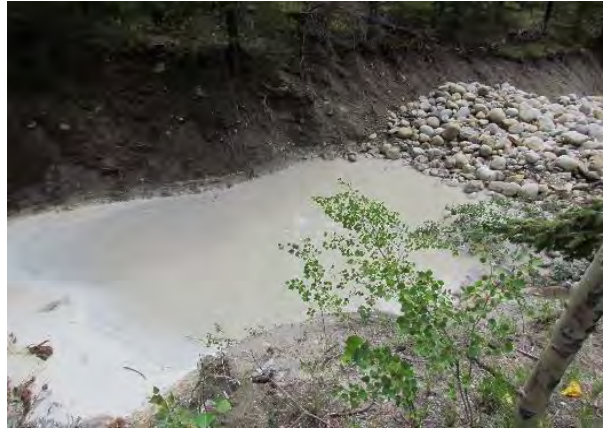
*Rock check dams filled with sediment and runoff in California creek drainage.*

Where large sediment point-sources exist, rock check dams have been utilized to capture and settle all transported materials and runoff. Located at the toe of sediment plumes and large gullies, rock check dams are a mix of earthen berms, rock-reinforced spillways, and settling ponds. Geotextiles are often used to stabilize the earthen berms while rock is used to reinforce spillways to prevent under scour and headcuts.

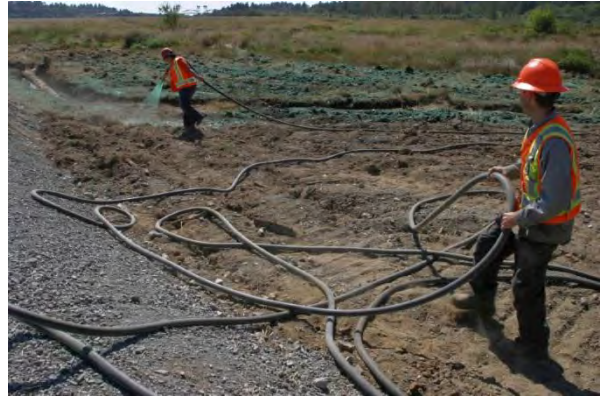
*Hydroseeding applications are restricted to roadsides and can extend upwards of 300- 500 feet from pull-out.*

After construction efforts are completed, large areas of bare soil can be seeded, mulched and fertilized with various hydraulic applications. Hydro-seeding combines mulch, seed and soil amendments into a slurry that is then applied directly onto bare soil. It is often used for erosion control on road construction sites and can include customized recipes for site specific applications.

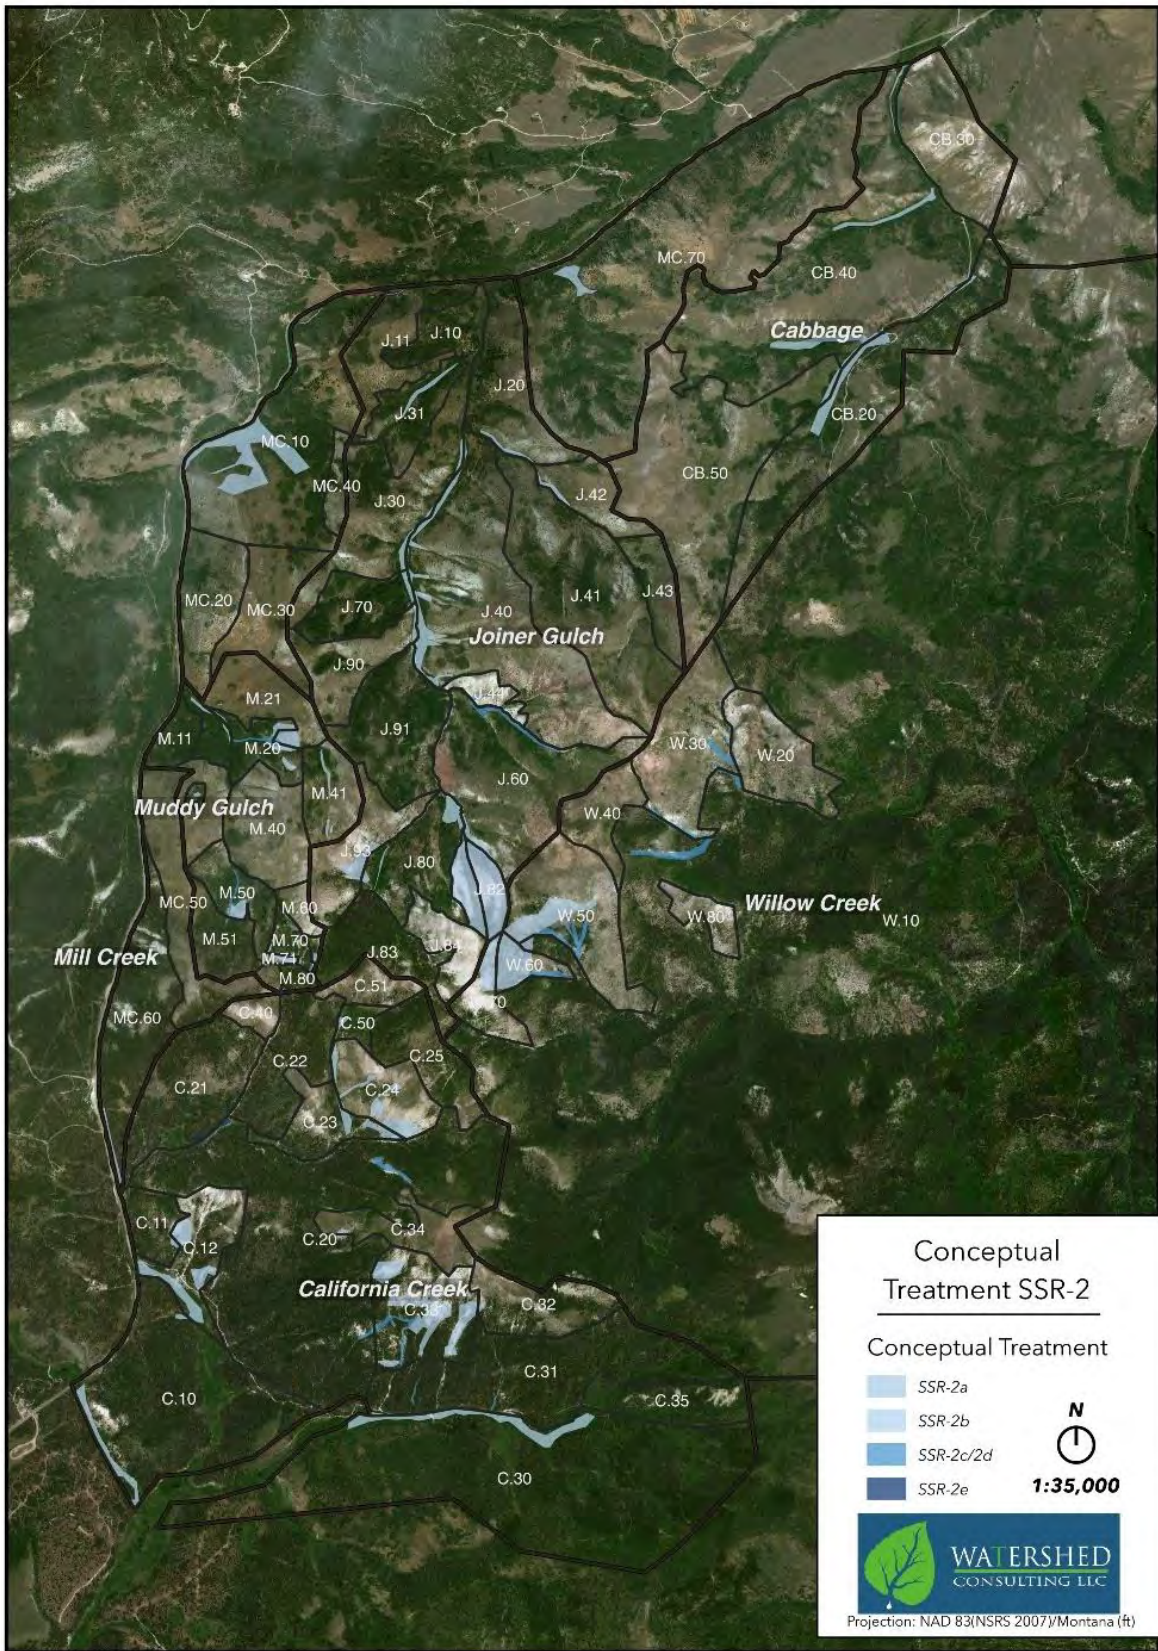
Figure 34. SSR-2 Remedial Design

Specific treatments within each SSR type are shown in more detail by polygon in **Appendix D: Polygon Data Sheets**. Given the adaptive and iterative approach of the remedial strategy presented in this plan, treatment quantities and locations are subject to change depending on site conditions and performance of the applied remedies. Tasks and contracting related to the implementation of this plan will be specified in more detail through task orders, annual work plans and contracting documents to be drafted between NRDP and its contractors and in coordination with the MHTWG. Treatment areas are shown by SSR type in **Figure 33, Figure 34 and Figure 35**

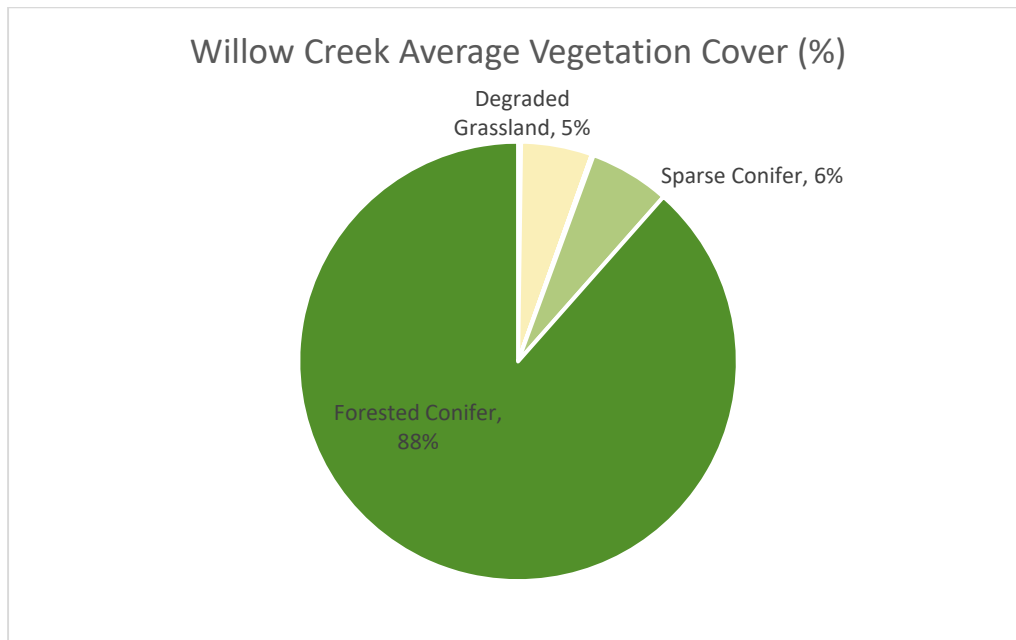
A rapid aerial assessment of vegetation cover in the upper watershed was conducted by NRDP in 2017, shown in the figure below. Due to the inaccessibility of much of the upper watershed, more precise vegetation estimates were not conducted. A more precise survey, based on photographs taken in the area, would likely show more acreage of dense shrub as well as moderate shrub cover, as well as sparse conifer, while estimates of bare slopes and degraded grasslands have a higher degree of certainty.

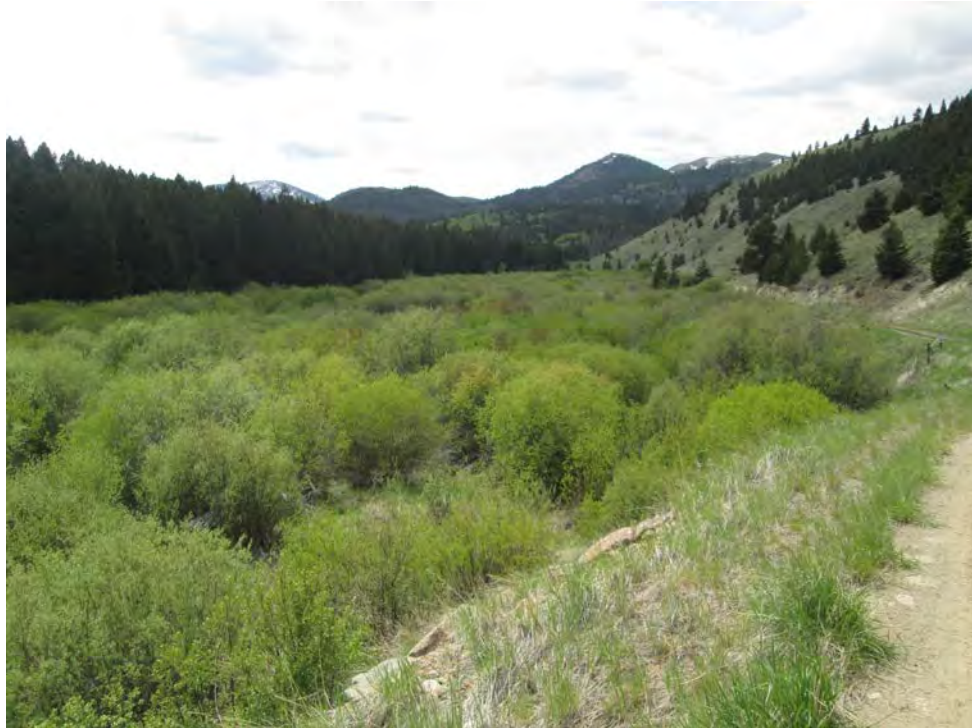
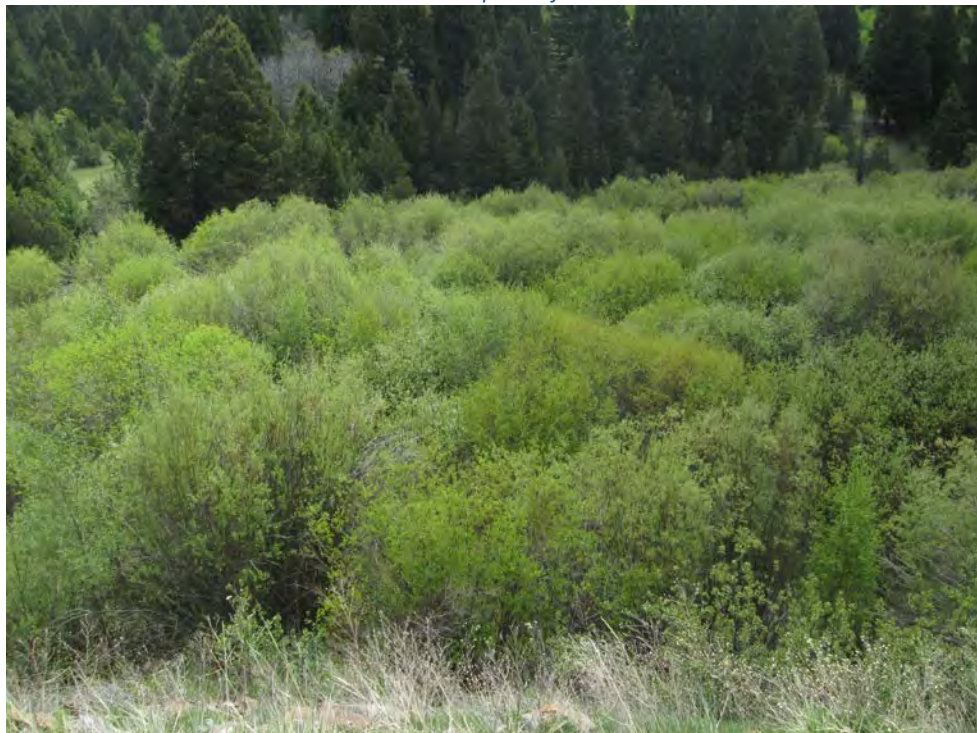
*Figure 1. Willow bottom looking north (above) and west (Below) inside the WMA boundary. These conditions persist for 1.2 miles.*

The Willow creek valley bottom in the area surveyed is in reference condition. Mature, often 12-foot tall and dense stands of willow (*Salix sp.*), alder (*Alnus rubra*), dogwood (*Cornus sericea*) blanket the valley bottom as far as can be seen from the road. Aerial imagery shows an average width of 180 ft. of mature willow bottom for the first 1.3 miles of Willow creek inside the WMA. Below the dense canopy, the creek braids often, with abundant side channels and pools providing moisture throughout the valley bottom. Aerial imagery from 2014 shows active beaver dams over 1.5 miles into the WMA. Beaver have likely been a consistent part of this ecosystem for at least the past 40-60 years.

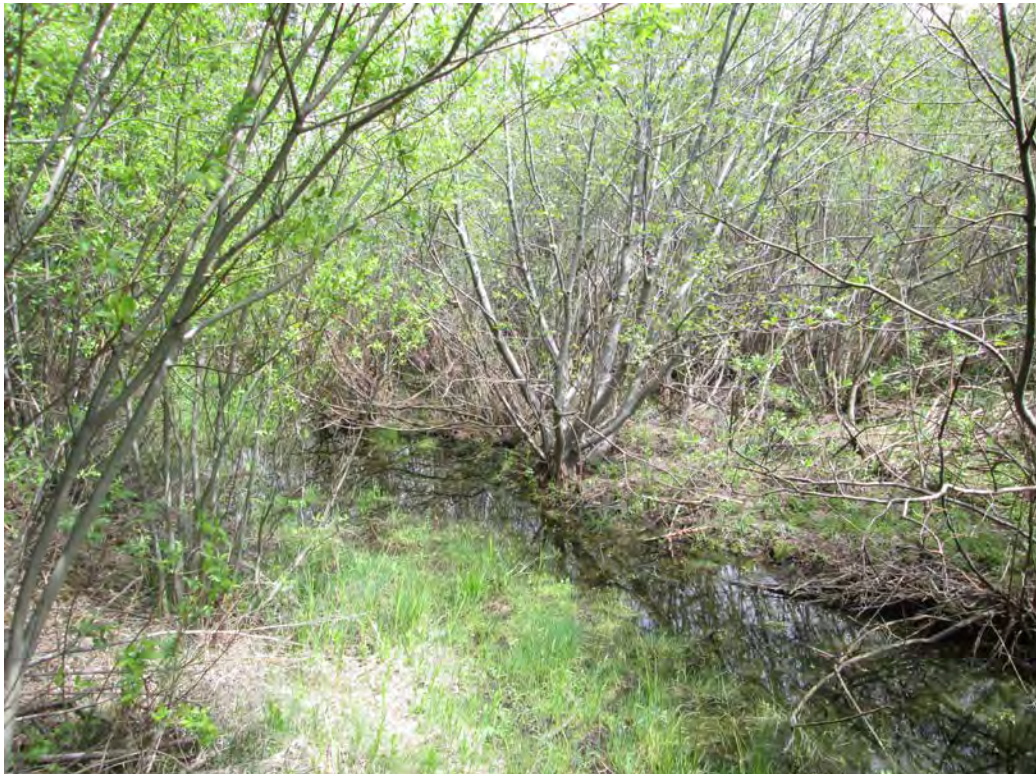
Figure 3. Understory by small side channel. Dense willow, alder, dogwood stands and noticeable litter/duff and soil accumulation.

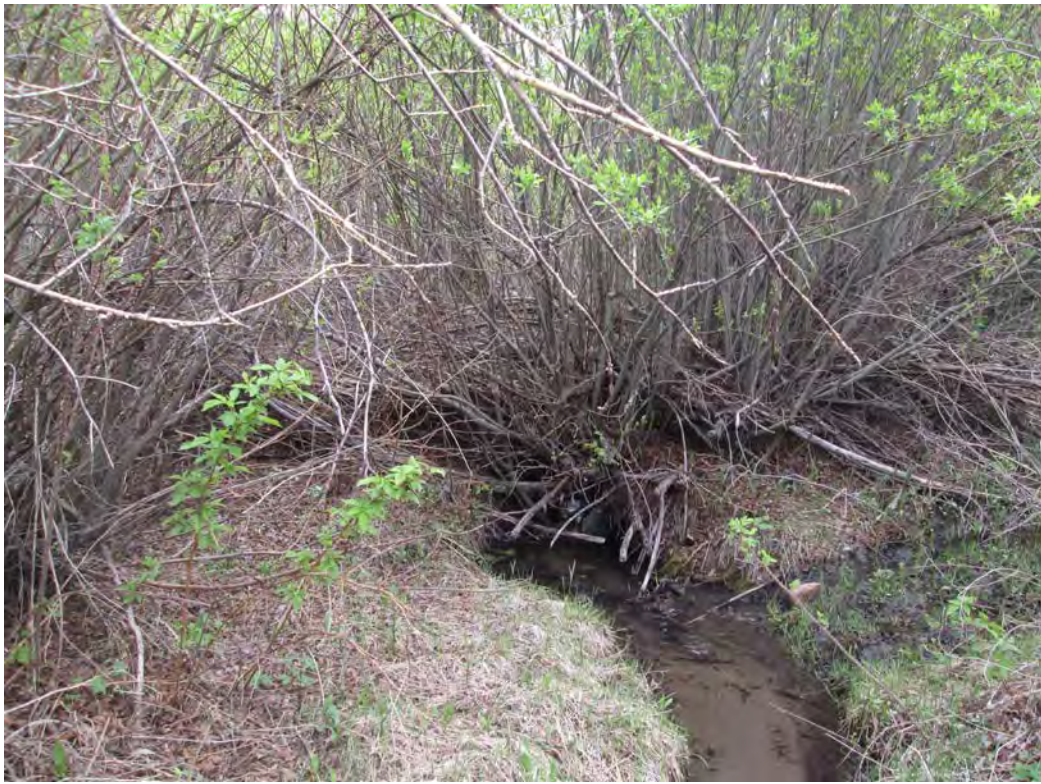
*Figure 4. Perched willow show evidence of past inundation from beaver ponds and also demonstrate thick litter and duff accumulation, reduction of water velocity and sediment trapping.*

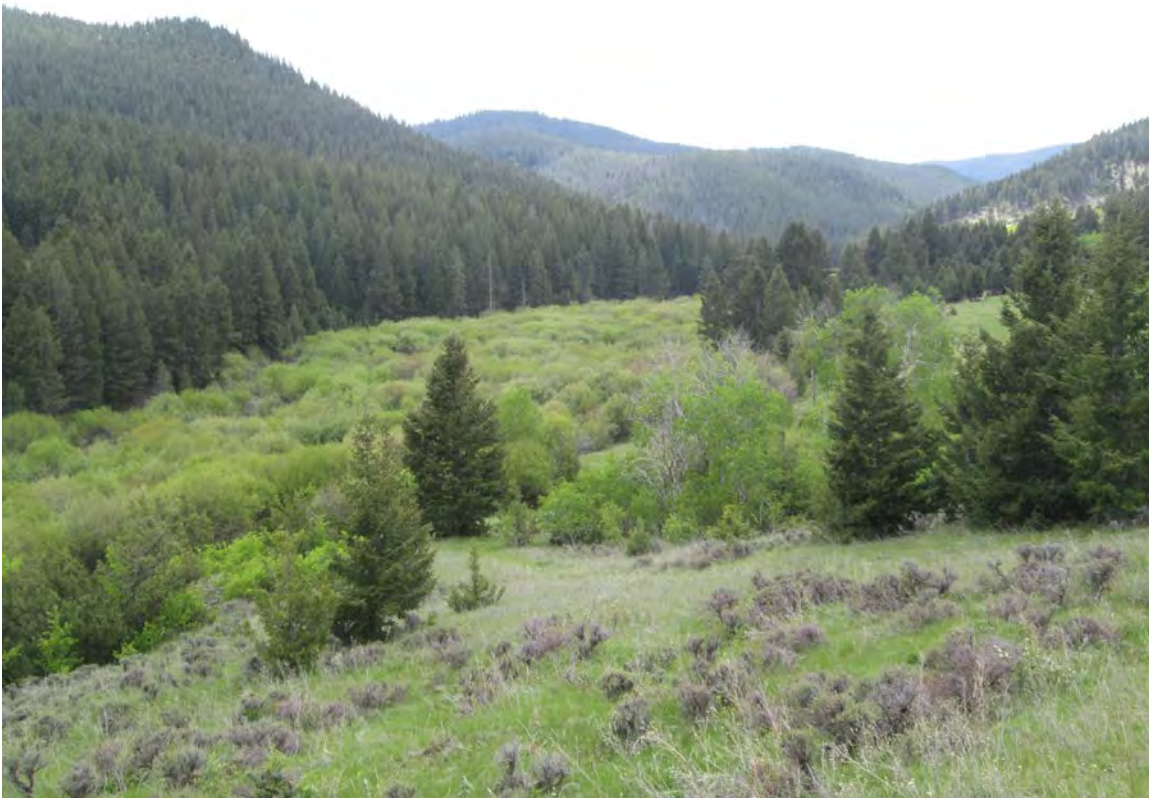
*Figure 5. Dense willow bottom and confluence with un-named creek. Side channels also show abundant shrub growth and excellent natural recovery trends.*

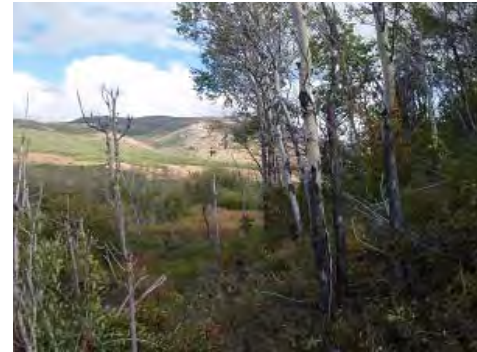
Image 1: Mature riparian vegetation moving up slope from wet valley bottom

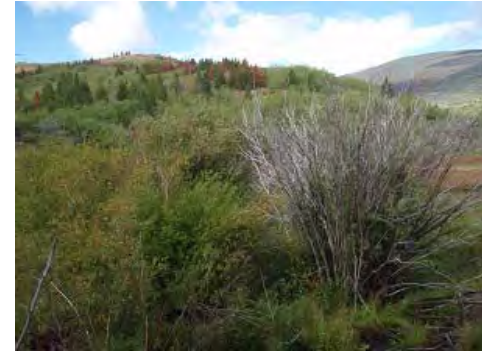
Image 1: Mature riparian vegetation in valley bottom due to beaver activity

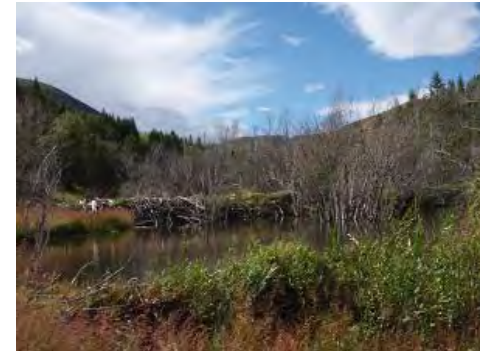
Image 1: Beaver pond complex in low-lying area

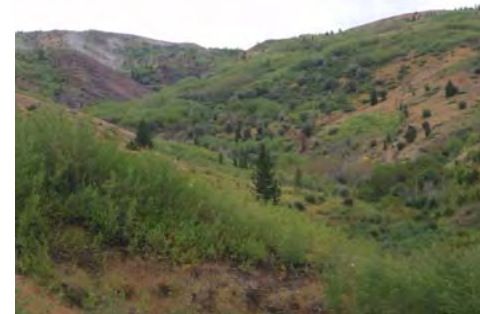
Image 2: Strong shrub and aspen regeneration

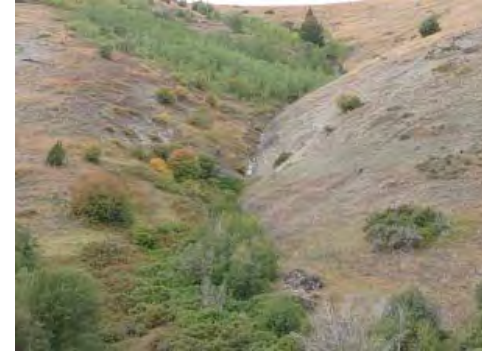
Image 1: Mature riparian vegetation in draw characteristic of unit

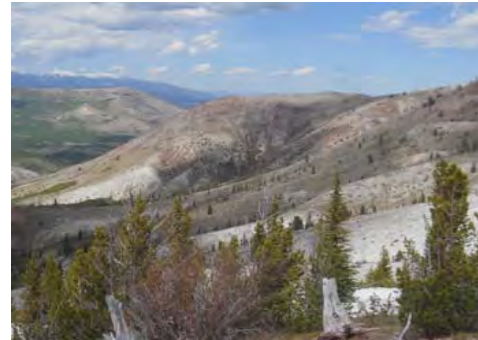
Image 1: Upper reaches of unit in background- mix of welded tuff and rhyolite parent materials

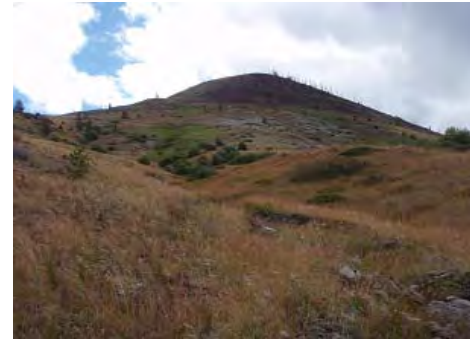
Image 1: Typical Upland conditions of J42

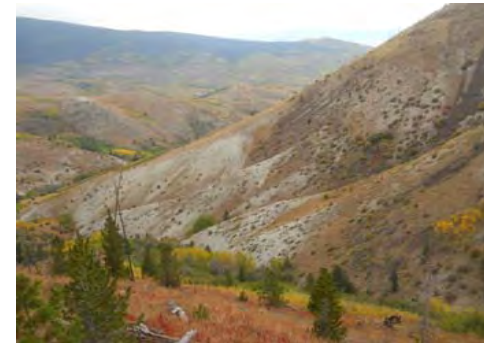
Image 1: Bare area of unit distinct from surrounding areas

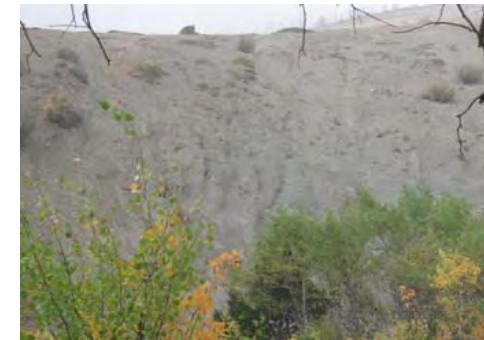
Image 2: Extremely steep slopes beyond scope of any BMP

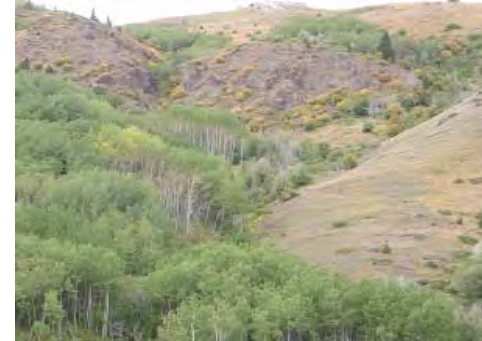
Image 1: Robust riparian shrub growth extending into grasslands and talus slopes

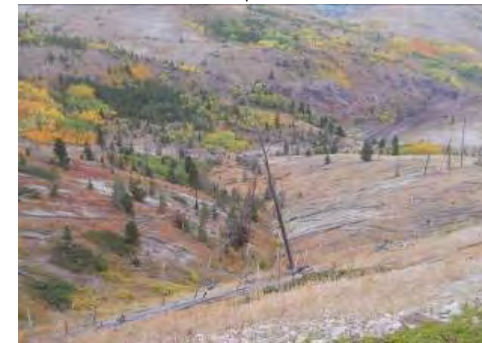
Image 2: Degraded grasslands and mixed vegetation on west-facing slopes

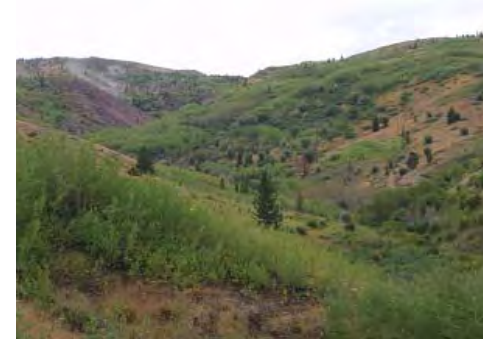
Image 1: Mature shrub growth has colonized most of hillslope

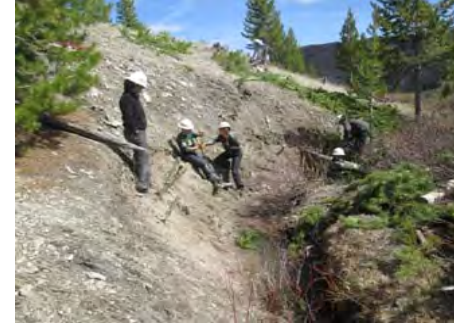
Image 2: Crews treating gully at bottom of unit in 2015

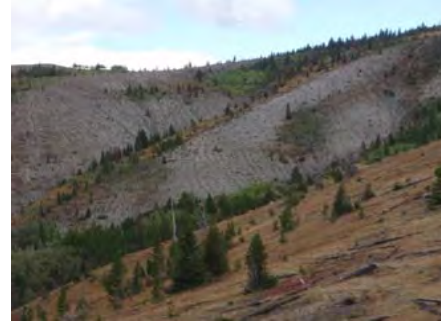
Image 1: Bare, actively eroding slopes

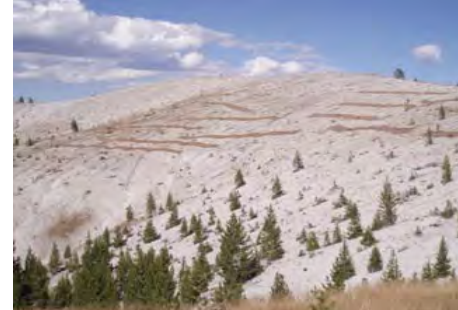
Large bare area is largest active sediment source in drainage. A 4-acre SSR-2c project established nearly 50% vegetation cover. Mechanized and hand-approaches will be employed to across remaining acreage to create suitable conditions for vegetation growth.

Image 1: 4 acre treatment of SSR-1c in bare slopes, October 2015

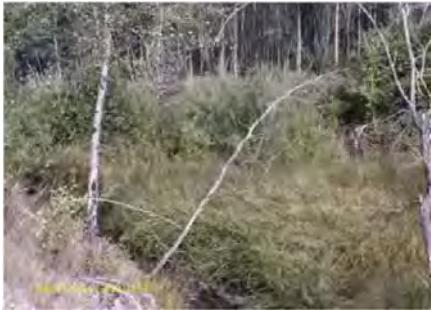
Image 1: Wetland vegetation and incised stream channel

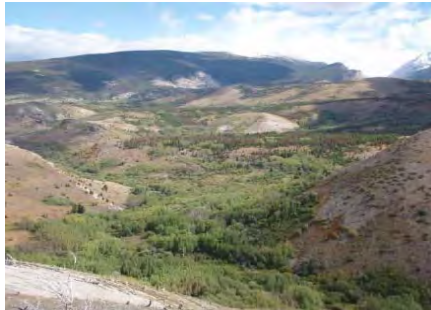
Image 2: Dense Wetland vegetation at outlet of drainage

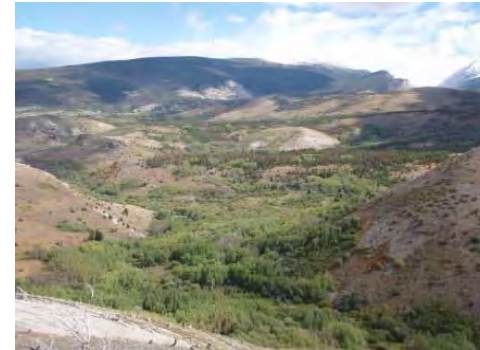
Design Justification
Mature riparian community at base of drainage. No treatments prescribed. Weeds will be monitored.

Image 1: Dense riparian vegetation characteristic of the unit

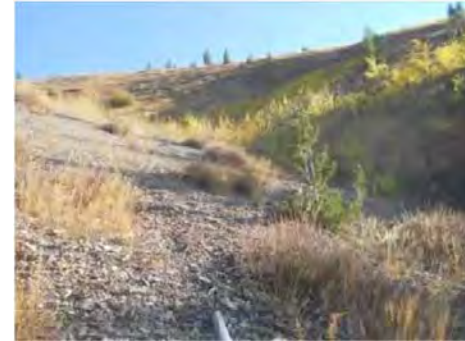
Image 1: Upland areas of the unit are degraded grasslands

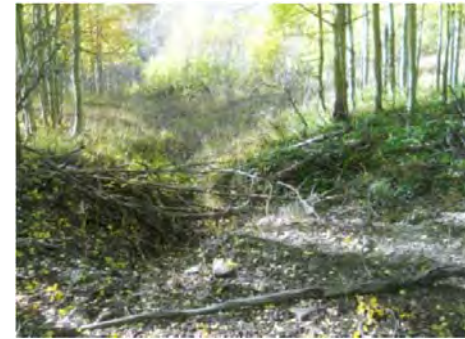
Image 2: In the large aspen grove characteristic of most of unit

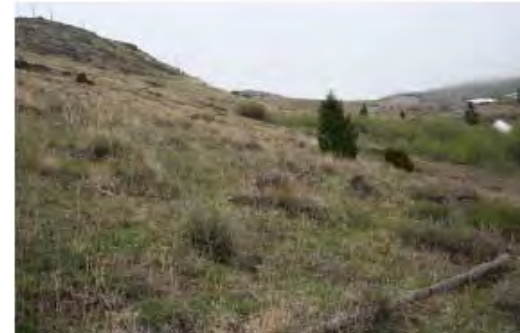
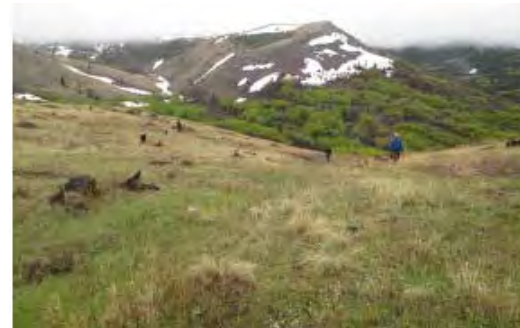
Images 1 and 2: Upland grasslands typical of unit.

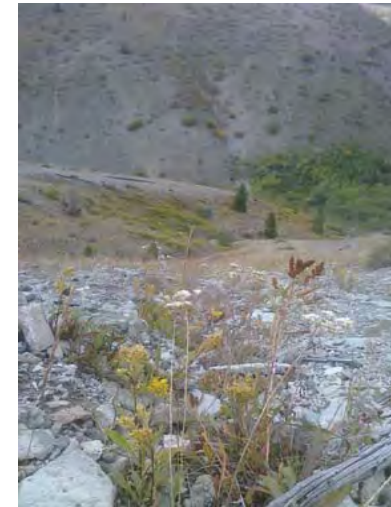
Design Justification
Steep east-facing slope has been historically de-stabilized by channel below eroding away toe of the slope. Most erosive areas will be aerially fertilized and trenched to enhance vegetation establishment.

Image 1: Bare areas of unit on steep slopes

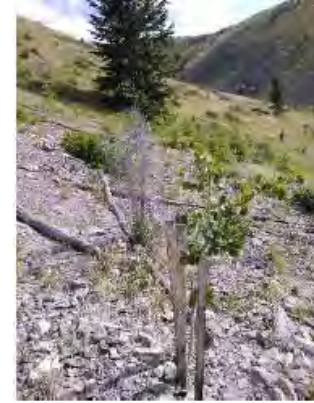
Image 1: Thriving aspen from test planting in 2011

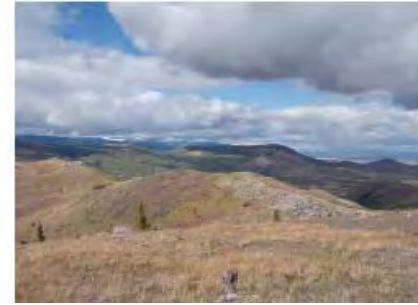
Image 1: Typical grassland conditions at top of unit

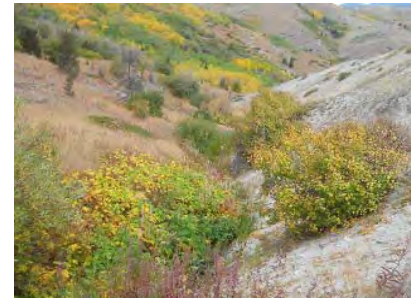
Image 2: Shrub community typical of unit

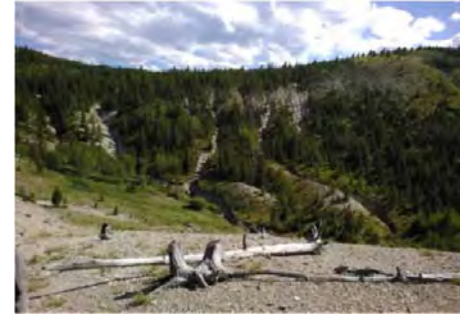
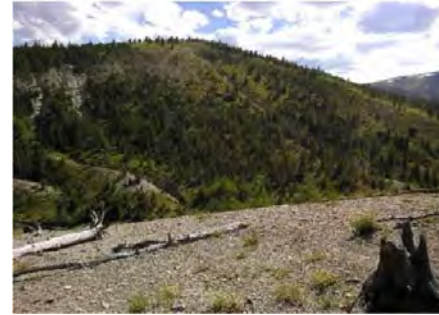
Images 1&2: Shrub vegetation and bare erosive gullies mixed with conifer

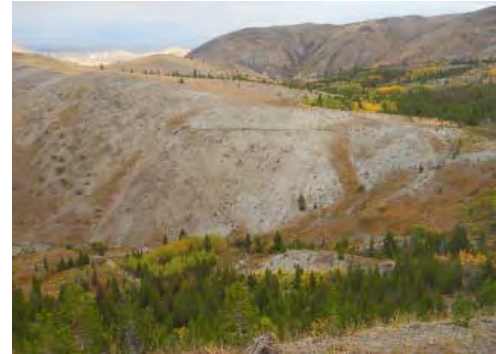
Area is a predominantly bare and degraded upland slopes heavily impaired by past logging, mining and smelter activities. These areas were treated in 2016, setting the landscape for natural processes to halt erosion. Areas not treated in 2016 will be fertilized.

Image 1: Degraded and bare steep slope of unit. Southern end was treated with fertilization in 2016

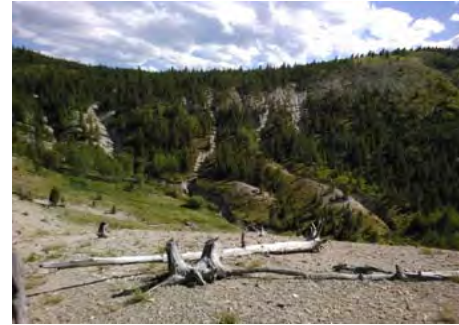
Well vegetated north-eastern slope holds snowpack into mid-June. Area is bisected by gullies and was treated in 2016 with check structures and mechanized sediment catchment below. Follow-up fertilization and rill treatments are prescribed.

Image 1: Forest with gullies to left of image

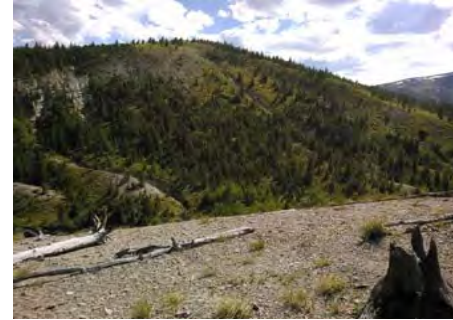
Image 1: Bare strip at top of image characterizes unit. 1 acre treated in 2016 with organic fertilization

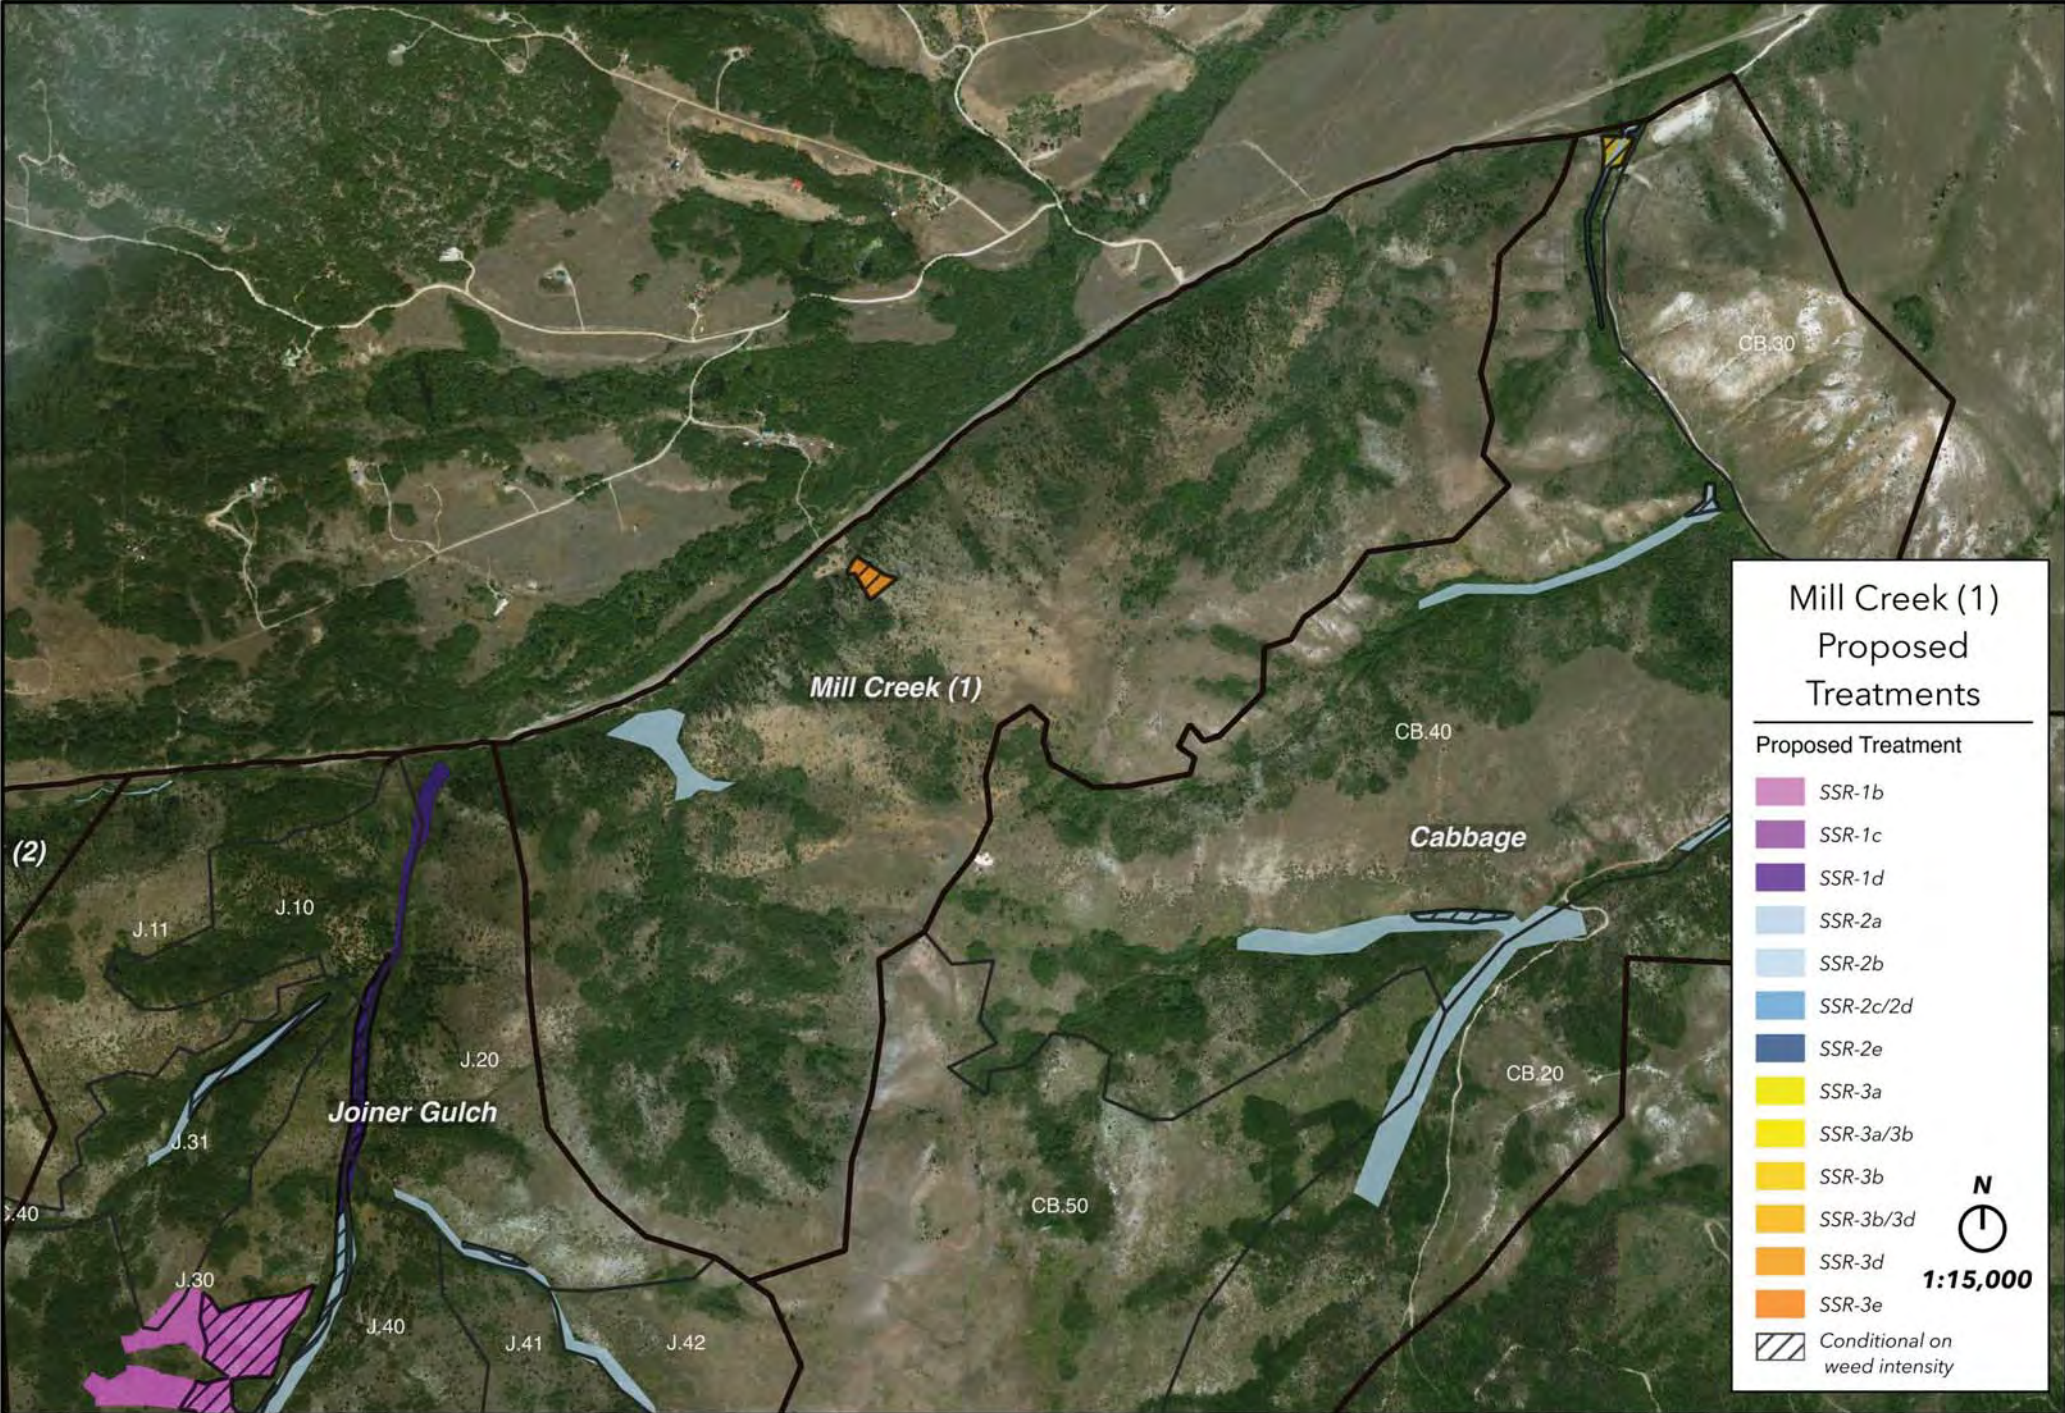
### Mill Creek (1) Proposed Treatments

Proposed Treatment

Conditional on weed intensity

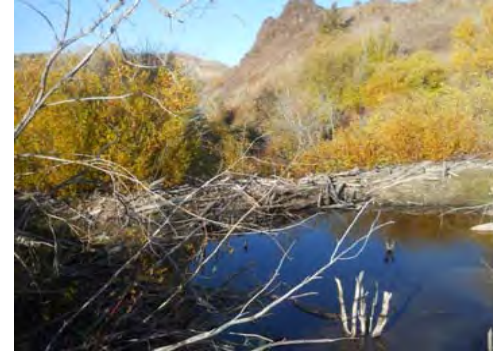
Large area along Mill Creek highway also contains portions of log flume and old transportation corridors. Areas of flume will be mitigated with fertilization and slash treatments to establish vegetation. Areas of Mill creek by highway will be targeted for in-stream structures to enhance sediment capture

Image 1: Beaver dam and riparian vegetation near highway

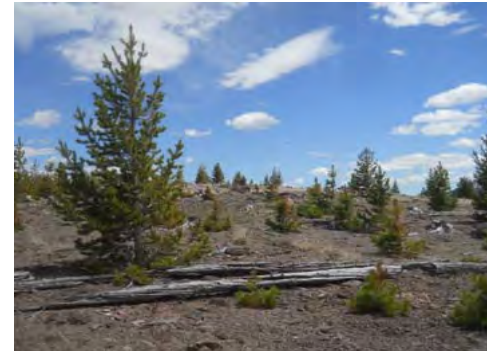
Image 1: Conifer regeneration on armored rhyolite slopes

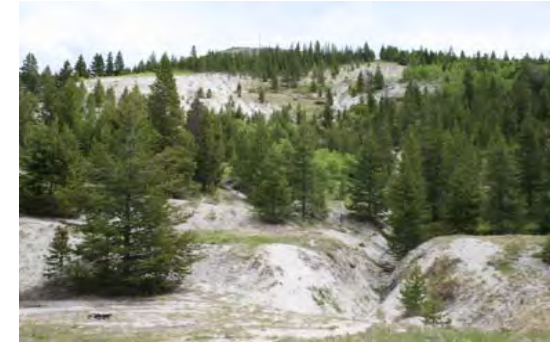
Image 1: Bare areas and Gullies drain under highway to Mill Creek

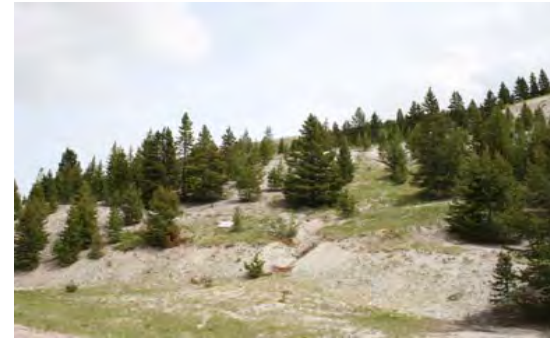
Image 2: Gullies become less severe further North in unit

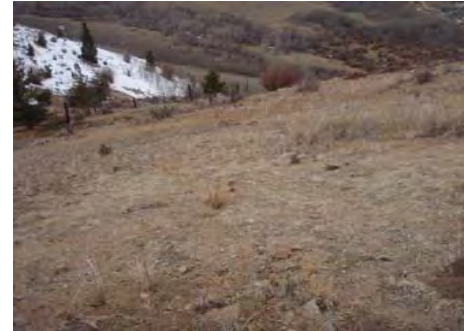
Image 1: Granitic parent material above highway prior to 2010 planting

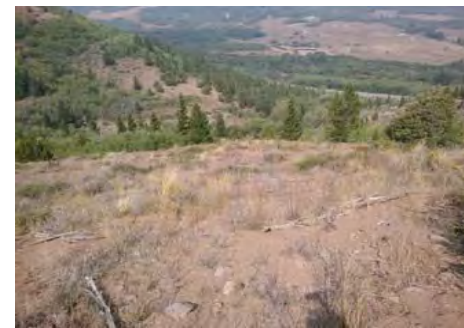
Image 2: Upland conditions in granitic parent material above highway

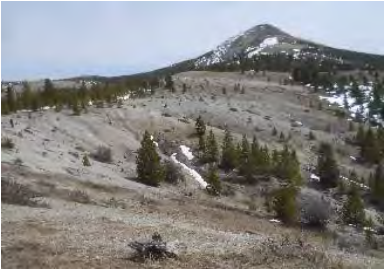
Image 1. C.12 Bare slopes prior to treatment

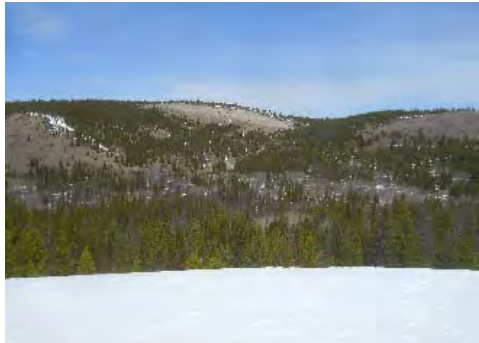
Image 1. C.21 bare areas on forested hillslopes.

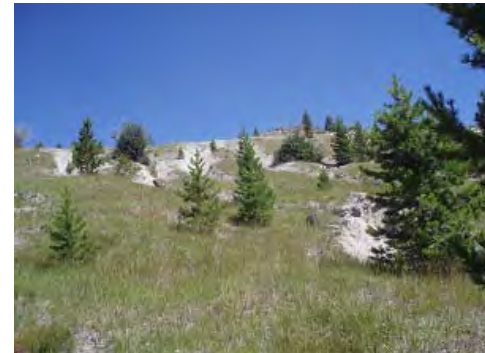
Area consists of one bare area and erosive gullies forming through sparse conifer forest. Area will be treated with fertilization and gully control structures to enhance vegetation and stop erosion

Image 1. C.23 gully formation through sparse conifer forest

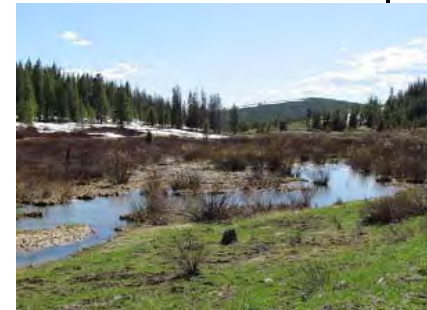
Image 2. C.30 Functioning wetlands

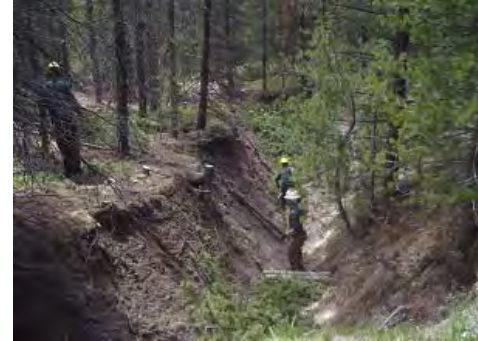
Design Justification
Area consists of conifer forest bisected by large gully networks, most of which have been treated. Untreated gullies will be treated and filled structures will be enhanced with gully BMPs

Image 1. C.31 Steep gullie slopes being stabilized with SSR-2d structures

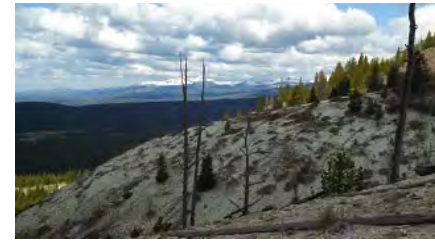
Image 1. C.33 steep and bare slopes

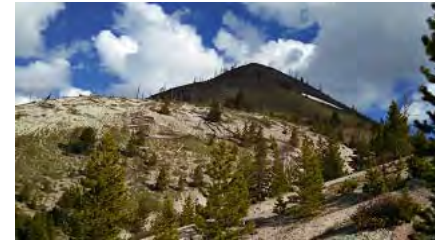
Image 2. C.33 mix of bare slopes and sparse conifer forest

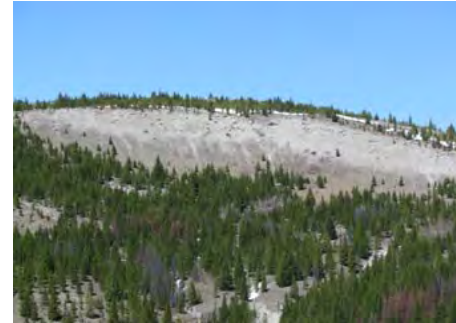
Image 1: Eroding slopes seen in May 2014 photo

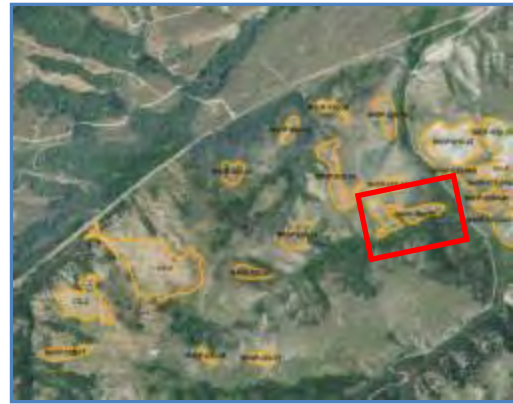
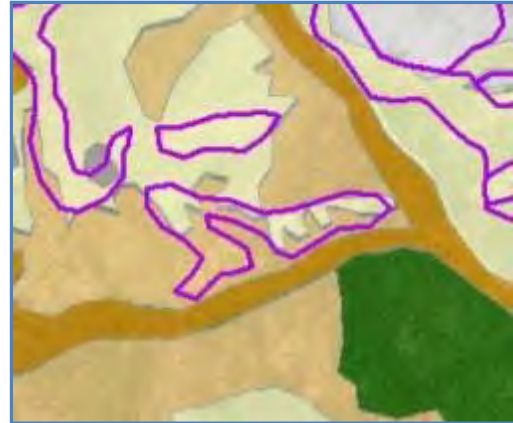
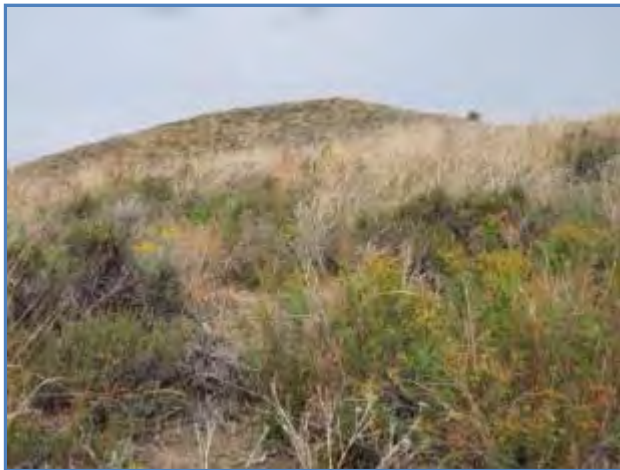
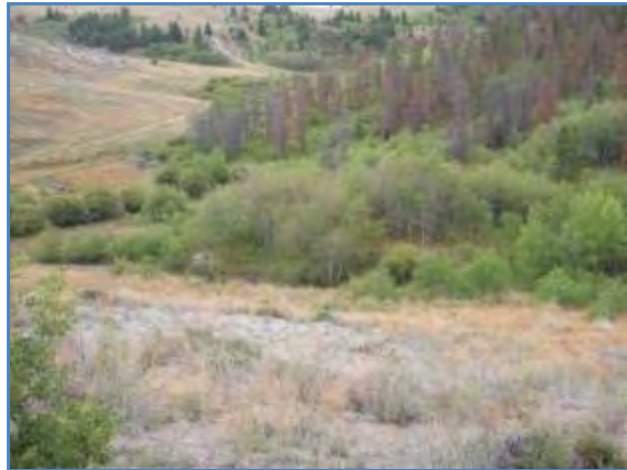
Aspen, antelope bitterbrush, rubber rabbitbrush, great basin wildrye, and snowberry are abundant on this site, as well as redtop as the dominant grass. Spotted knapweed and some leafy spurge were common on site until weed spraying began. The lower photo shows sprayed knapweed and live spurge among bitterbrush and rabbitbrush. On our vegetation map, this unit is considered 60% sparse shrub and 40% degraded grassland.

Most importantly is the dense riparian buffer of willow and aspen below this unit (image to right). There was no indication of soil erosion from this unit into the creek below.

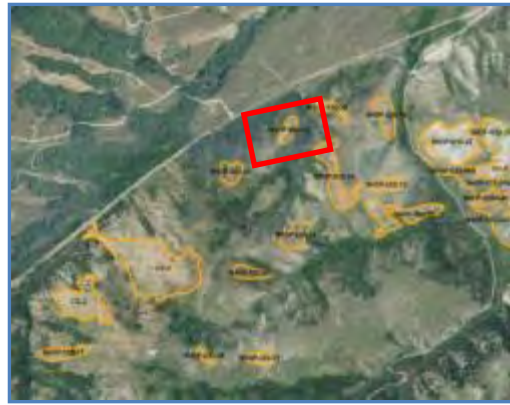
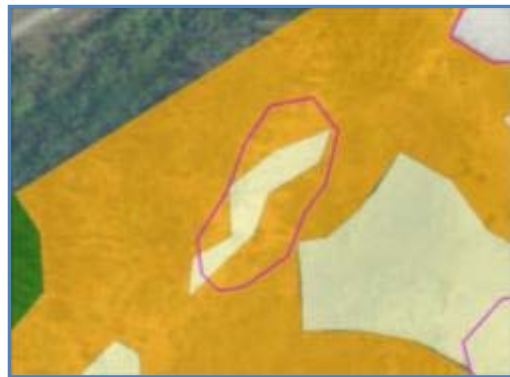
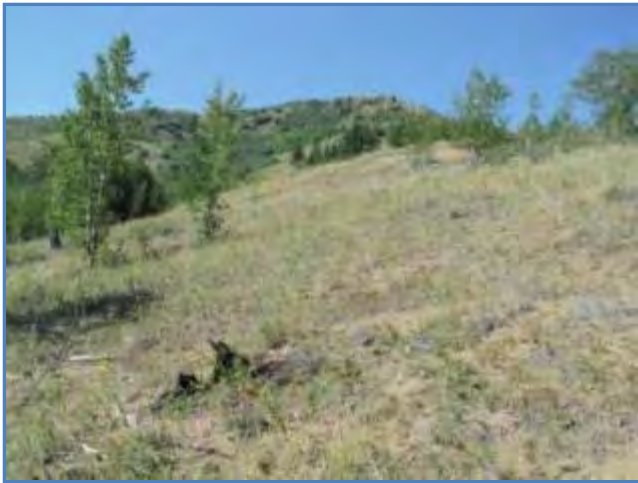
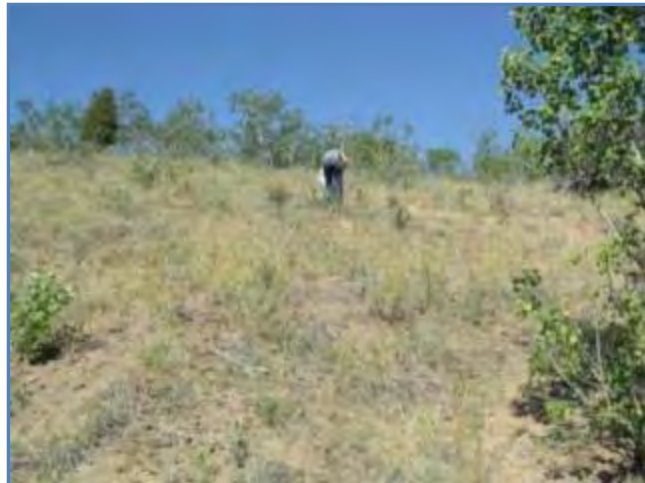
## SHOP 20.02

Vegetation on this unit consists of aspen colonies, dense at the top and bottom of the polygon and slowly colonizing the middle, where the dominant vegetation is redtop with sparse woods rose, antelope bitterbrush and some scouler willow. The unit is approximately 40% degraded grassland and 60% sparse shrub in our mapping (image below).

Below this site is a thick riparian of aspen. There is no active rilling or sign of any sediment delivery issues from this unit.
