# Anaconda Smelter NPL Site Mount Haggin Uplands (RDU 15)

## Remedy and Restoration Work Plan

PREPARED BY:  
MONTANA DEPARTMENT OF JUSTICE  
NATURAL RESOURCE DAMAGE PROGRAM

MAY 2018

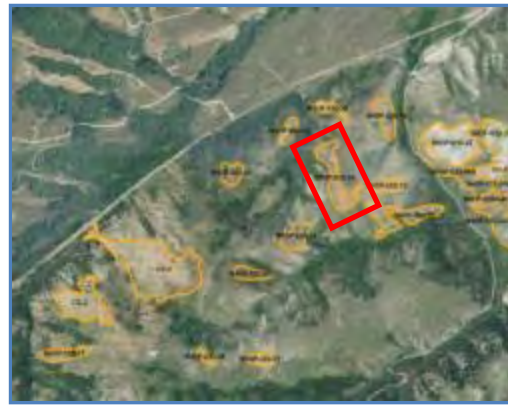
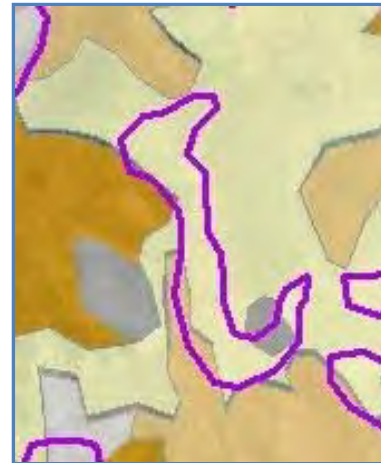
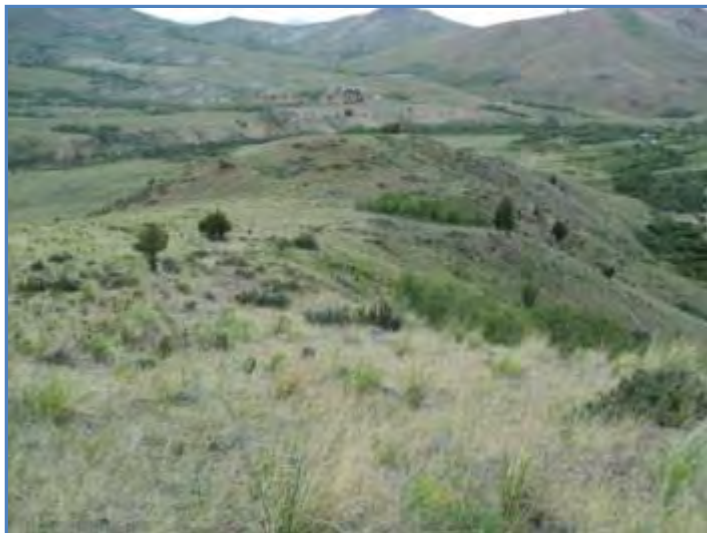
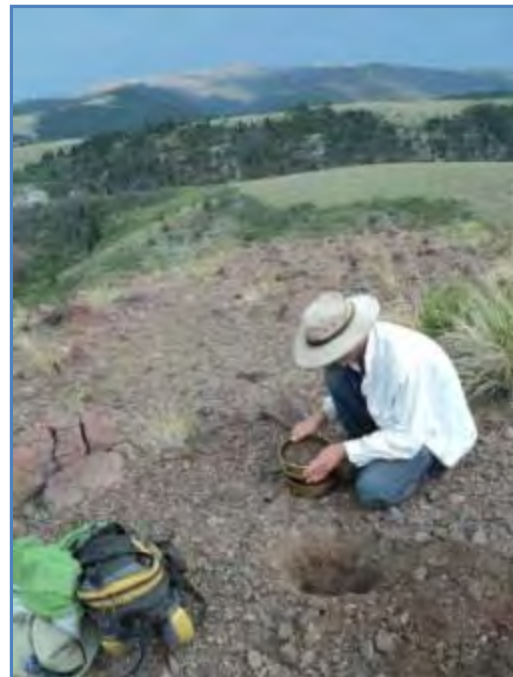
### SHOP 20.03

The majority of the polygon is a winding ridgeline that appears to be in a healthy state of recovery. Silver buffaloberry, horizontal juniper, common juniper are among the dominant shrub and tree species present, while redtop and great basin wildrye are the primary grasses. The unit is primarily considered degraded grassland in our vegetation map.

Ecological trends in this polygon are on a recovering trajectory. Bare areas (dark gray in vegetation map below) are armored with rhyolite colluviums and are not considered a sediment source.

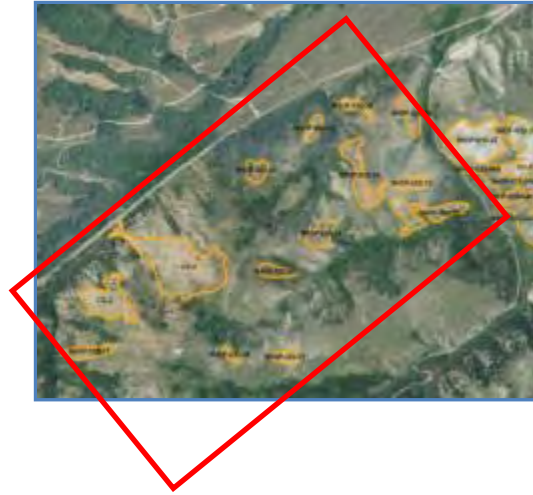
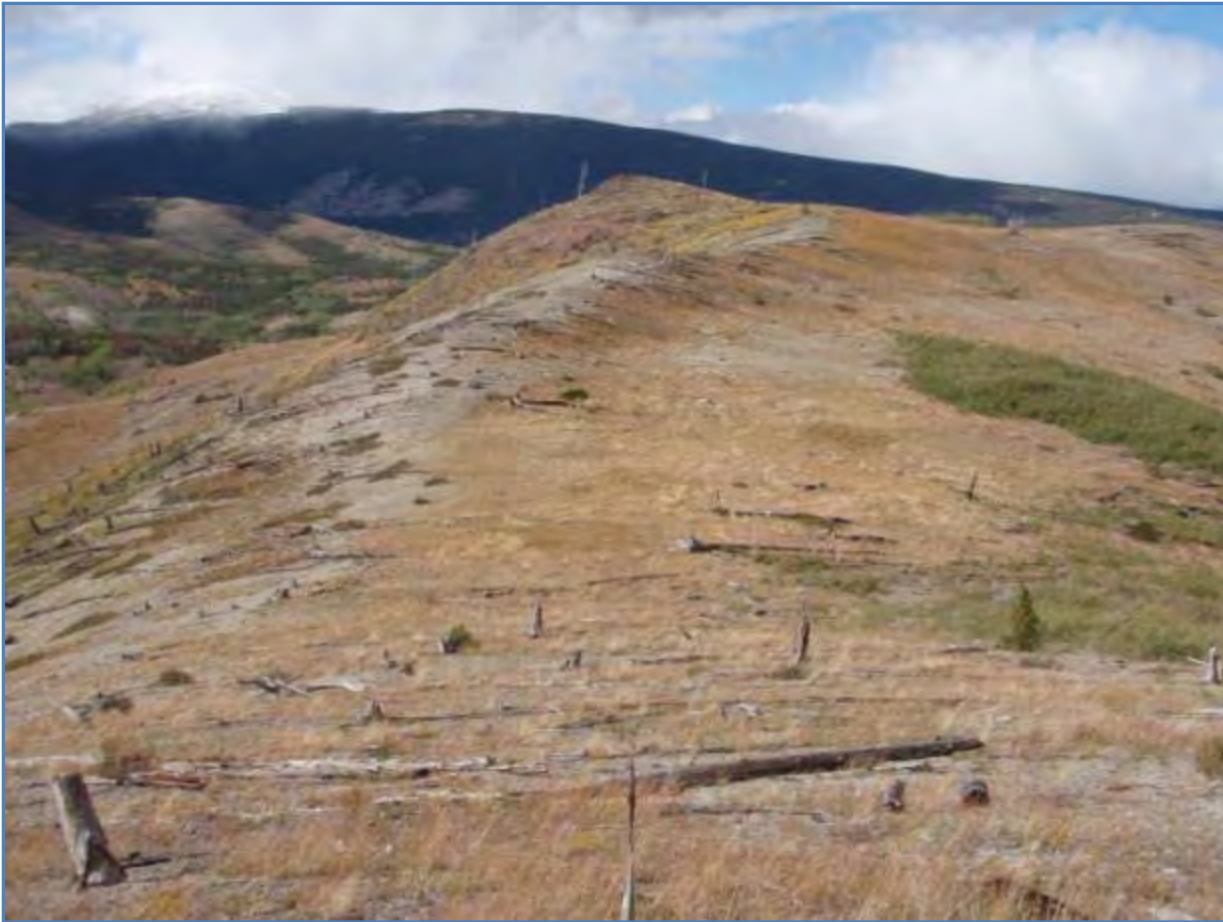
## SHOP 20.05

This unit comprises the general area encircling the polygons in the northeastern corner of the Mt. Haggin Uplands. Conditions vary across this unit, ranging from densely vegetated riparian areas to bare slopes similar to conditions found in polygons, and everything in between.

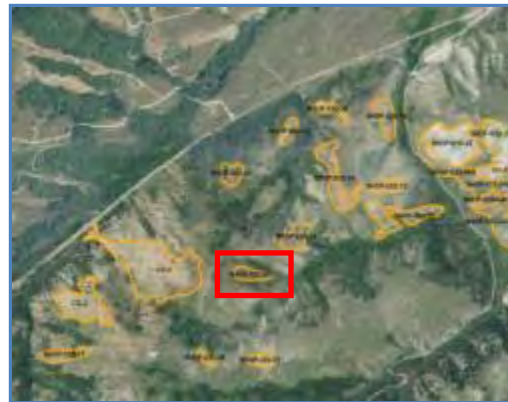
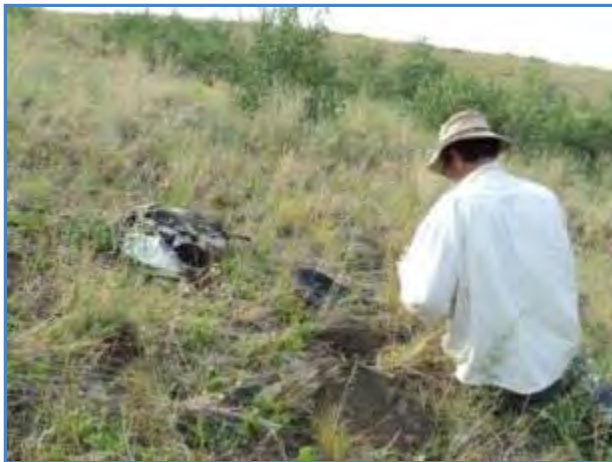
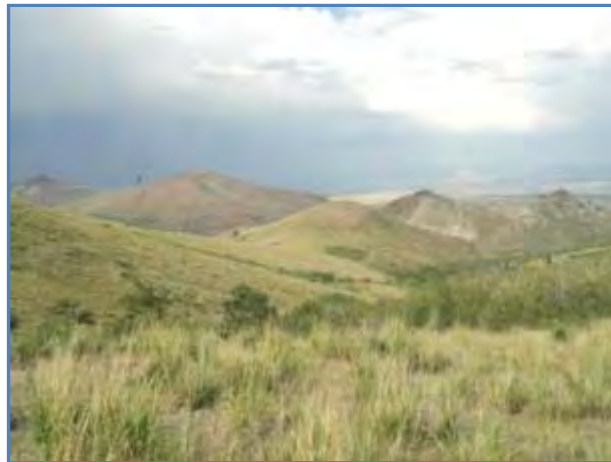
This unit is located between two fingers of aspen colonies moving uphill from a lush draw. Vegetative cover in this unit is close to 60%, predominantly degraded grassland, with few large areas lacking vegetation. Great basin wild rye and redbtop are the primary vegetation, with snowberry, antelope bitterbrush and some oregon grape coming in. As seen in the image below, and to the right, the unit is flanked by aspen colonies on both sides.

Soil samples taken just outside of this unit in 2007 (Keck) showed pH values of 5.4 and 6.0 at the 0-2" and 0-6" depths respectively. Soil samples taken in 2012 showed pH levels of 6.3 from 0-6".

Though vegetation cover could be improved, the system is well on its way to recovering on its own and is not a sediment source.

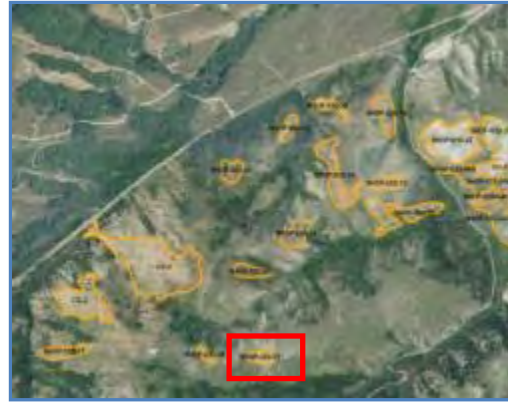
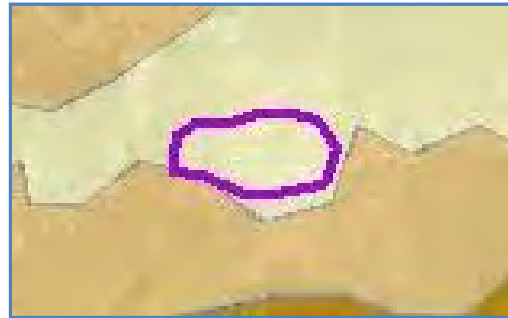
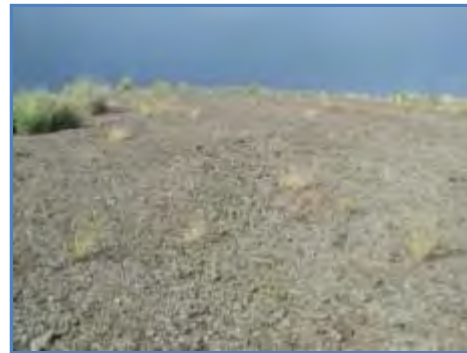
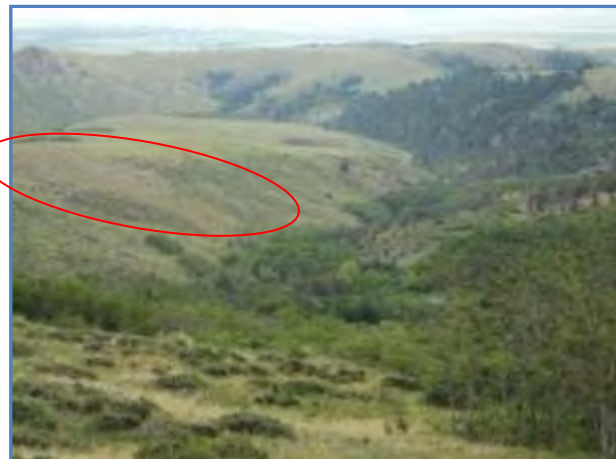
**SHOP 20.07**

Soil samples in 2007 (Keck) showed pH values of 4.6 and 5.6 at the 0-2” and 0-6” depths respectively. The soil sample taken in 2012 showed pH of 5.0 at the 0-6” depth. The soil here was low in calcium relative to other units.

Though pH levels may indicate persistent problems in this polygon, it is not a contributing sediment source to the system (see unit in image at right).

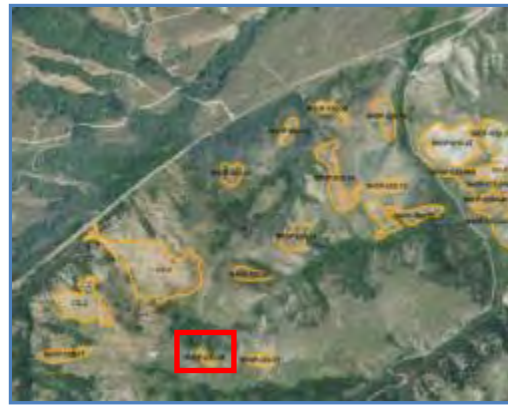
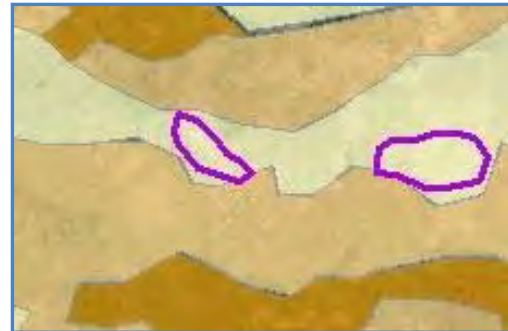
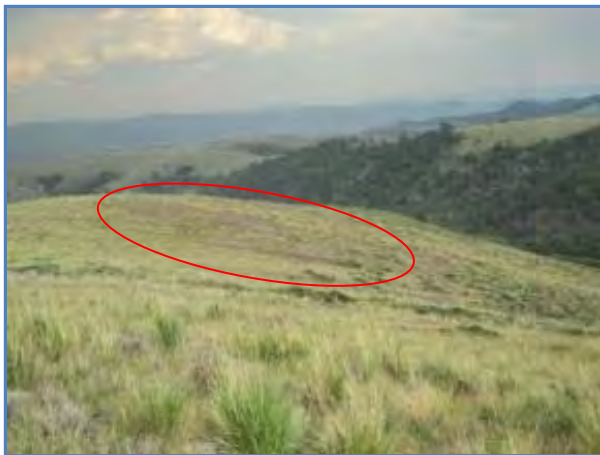
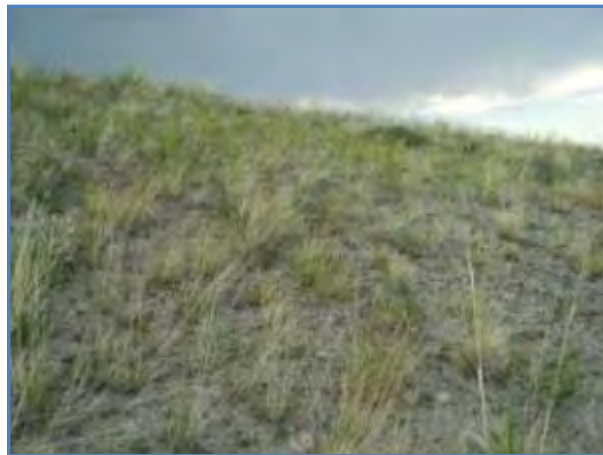
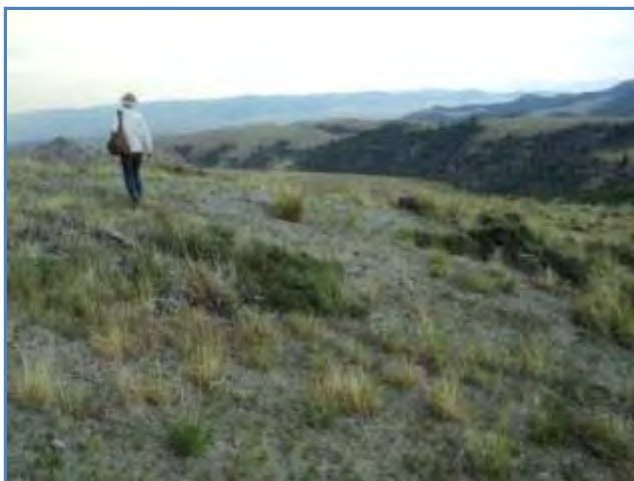
**SHOP 20.08**

Soils of this unit are ashy, gravelly, sandy loam. Generally, water retention on this site is poor and parent material is between 18-35". Due to inclement weather no soil sample was taken at this site. It would be reasonable to assume soil properties are similar to those in SHOP 20.07.

Like SHOP 20.07, soils are lightly armored, there is no sign of active rilling or sediment delivery, and a large riparian buffer below this polygon is reassurance that this unit is not a sediment source.

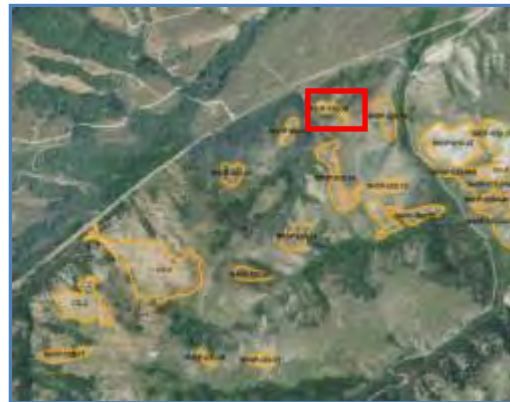
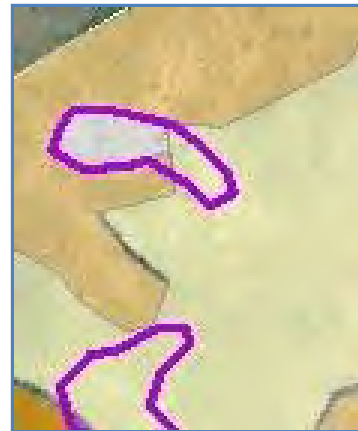
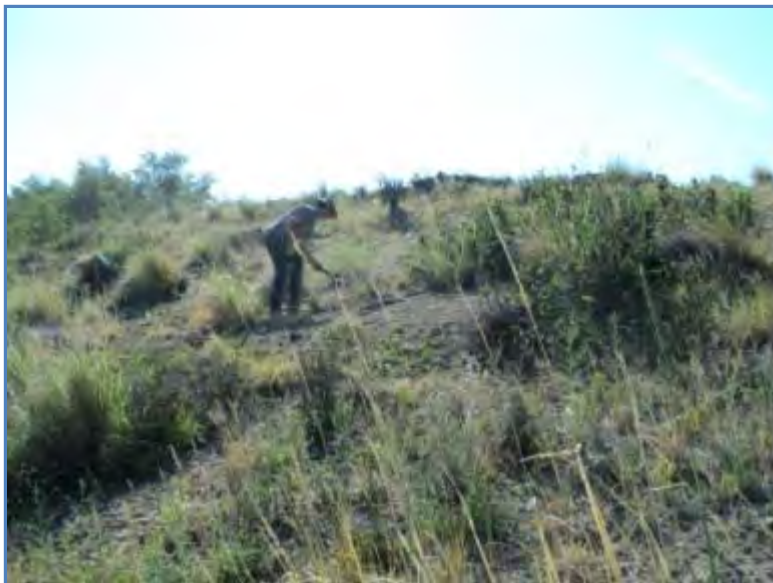
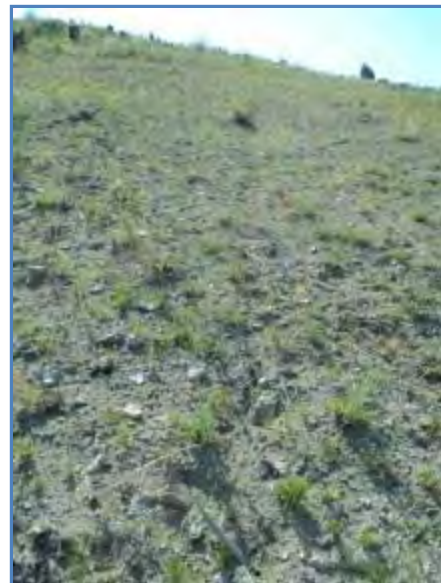
### SHOP 20.09

Soils of this unit are ashy, gravelly, sandy loam. Generally water retention on this site is poor and parent material is between 18- 35”.

Existing vegetation in the unit is redtop and great basin wildrye, with oregon grape, antelope bitterbrush and scouler willow. Vegetation cover is approximately 30-40% over the whole unit, with the lower portion considered bare and the upper a degraded grassland condition.

Soil samples here showed pH levels of 6.1 from 0-6”. Organic content is very low, while potassium and phosphorous levels are very high, as with all other polygons in the uplands.

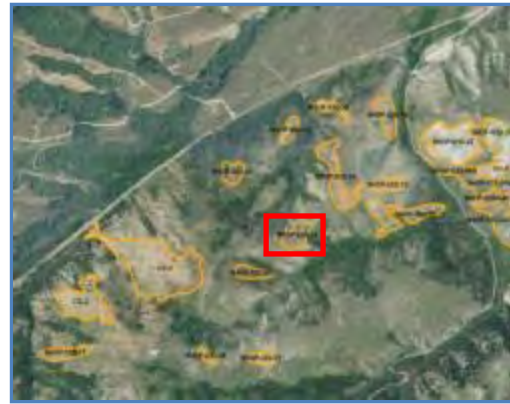
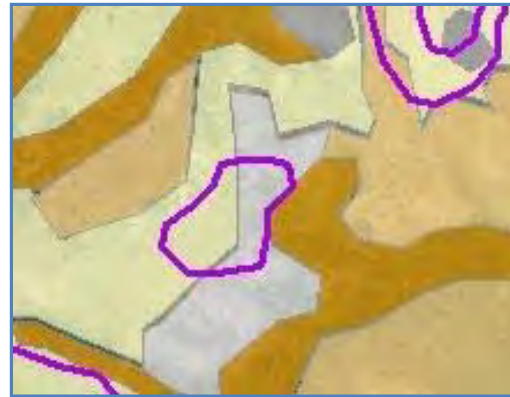
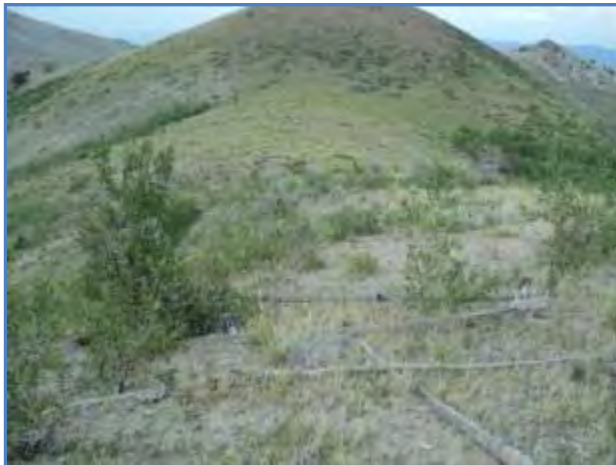
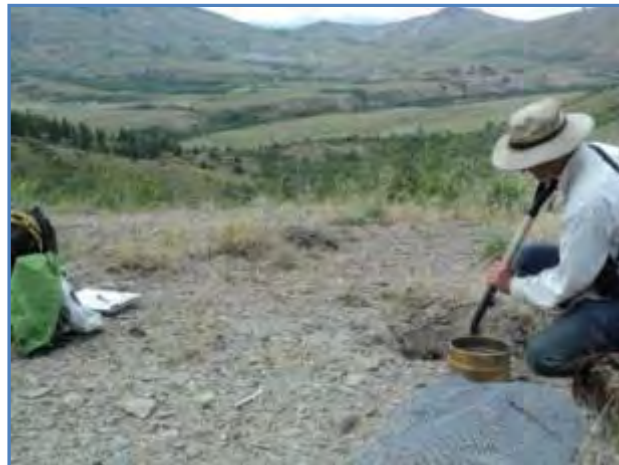
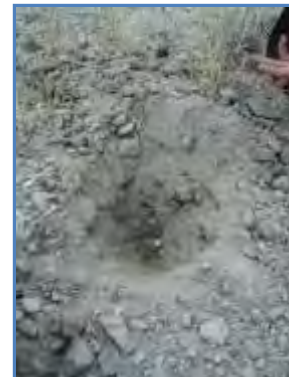
## SHOP 20.11

This unit is on a convex saddle landform. Soils of this unit are ashy, gravelly, sandy loam with poor water retention. The parent material is mostly volcanic tuff, evidenced by the typical plated gravel-sized substrate on the surface.

Species present include aspen, antelope bitterbrush, redtop, oregon grape, with a vegetative cover ranging from approximately 20% to 40%.

pH readings taken in 2007 (Keck) showed levels of 5.4 and 6.0 at depths of 2" and 6", respectively. Samples taken in late 2012 showed pH of 5.6 from 0-6".

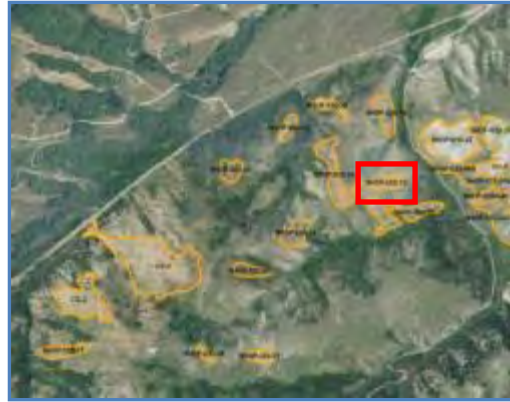
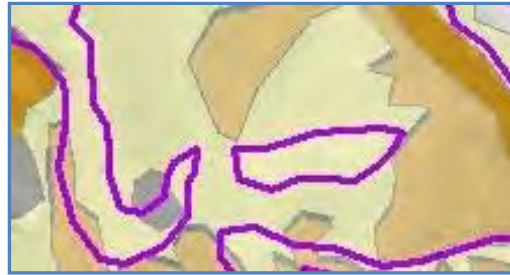
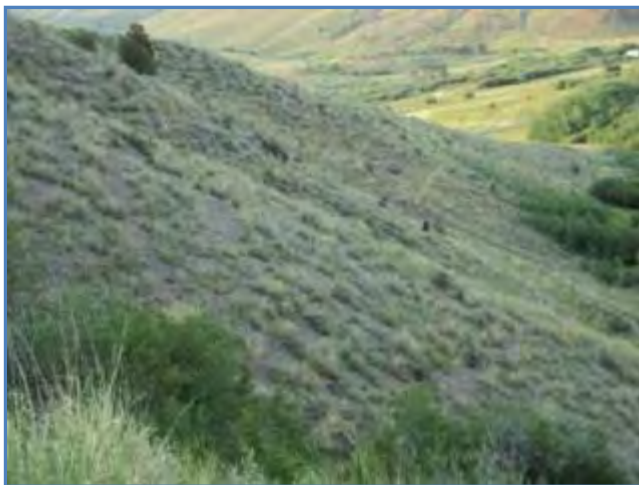
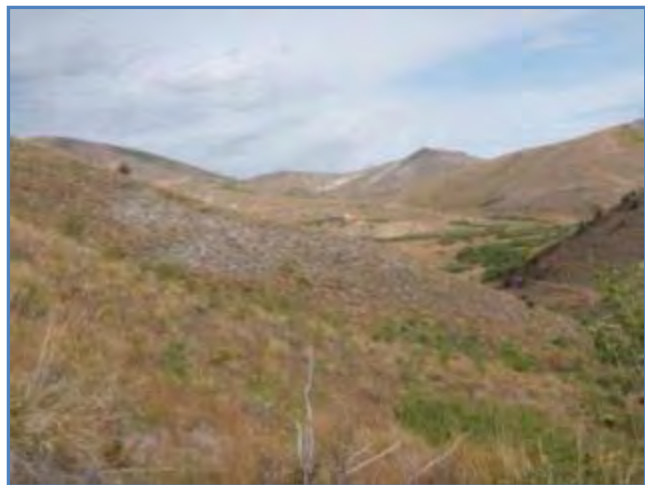
## SHOP 20.12

Soils of this unit are ashy, gravelly, sandy loam with poor water retention. This polygon, with a northeastern aspect, used to be forested, most likely with lodgepole pine, but, similar to other areas in the uplands, was logged extensively.

No soil samples were collected at this site, but we estimate pH levels to be in the 6.0 range from 0-6", similar to readings in SHOP 20.13, adjacent to this unit to the north.

There have not been any signs of erosion from this unit entering waterways, and ecological trends point to natural regeneration recovering this site within the foreseeable future, provided adequate climatic and rainfall conditions, which ultimately are the most significant determining factors for revegetation success.

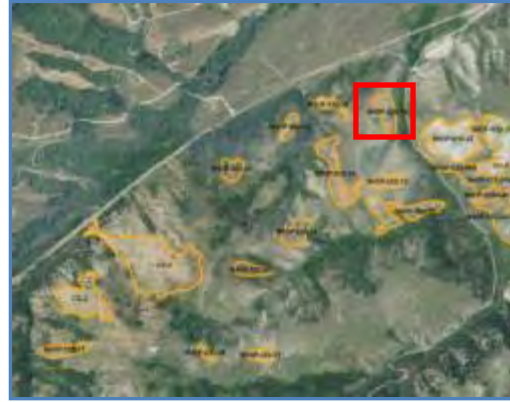
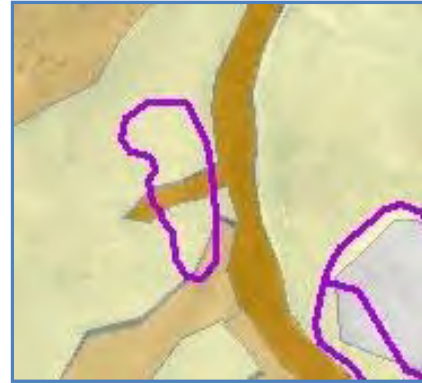
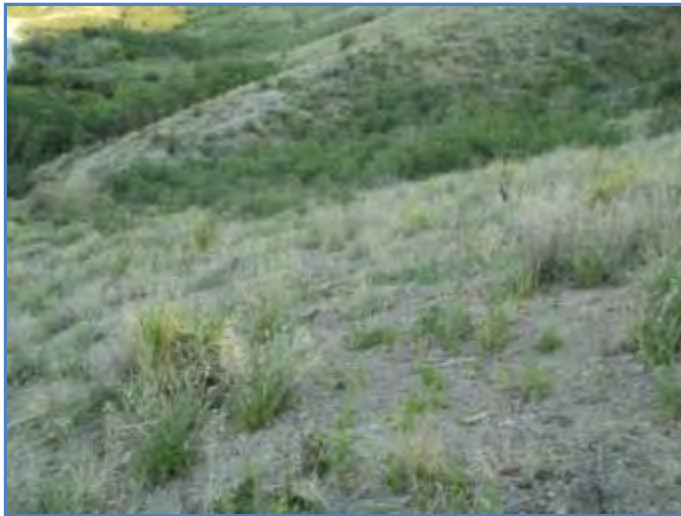
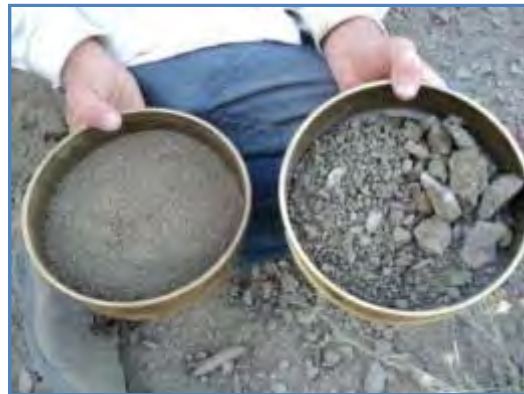
## SHOP 20.13

This unit exhibits similar characteristics of SHOP 20.12, with a northwestern aspect, well vegetated toe slope and a mix of great basin wildrye, weeds and aspen regeneration.

Potassium levels on this unit were nearly two to three times those of other units sampled.

There were no signs of active erosion threatening the creek below and this polygon should not be considered a sediment source to the system.

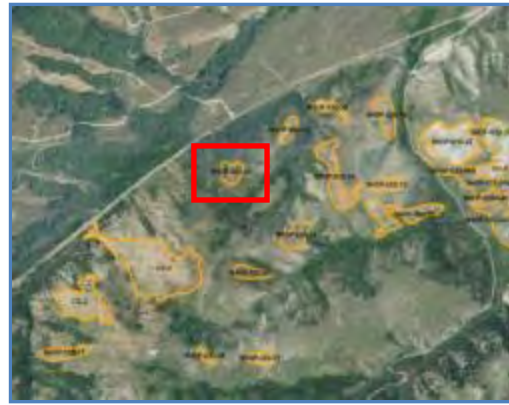
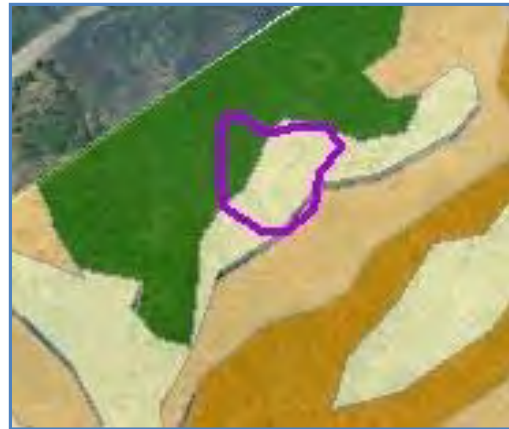
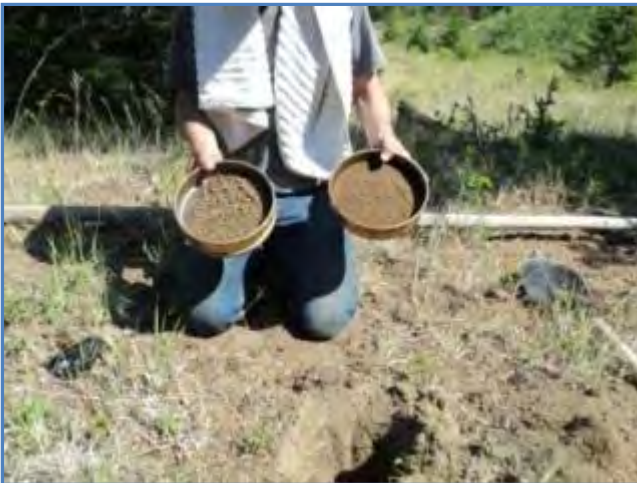
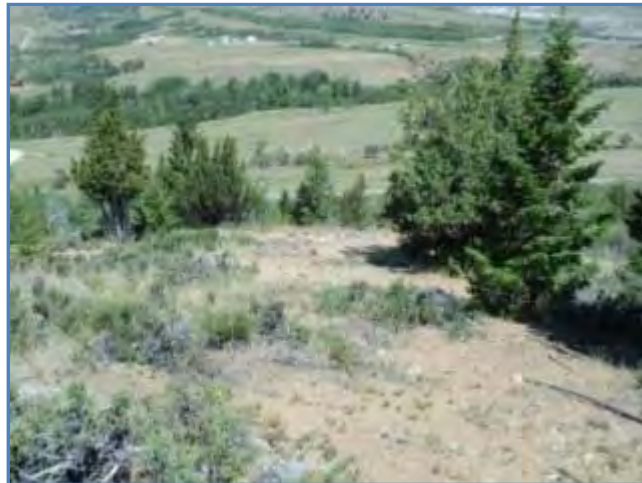
## SHOP 20.16

This polygon has an almost due north aspect, and like other polygons with this aspect, contain soils described as “granitic sand”. These soils are characterized by very thin (0-1”) organic horizons and very stony sandy loam beneath. Slopes on this unit range from 15-60%.

Soil samples taken in 2012 show pH values of 6.5 from 0-6”, likely indicating a smaller presence of contaminants in the soil profile. Organic matter is very low in these soils.

Areas below this unit are thick with shrubs and trees, forming a dense buffer between this unit and the road and/or creek below. There are no signs of active rilling or sediment delivery through this system. The vegetation map shows this unit as approximately 30% forested and 70% degraded grassland.

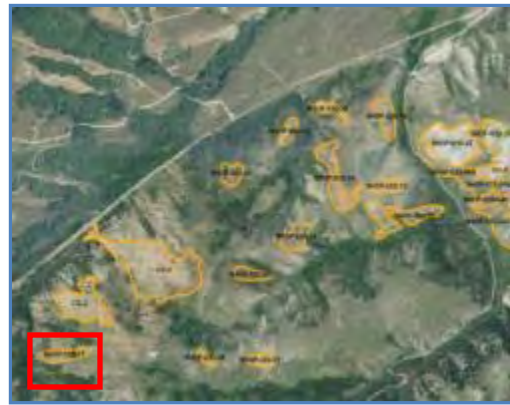
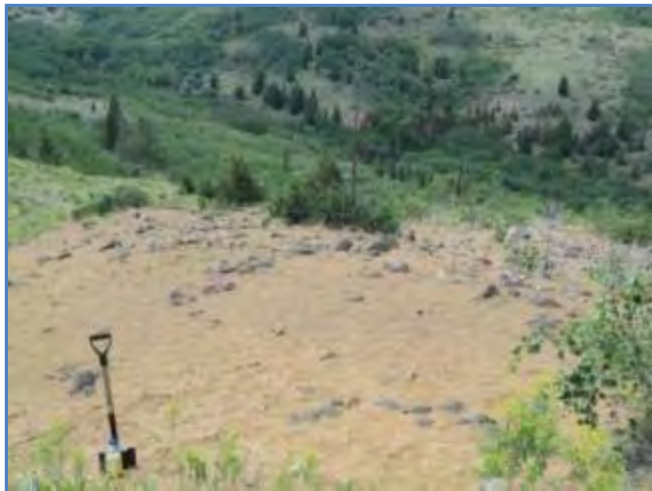
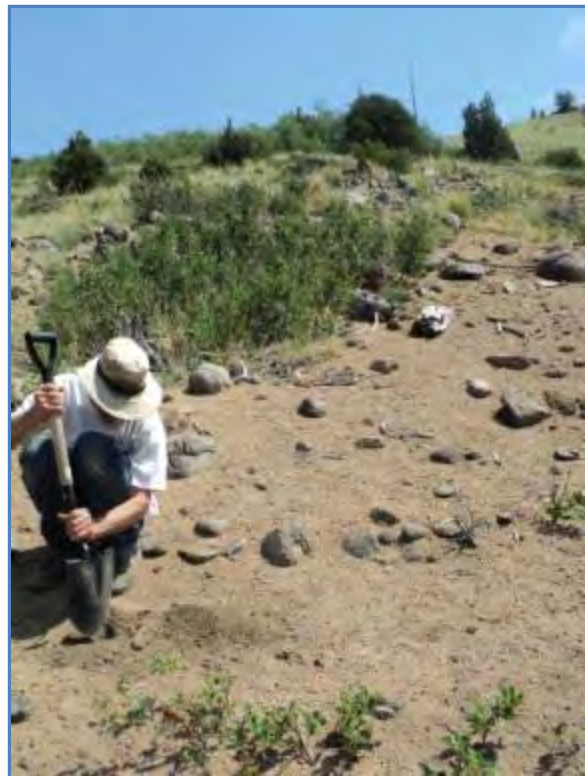
## SHOP 20.17

Spotted knapweed and leafy spurge are present in this unit, as was one specimen of toadflax, seen at the top of the unit. This toadflax should be eliminated as soon as possible and is documented in other weed reports provided to NRDP.

No soil samples were taken in this unit in 2007. Samples taken here in 2012 showed very low organic matter and a pH of 5.9 down to 6 inches.

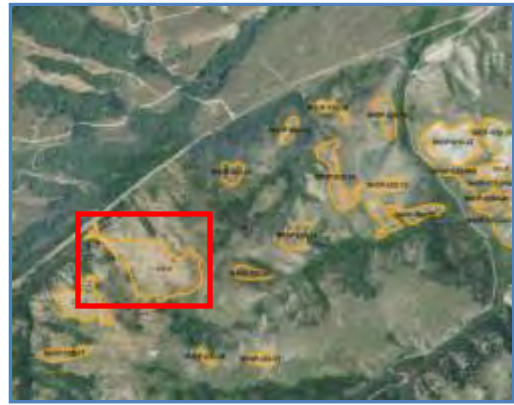
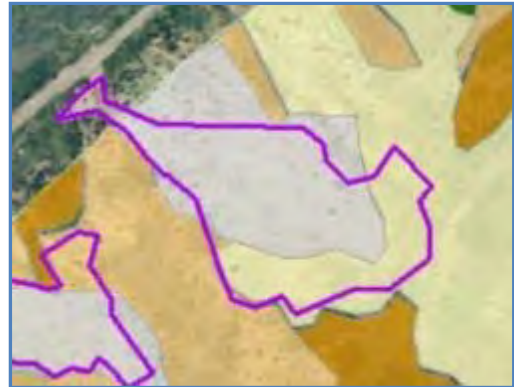
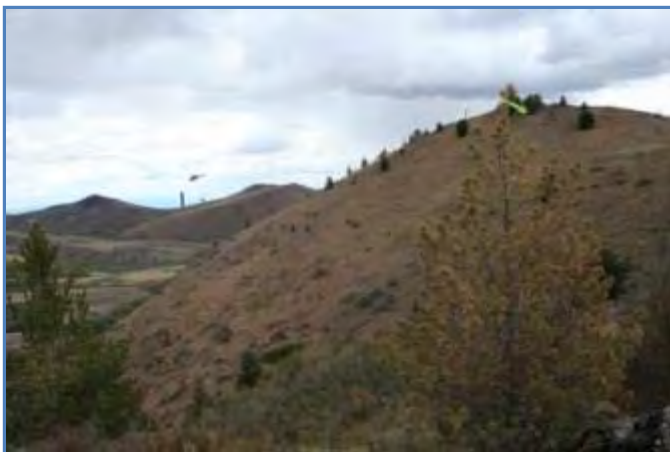
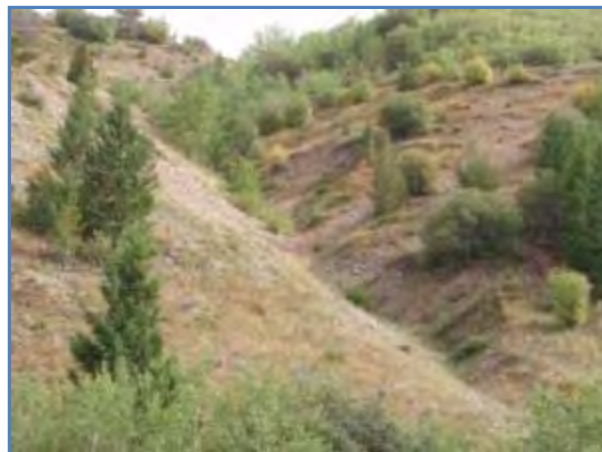
As the creek is on the other side of the highway from the funnel, there is no immediate risk of sediment being delivered into water from this unit. The steepness of the funnel leaves few viable options for catching or holding eroding sediments on the hillslope.

In 2010, 5500 trees and shrubs were planted throughout unit CG-1, and the area was grass seeded. Approximately 25% of the plants installed were protected from browse. Plant monitoring after 1 growing season showed survival rates of 57-72% for installed plantings. Grass seeding results were not monitored.

The following pages describe each polygon. Figures show typical conditions in each polygon as well as the polygons overlaid on the new vegetation maps.

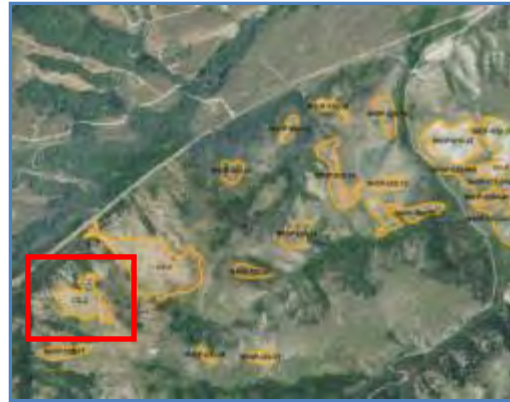
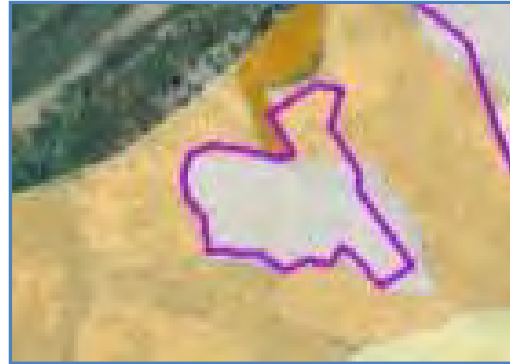
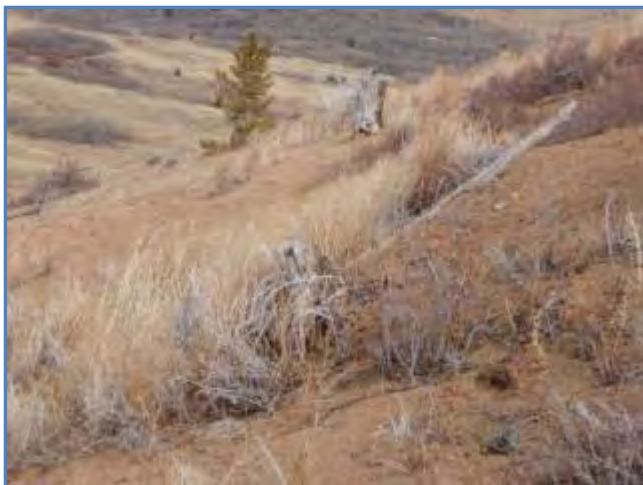
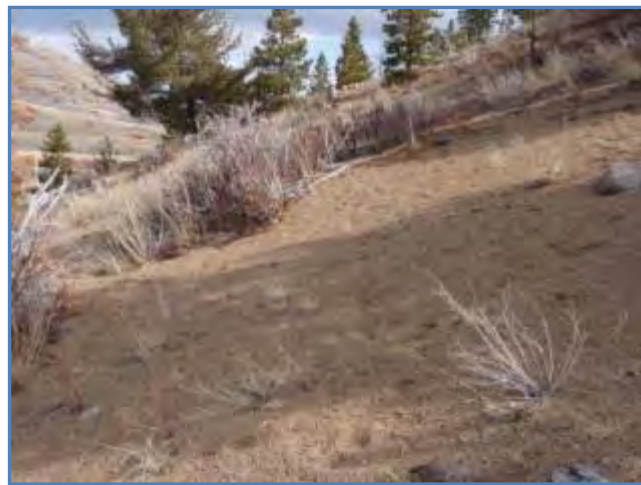
## **SHOP 20.04 (CG-2)**

An emerging stand of aspen borders this unit to the southwest, forming its bottom boundary. Below the aspen is a thick riparian.

To date, the area has been treated with planting of 1448 trees and shrubs, including plant protection of approximately 25% of those. Plant protection from dead plants were re-installed on live plantings in 2012. In addition, 16 exclosures were installed on natural revegetation to provide some relief from intense browse pressure, also in 2012.
