Lower Big Hole Irrigation Infrastructure Survey and Prioritization

March 2008

Executive Summary

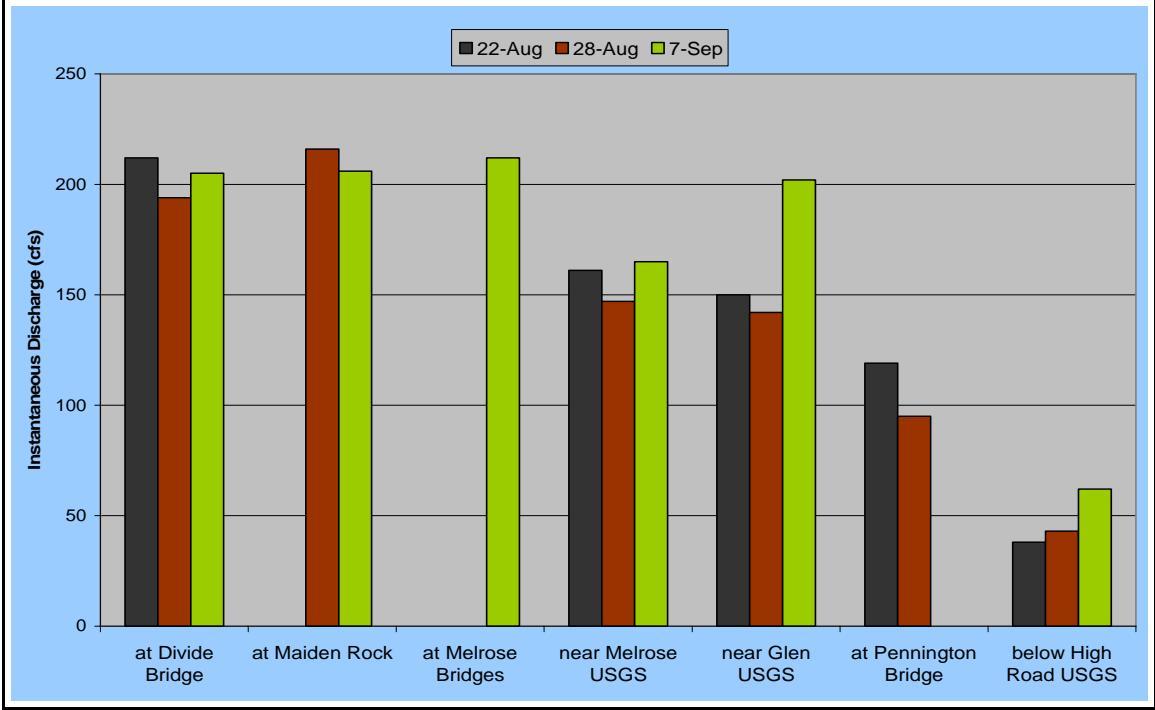
Figure 3-1. Lower Big Hole River Synoptic Streamflow Measurements, August 2007.

Streamflow measurements performed at the Divide Bridge, at the bridge in Maiden Rock Canyon, at the Melrose Bridge and at the USGS near Melrose gage downstream of the Kalsta Bridge suggest that streamflow remains relatively stable between the Divide Bridge and the Melrose Bridge and then decreases between the Melrose Bridge and the USGS near Melrose gage (**Figure 3-1**). Synoptic streamflow measurements at the Divide Bridge, the bridge in Maiden Rock Canyon, and the Melrose Bridge documented flows of 205, 206 and 212cfs, respectively, on September 7th, 2007. Synoptic streamflow measurements between the Melrose Bridge and the USGS near Melrose gage, recorded a decrease of 47cfs between the two sites on September 7th, 2007. During the summer of 2007, mean daily streamflow decreased by an average of 28cfs between the Divide Bridge and the USGS near Melrose gage (**Table 3-2**).

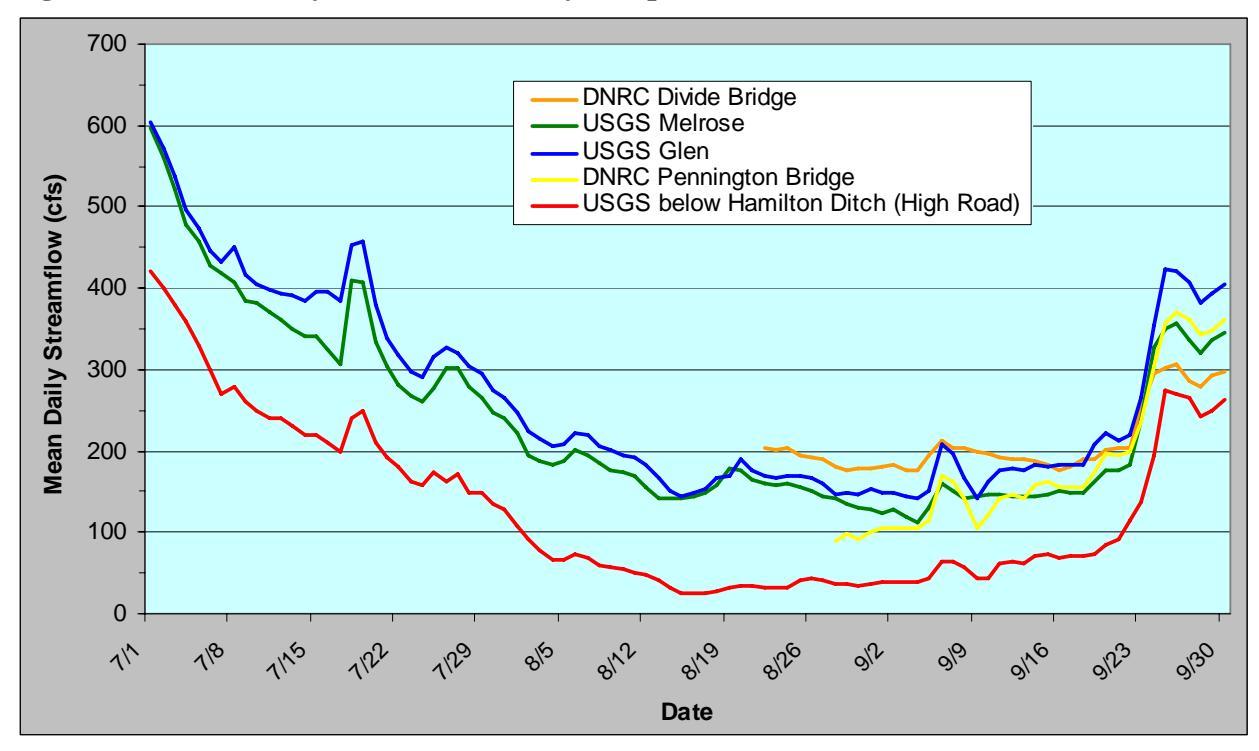
Figure 3-2. Mean Daily Streamflows, July 1-September 30, 2007.

Based on this assessment, streamflows appear to decrease between Maiden Rock Canyon and USGS near Melrose gage and then remain stable or slightly increase between the USGS near Melrose and the USGS near Glen gages (Figure 3-2). Downstream of the USGS near Glen gage, mean daily streamflows between 2001 and 2007 decreased by an average of 148cfs, while mean daily streamflow decreased by an average of 119cfs between the Divide Bridge and the High Road Bridge in 2007 (Table 3-2).

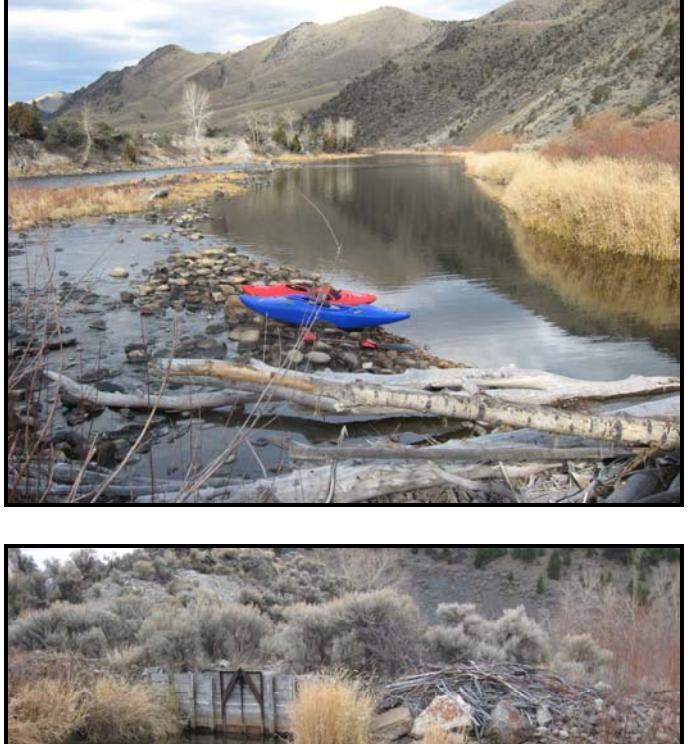
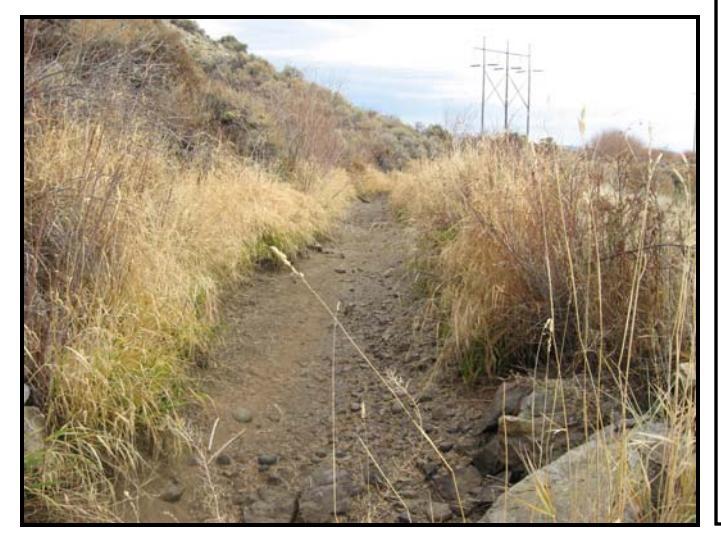
Diversion 18 - Upper McCauley

Diversion 18 (Upper McCauley) is located on the river left bank at the inside of a meander bend in Maiden Rock canyon. The diversion weir is comprised primarily of large cobbles (channel materials) and boulders and extends most of the way across the channel. The weir does not appear to require regular maintenance and appears well-integrated into the natural channel morphology in this naturally confined section of river, though it may be a source of channel over-widening at the point of diversion. Channel confinement is provided by the canyon walls and the railroad on river left, while there is a terrace along river right. The channel bed material is large in this section of river. The diversion channel leads off to river left approximately 300 feet downstream to a headgate. There is a boulder check dam in the overflow channel that raises the water elevation at the headgate. The overflow water discharges through a vegetated gravel bar back into the Big Hole River. The headgate appears old and was comprised a metal "screw gate" in a wooden housing. After the initial diversion, the ditch is situated between the railroad track and the base of the canyon wall along the left side of the river. A portion of the ditch is transported in a pipe, which outlets back into a gravel and sand bottom ditch on river left at the mouth of the canyon. When the ditch enters the valley, it irrigates an area between the river and the interstate to the east of the Big Hole River at the mouth of Maiden Rock Canyon.

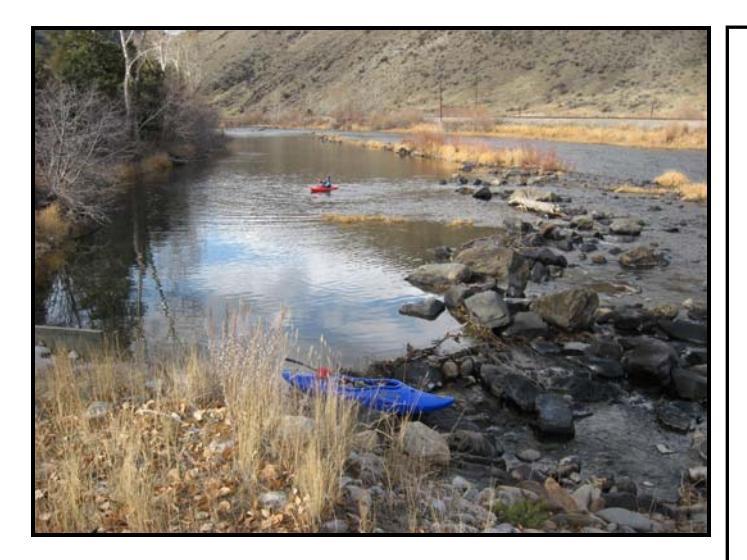
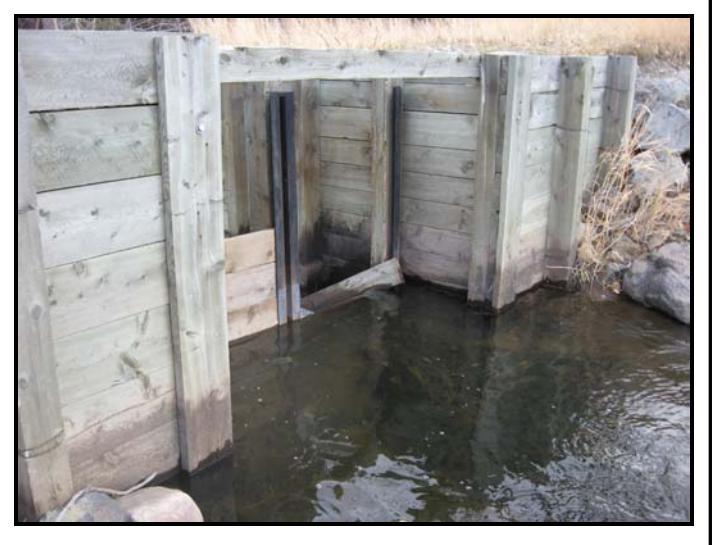
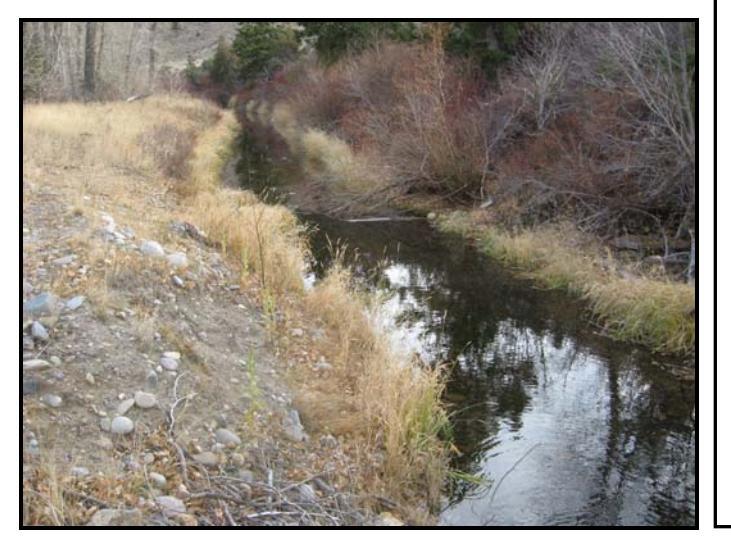
Diversion 19 – Meriwether's

Diversion 19 is located along the river right bank in a relatively straight section of Maiden Rock canyon. There is a very long cobble (channel materials) and boulder weir extending approximately 800 feet from the headgate. The diversion dam starts pulling water at the inside of the bend in a shallow riffle. The diversion dam includes a section of boulders that appears to be abandoned in the channel. The "pin and plank" headgate has two openings and the ditch has a gravel substrate. The ditch flows along the river right side of the canyon and irrigates an area downstream of the mouth of the canyon. There is reportedly a Parshall plume in this ditch.

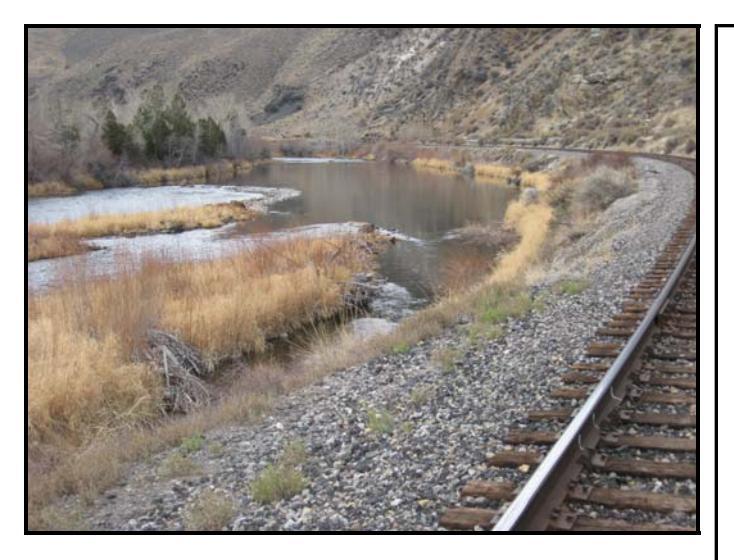
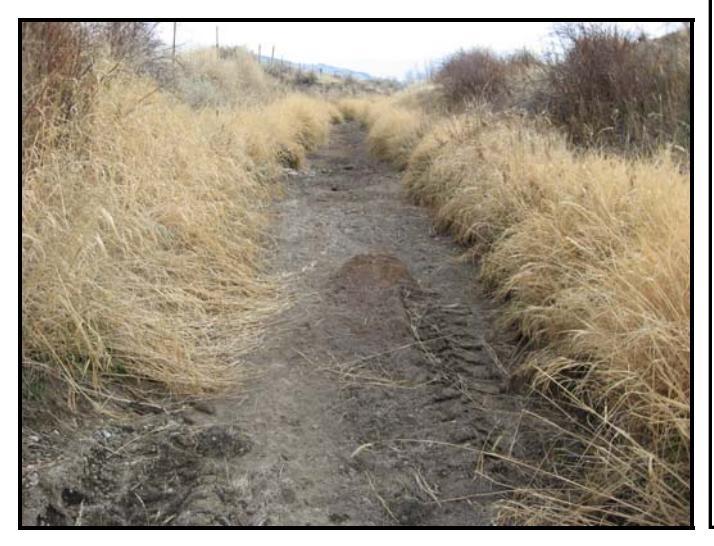
Diversion 20 – Lower McCauley

Diversions 20 and 21 on the river left bank and are both fed by a large diversion weir located at the outside of a bend in the main channel at the mouth of Maiden Rock canyon. The diversion structure is located in a naturally confined area just before the canyon opens up. The floodplain berm along the railroad on river left also confines the channel. The large cobble (channel material) weir extends most of the way across the channel, where it transitions to boulders with a large boulder "anchoring" it at its farthest extent. This weir diverts water into two diversion channels along river left. The upper diversion (Diversion 20) and the lower diversion (Diversion 21) both serve ditches that run between the river and the railroad and are then directed under the railroad and frontage road where they irrigate the valley to the east of the Big Hole River upstream of Melrose, with the ditch fed by Diversion 20 located along the interstate.

Diversion 20 is a single metal "screw gate" in a wooden housing. Diversion water is partially regulated by a collapsible jack. The wooden housing for the headgate and the collapsible jack is nearing the end of it operational lifespan. This ditch had a sand and gravel bottom where observed, though both of these ditches reportedly have cobble bottoms in the valley. Return flow from both of these ditches reportedly occurs through Camp Creek, with some water passing under the Frontage road and used in the next field to the south.

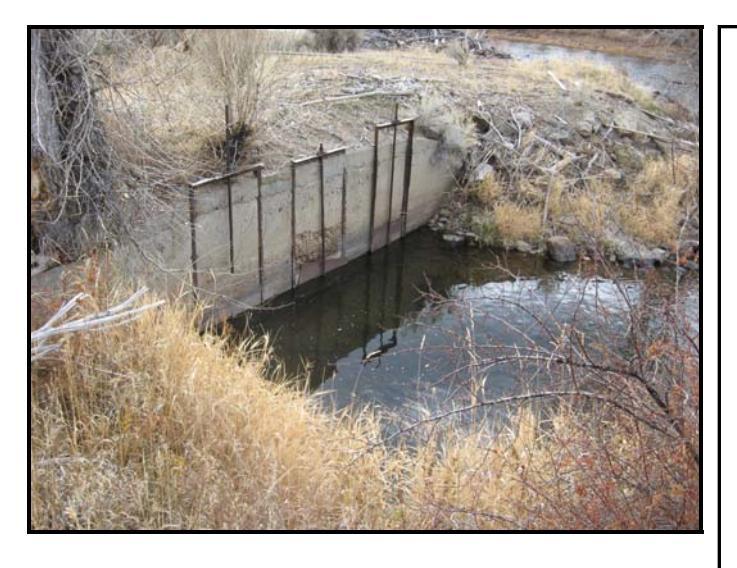
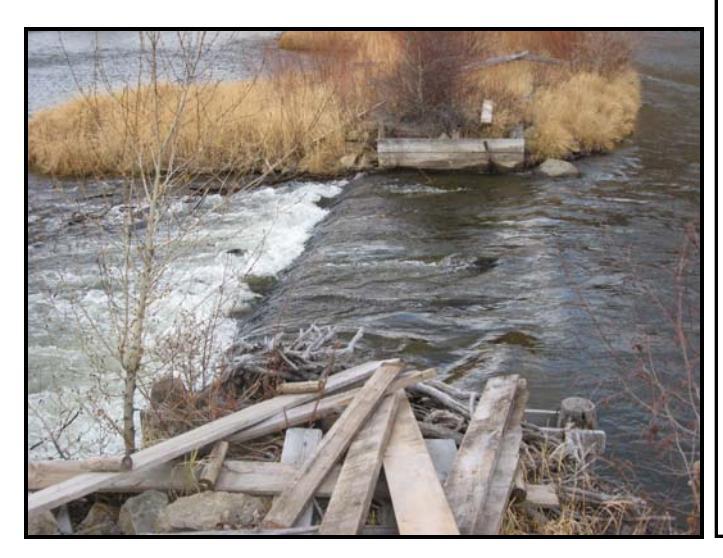
Diversion 21 – Melrose Canal

Diversions 20 and 21 on the river left bank and are both fed by a large diversion weir located at the outside of a bend in the main channel at the mouth of Maiden Rock canyon. The diversion structure is located in a naturally confined area just before the canyon opens up. The floodplain berm along the railroad on river left also confines the channel. The large cobble (channel material) weir extends most of the way across the channel, where it transitions to boulders with a large boulder "anchoring" it at its farthest extent. This weir diverts water into two diversion channels along river left. The upper diversion (Diversion 20) and the lower diversion (Diversion 21) both serve ditches that run between the river and the railroad and are then directed under the railroad and frontage road where they irrigate the valley to the east of the Big Hole River upstream of Melrose.

Diversion 21 has 3 metal "screw gates" in a concrete housing, though only one headgate (most river right) appears functional. Water was ponded in the ditch below Diversion 21. The overflow channel at Diversion 21 is regulated by a large collapsible jack, which is reportedly difficult to operate when the water is high. Return flow from both of these ditches reportedly occurs through Camp Creek, with some water passing under the Frontage road and used in the next field to the south.

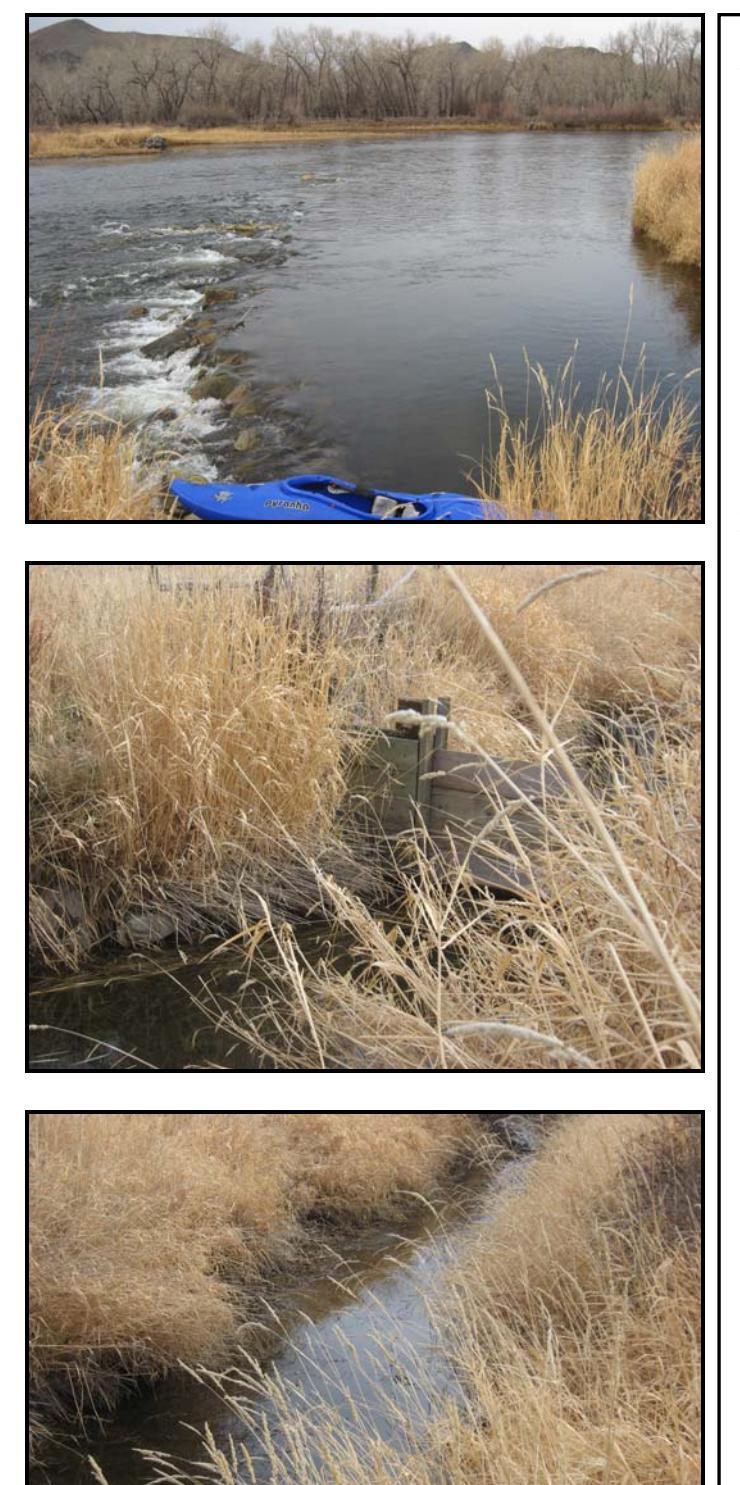
Diversion 22 – Meriwether's

Diversion 22 is located along the river left bank on the inside of a bend in the left channel just downstream of where the Big Hole River splits into two channels at the Meriwether Ranch. The left channel now carries the majority of the flow, though it was formerly known as "County Line Slough". The diversion structure is located in a relatively flat floodplain area and has the potential to dramatically influence channel form in what would naturally be a meandering gravel bed system. At this diversion, water is directed through a short diversion channel to the wooden "pin and plank" headgate. The cobble (channel material) and boulder diversion weir extends approximately a third of the way into the channel, where it meets a riffle. This ditch irrigates an area to the east of the Big Hole River upstream of Melrose.

There is a second un-assessed diversion on the right channel across from Diversion 22. This diversion (D44) is located along the left bank of the right channel (also called "Buyan Slough") near the upstream point of the island. Water from this ditch is used to irrigate the island.

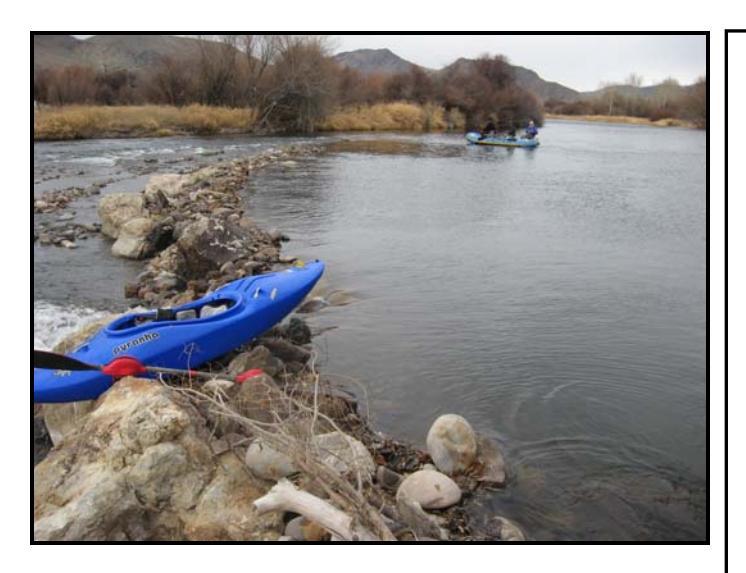
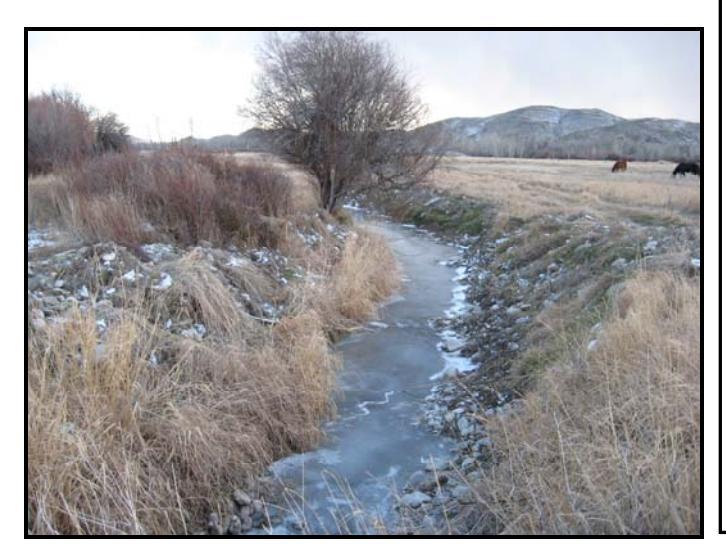
Diversion 24 – Carpenter's

Diversion 24 is the more downstream of the two Carpenter's diversions. It is located on the river left bank at the outside of a bend. The diversion structure is located in a relatively flat floodplain area and has the potential to dramatically influence channel form in what would naturally be a meandering gravel-bar system. There is a large cobble (channel material) and boulder weir extending most of the way across the channel. This weir reportedly requires maintenance regularly. There is no diversion channel and the headgate is situated in the bank. The headgate is wooded "pin and plank" structure that is need of repair.

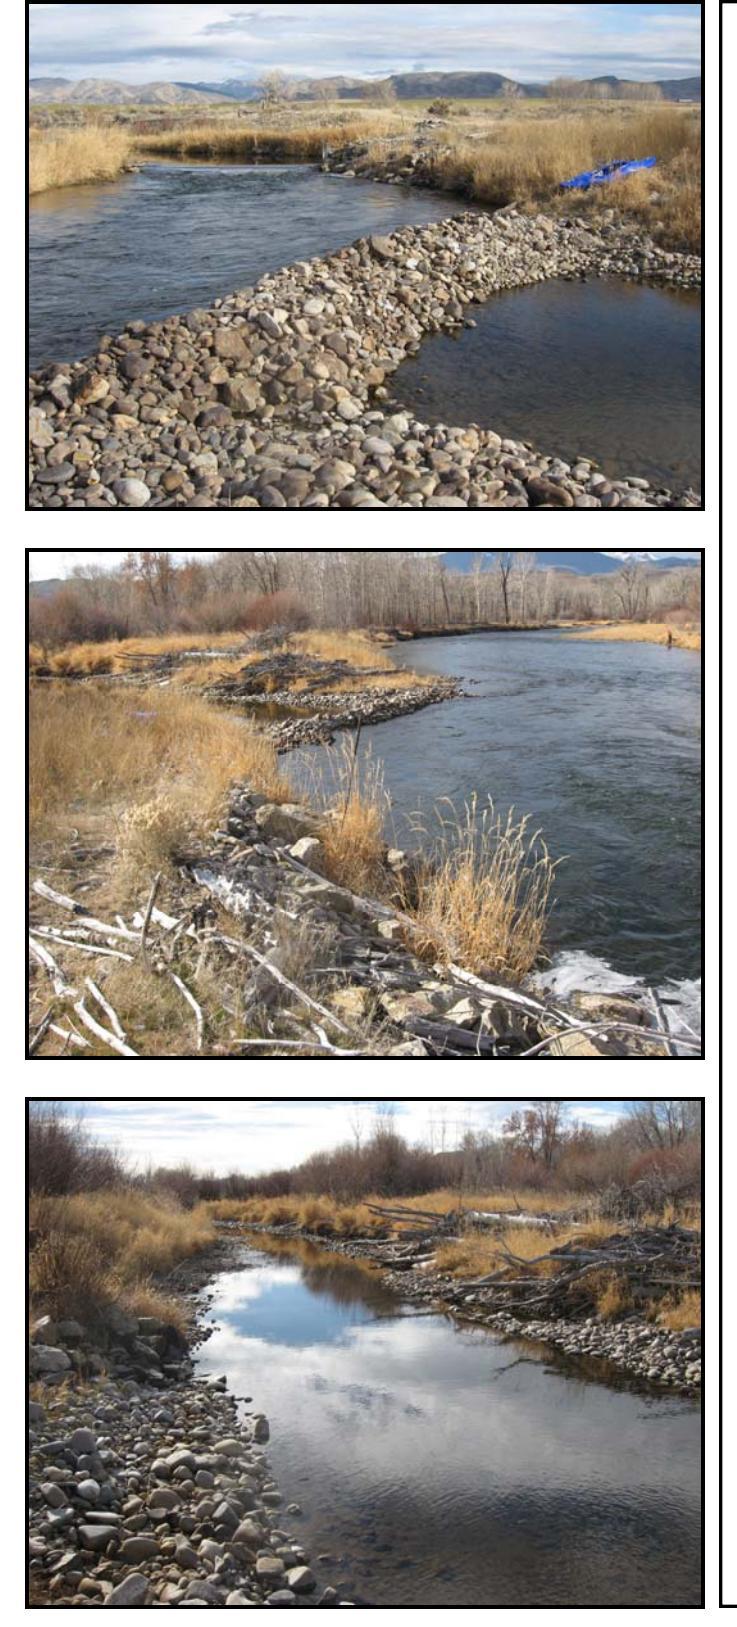
Diversion 11b – Gallagher Ditch

Diversions 11a and 11b are located along the river left bank at the outside of a bend in the left channel downstream of Melrose. The diversion structure was a small manmade island comprised of angular boulders and extended most of the way across the channel. There are two diversion channels, with a wooden headgate (Diversion 11a) on the more upstream channel and a gravel/cobble berm blocking the more downstream diversion channel (Diversion 11b), which prevents it from flowing during the winter. There is a second headgate (Diversion 29) in the Pendergast-Spears-McCullough ditch (11a) that directs water into the Gallagher ditch (11b). Return flow from the Gallagher ditch is directed back into a slough, which is then diverted at Diversion 30 into the Garden ditch.

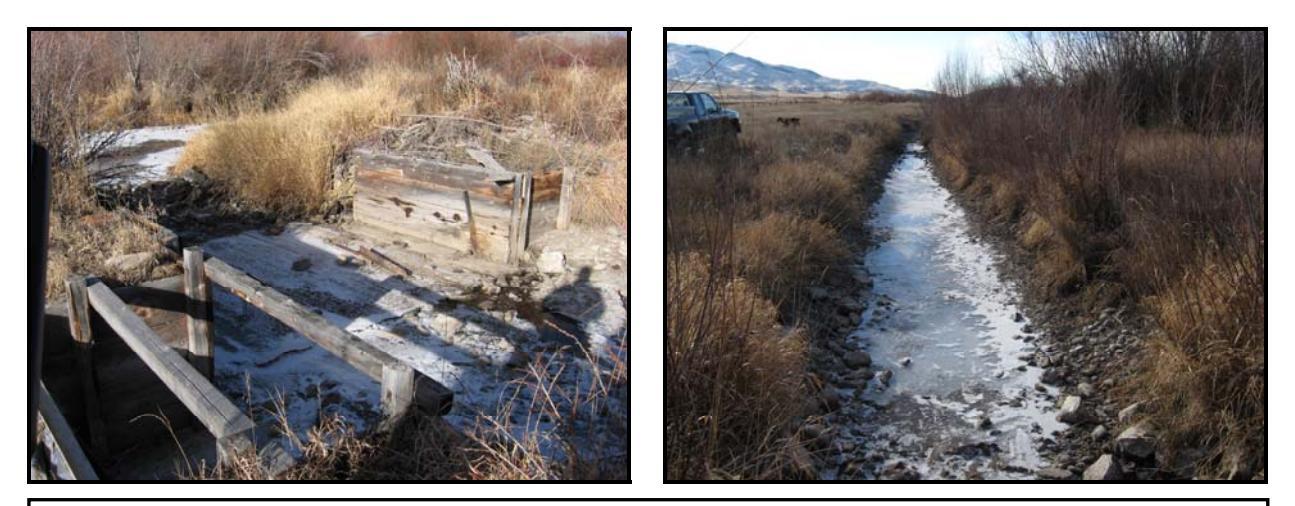
Diversion 29 directs overflow water from the Pendergast-Spears-McCullough ditch (Diversion 11a) into the Gallagher Ditch (Diversion 11b). This diversion is located approximately 500 feet down the ditch from the main diversion on the Big Hole River.

The collapsible jack is nearing the end of its operation lifespan.

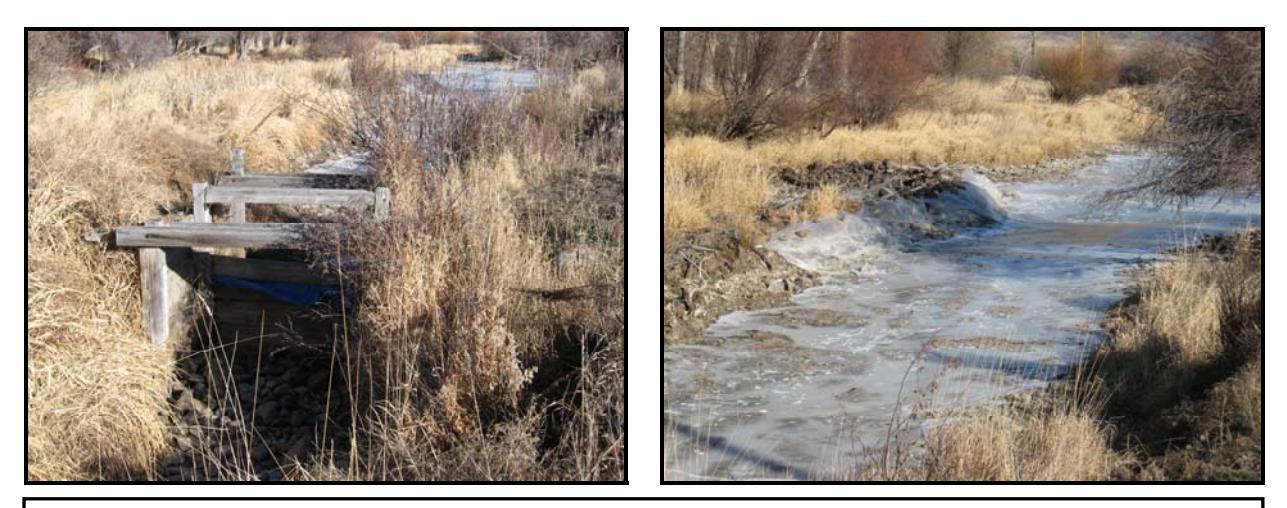
Diversion 30 – Garden Ditch

Return flow from the Gallagher Ditch (Diversion 11b) is directed into a slough at Diversion 31 and a portion of the water is then diverted into the Garden Ditch at Diversion 30. This ditch irrigates a relatively small area between the Big Hole River and the Frontage Road.

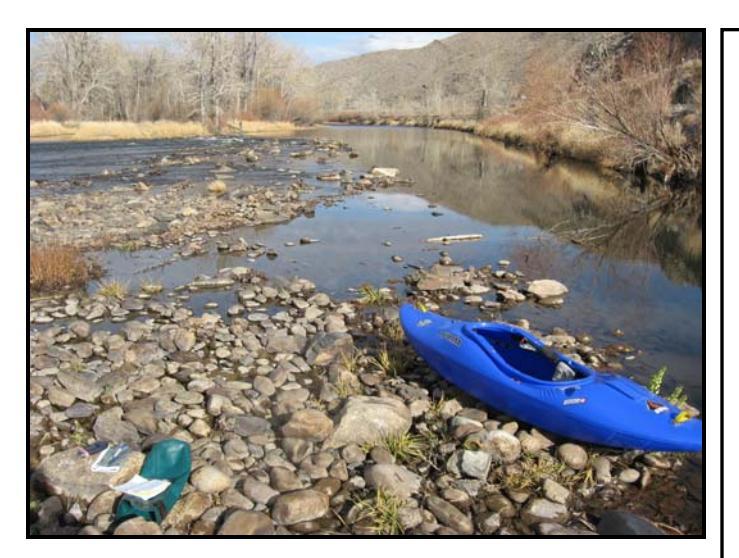
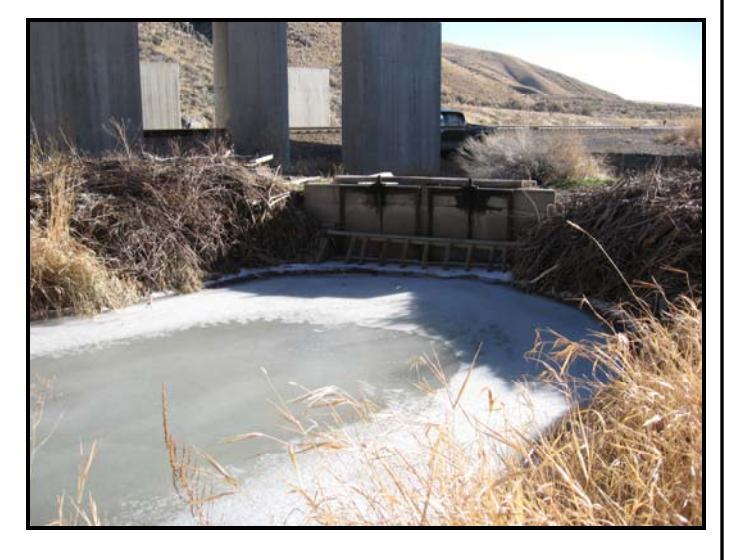
Diversion 12 – Kalsta's

Diversion 12 is located at the outside of a bend on the river left bank underneath the most upstream I-15 over-pass. The diversion weir is made of large cobbles and small boulders and extends across the entire channel and has a "flow through" chute for boat passage. The headgate is located approximately 800 feet downstream the diversion channel. There are two metal "screw gates" in a concrete structure leading into a concrete ditch, which includes a staff gage. This diversion irrigates land above and below Kalsta Bridge along the east side of the Big Hole River.

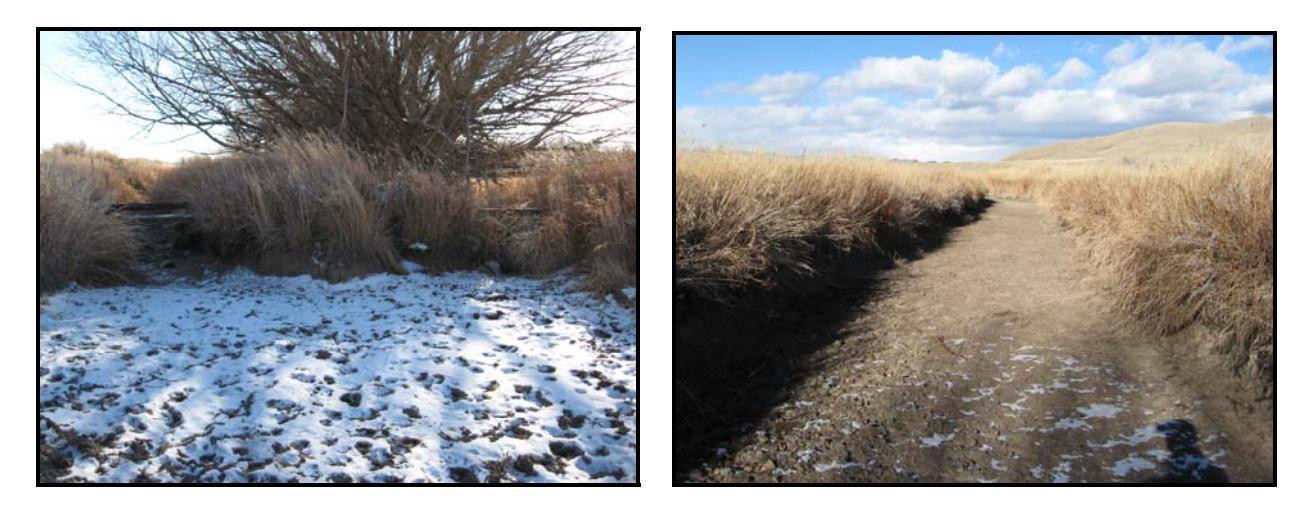
Diversion 34 – within Kalsta's Ditch

Diversion 34 is located approximately 1.7 miles down Kalsta's ditch (D12). At this diversion, the main ditch splits into two ditches. The right (west) ditch leads back to the river, flowing through a floodplain area feed by springs. The left (east) ditch flows approximately 2 more miles before returning to the river upstream of Diversion 15.

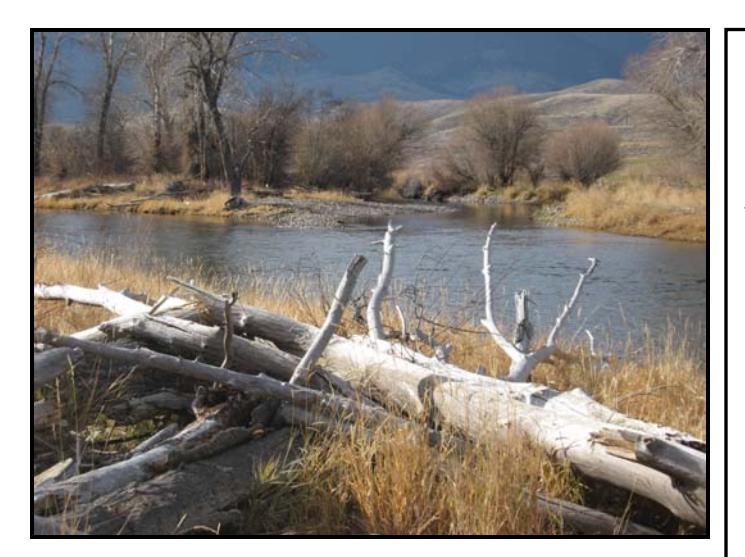
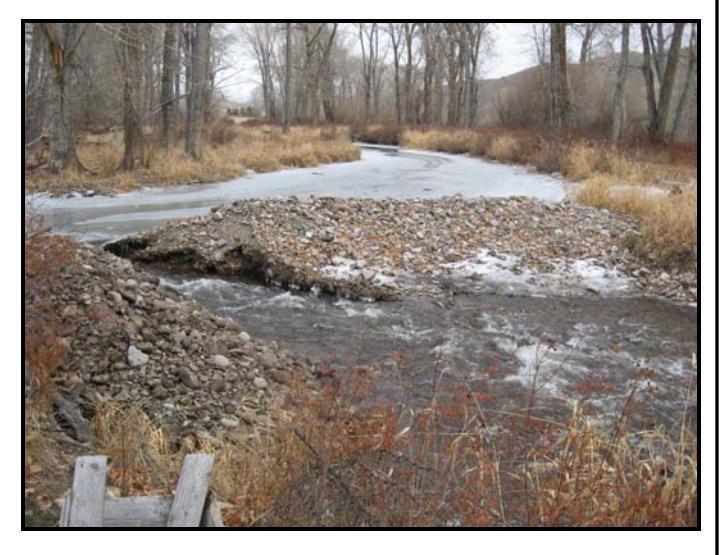
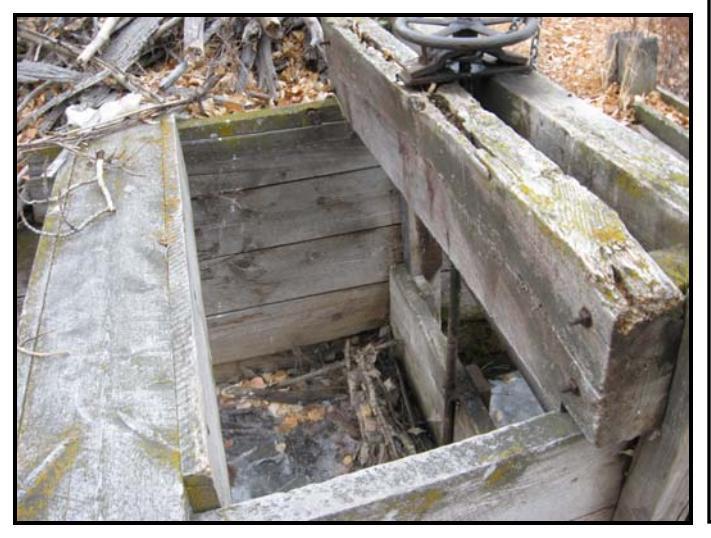
Diversion 13 – Hagenbarth's "Big Hole" Ditch

Diversion 13 is the located in a diversion channel along the river right bank. The diversion channel is formed by a seminatural looking gravel bar on river right just downstream of Kalsta's diversion weir. The single wooden headgate is located approximately 1,500 feet down the diversion channel and there is a "blow-off" channel approximately 600 feet down the diversion channel. Water is directed toward the headgate by a gravel berm. This ditch irrigates land on the west side of the Big Hole River downstream of the interstate crossing and upstream of Glen. Flow in this ditch is regulated by a second headgate (Diversion 42) at the mouth of Rock Creek. Water from this ditch then flows into a network of ditches downstream of Glen.

Both headgates are scheduled to be replaced in the spring of 2008. At the upper headgate (Diversion 13), they plan to add a "collapsible jack" to replace the gravel berm currently used. At the second diversion (Diversion 42) where the ditch intercepts Rock Creek, they are also planning to replace the wooden headgate and replace the existing Parshall flume with a 6' Parshall flume. **Diversion 14 – Hagenbarth's "River Field" Ditch**

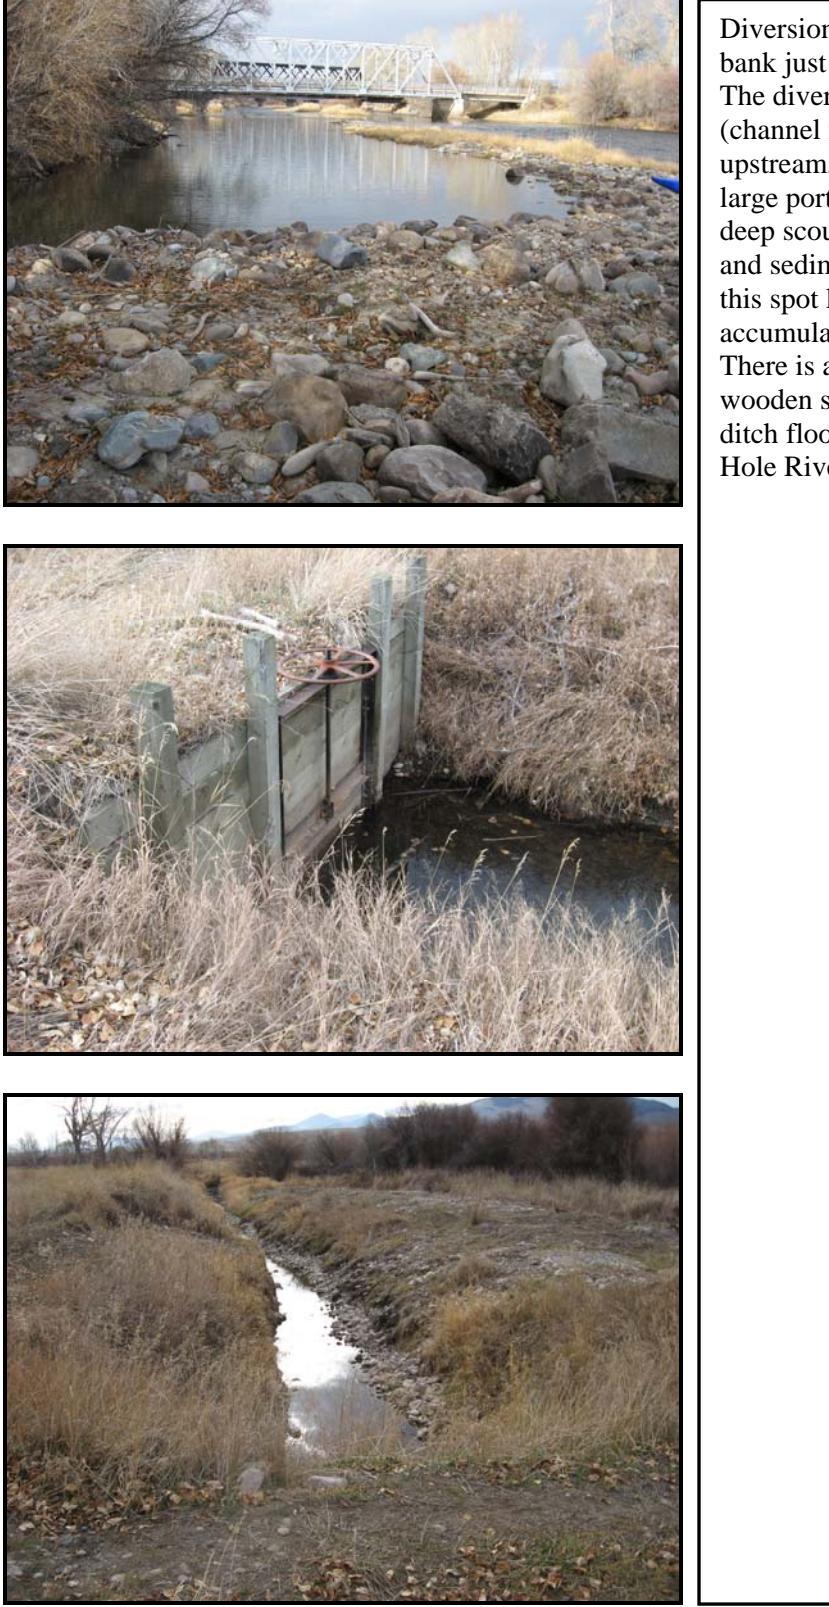
Diversion 14 is located on the river right bank just downstream of the Kalsta Bridge. The diversion dam is comprised of cobbles (channel materials) and is angled directly upstream, but does not extend across a large portion of the channel. There is a deep scour hole below the Kalsta Bridge and sediment deposition downstream of this spot likely leads to gravel accumulations at the entrance of this ditch. There is a single metal headgate in a wooden structure. This gravel bottom ditch flood irrigates land between the Big Hole River and the frontage road.

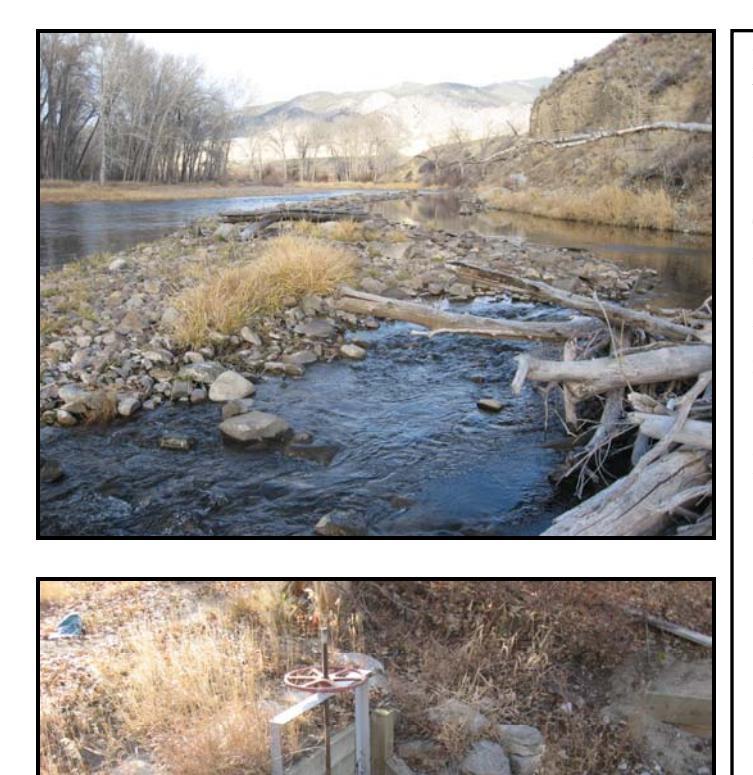
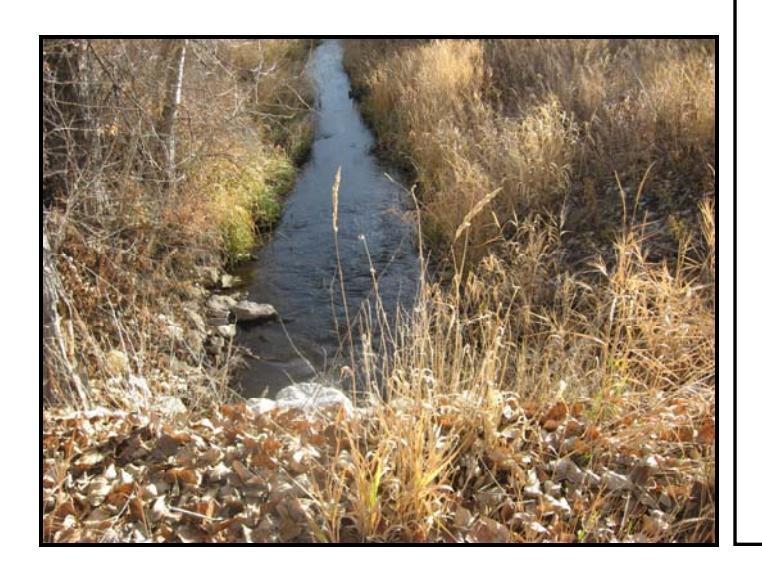
Diversion 15 – Gainy's

Diversion 15 is located on the river left bank at the outside of a bend. There is a cobble and boulder weir extending out into the channel straight upstream approximately 350 feet from the headgate. This ditch is located where the river meets the foothills along river left, so it is somewhat naturally confined currently, though this is subject to lateral channel migration. The headgate is a metal "screw gate" in a wooden housing and there is an overflow channel with a "collapsible jack". Return flow from this ditch feeds a series of ponds located on the floodplain.

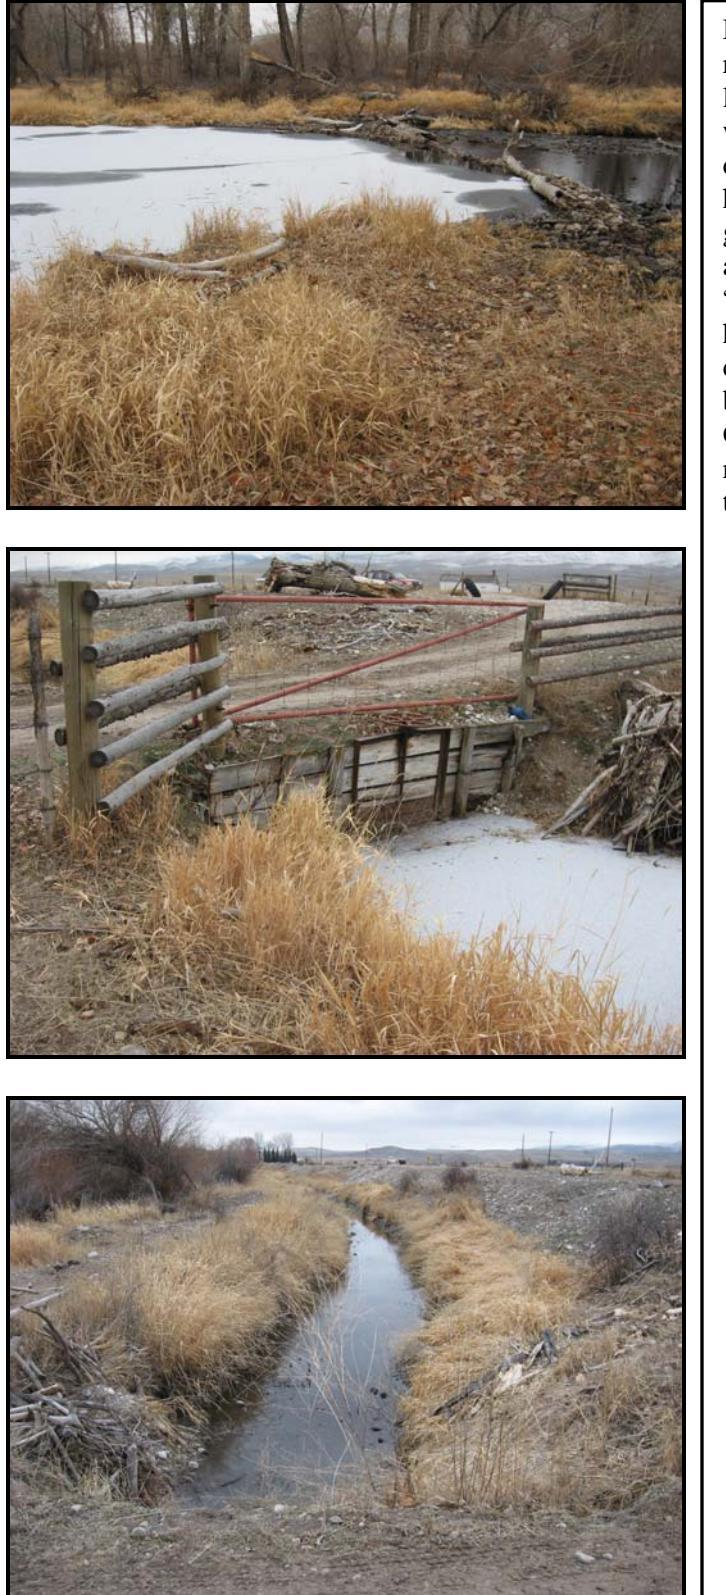
Diversion 39 – Smith's

Diversion 39 comes off a slough on river right and the initial point of diversion is located over a mile upstream. Overflow water from Hagenbarth's "River Field" ditch also feeds this slough. At the headgate, the diversion dam is made of gravel and cobble (channel materials), along with some wood. The single metal "screw gate" is situated in a wooden housing and is approximately 100 feet down a diversion channel. This gravel bottom ditch irrigates land downstream of Glen. There is a Pashall flume, though it reportedly may not function properly since the ditch is relatively flat.

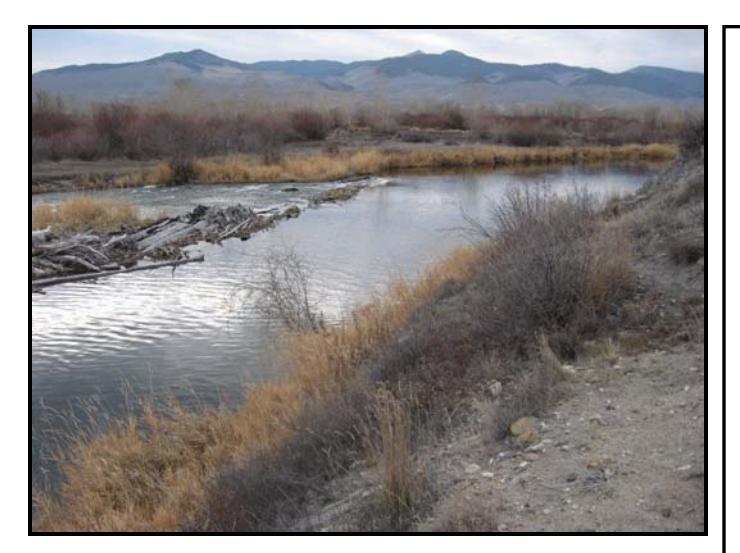
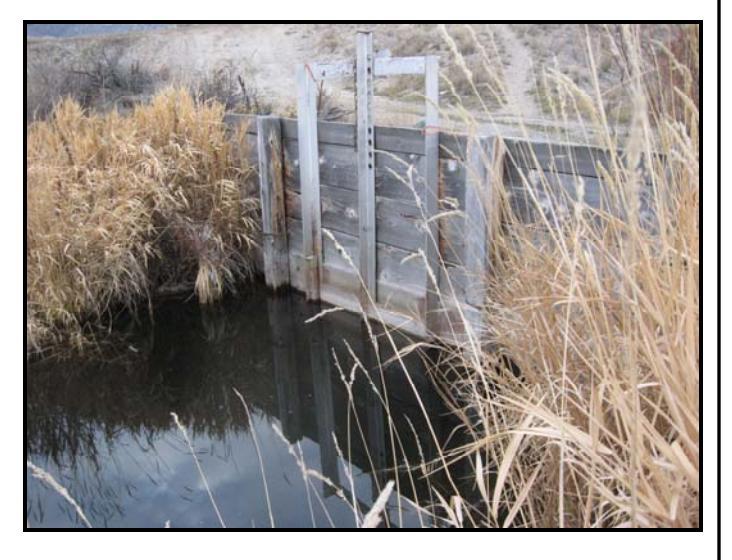
Diversion 16 – Gainy's

Diversions 16 and 17 are fed by a large diversion channel on the river left bank, with the initial point of diversion maintained by a gravel and cobble weir constructed out of channel materials in a riffle that is over-widened. Gravels have been piled up on both sides of the entrance to the side channel in an effort to maintain flow into the diversion channel. The initial diversion is located in relatively a broad and flat floodplain area with multiple channels.

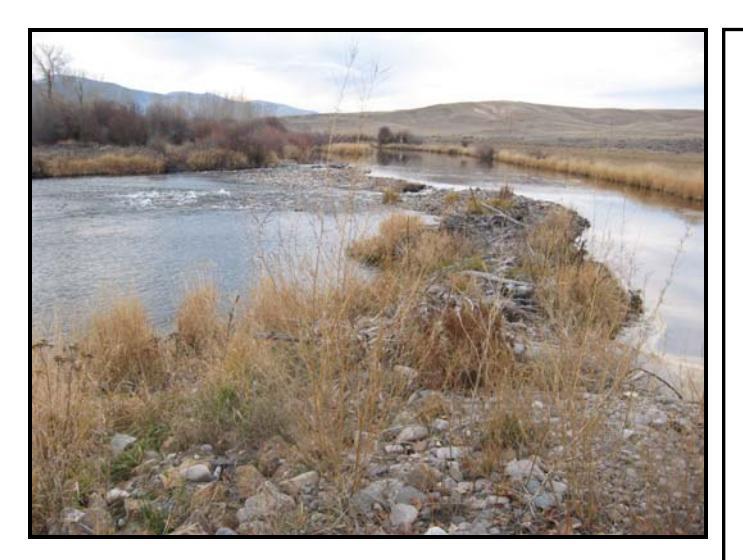
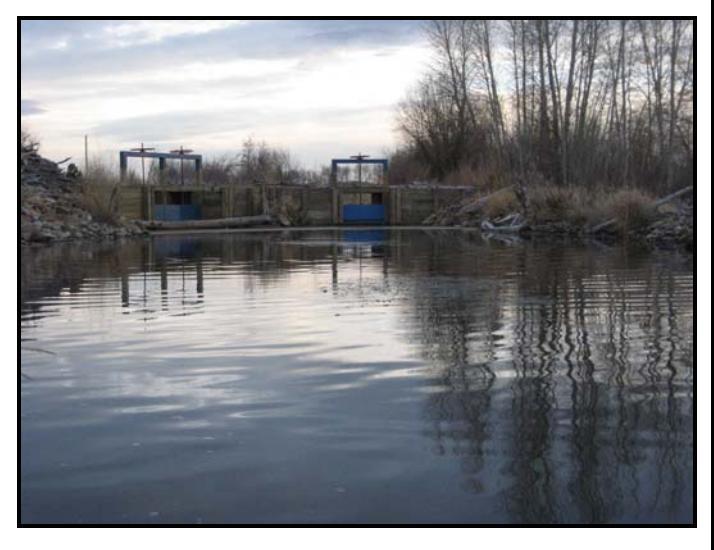
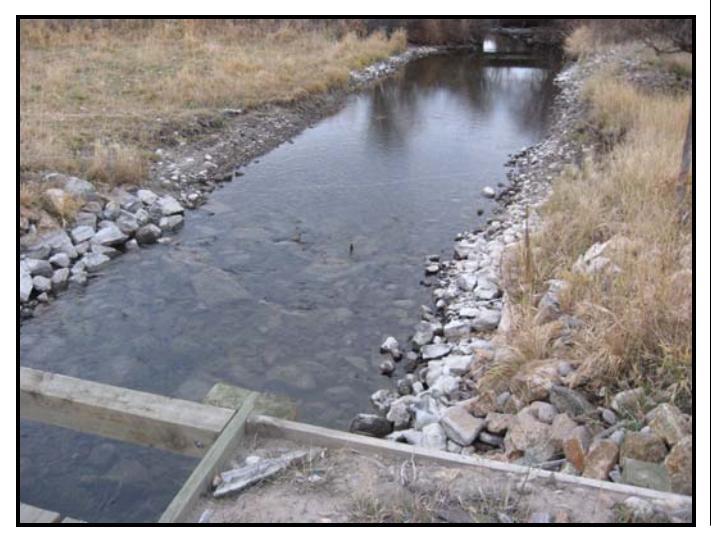
Diversion 17a – Garrison's (Buhrer-Garrison Ditch)

Diversions 16 and 17 are fed by a large diversion channel on the river left bank, with the initial point of diversion maintained by a gravel and cobble weir constructed out of channel materials in a riffle that is over-widened. Gravels have been piled up on both sides of the entrance to the side channel in an effort to maintain flow into the diversion channel. The initial diversion is located in relatively a broad and flat floodplain area with multiple channels.

There is currently a design in place to improve this diversion dam. However, concerns have been raised that the river could overflow onto the floodplain here, Diversion 17b – Kilwien's (Buhrer-Garrison Ditch)
