Lower Big Hole Irrigation Infrastructure Survey and Prioritization

March 2008

Executive Summary

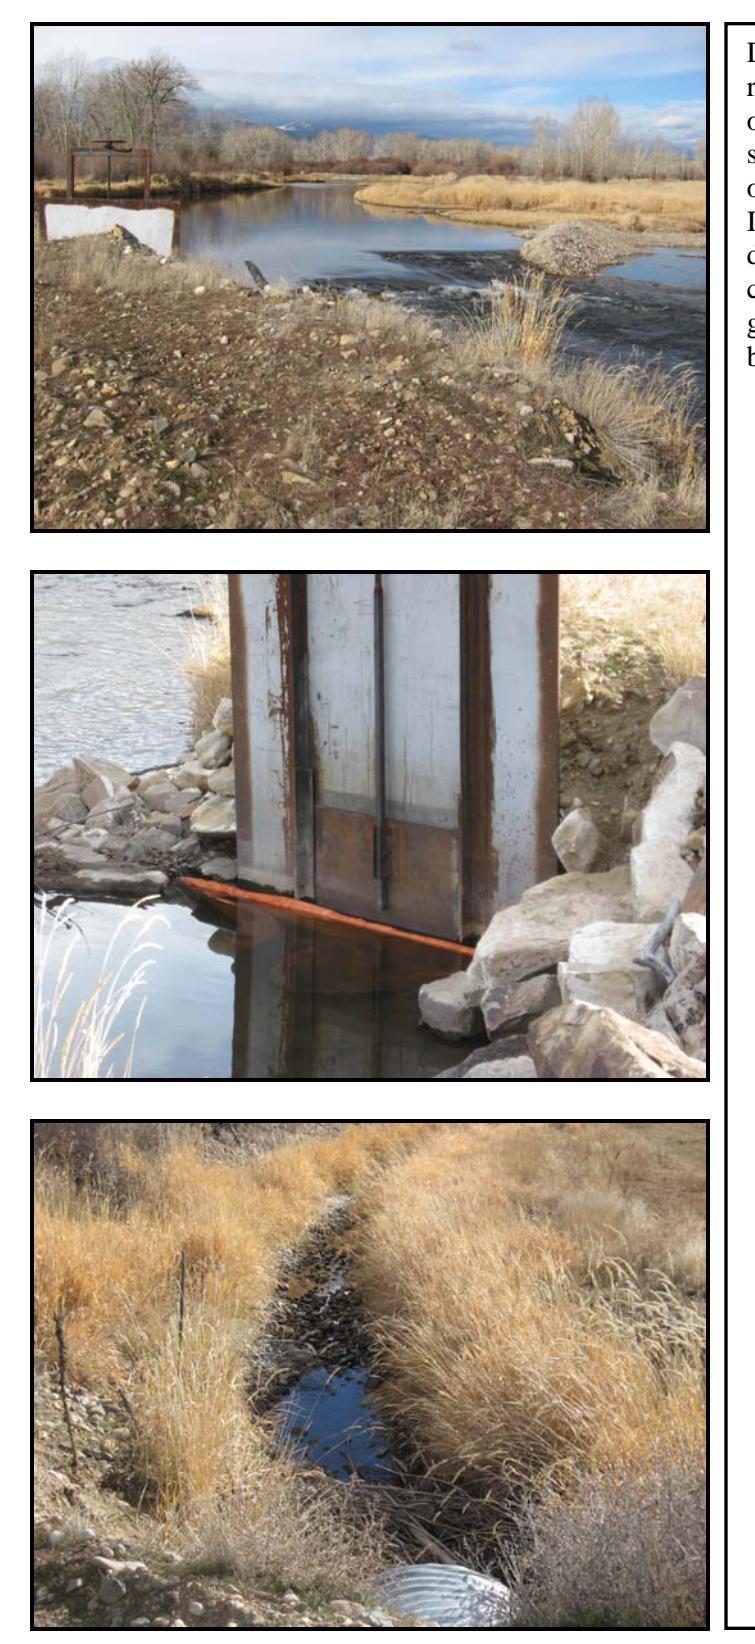
Diversion 25 is located along the river right bank in the right channel downstream of the Glen FAS. This is a large natural side channel. The diversion weir is made of cobble and gravels (channel materials). It appears that a portion of the diversion dam has washed out, leaving a plume of cobbles downstream. It is a metal "screw gate" in a metal housing surrounded by boulders (riprap) and cobbles. Diversion 26 - Garrison's "Wild Hay" Ditch

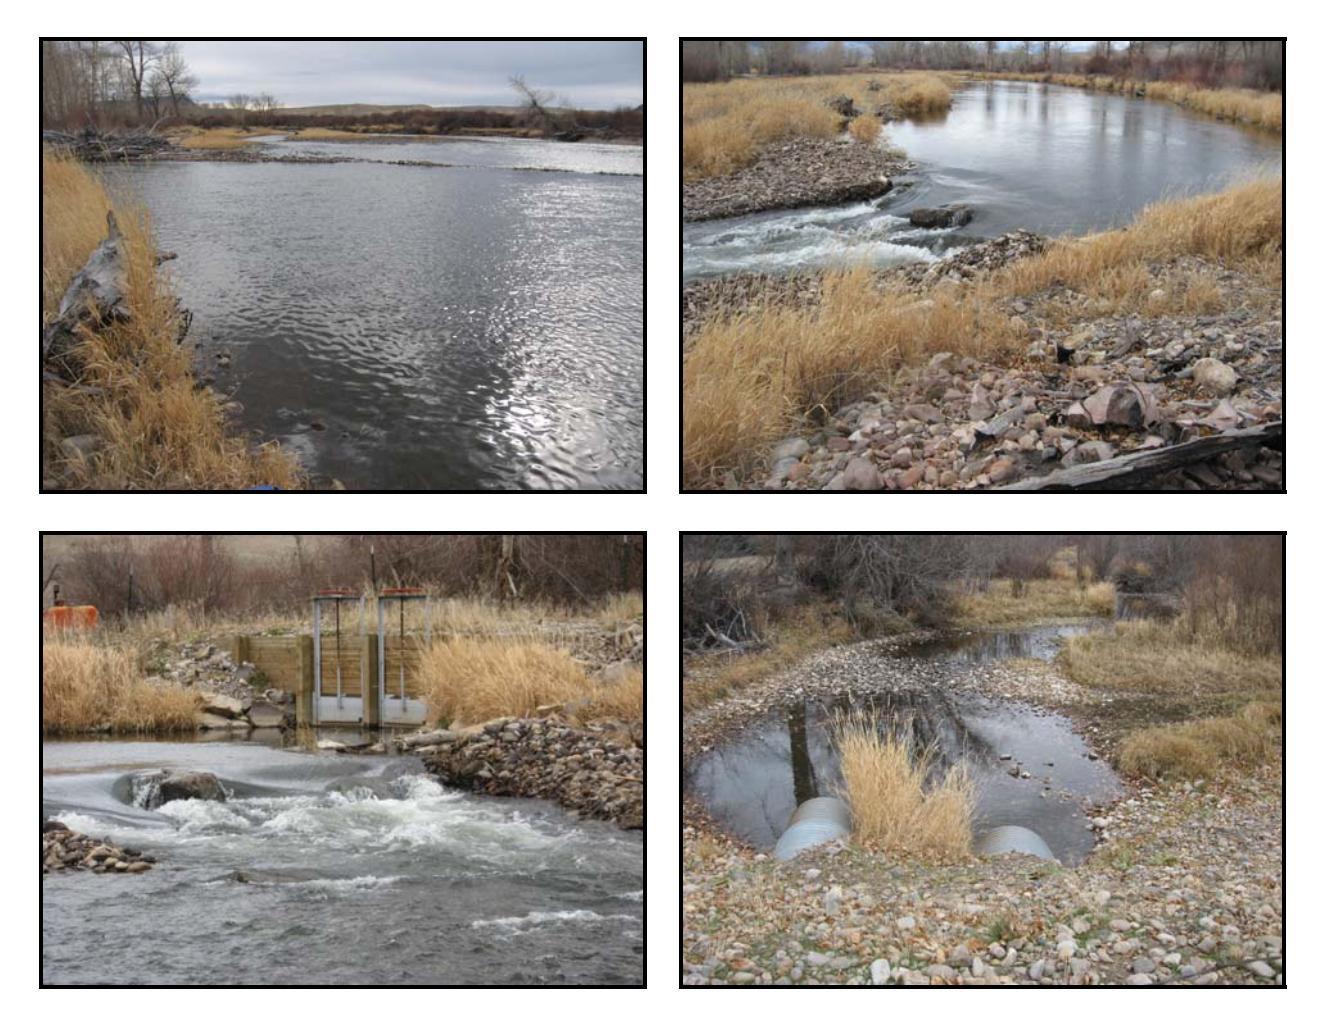
Diversion 26 is located in a diversion channel to the river left of the main channel. The diversion channel reportedly used to be the main channel. The initial point of diversion is maintained by a gravel and cobble (channel materials) weir that extends approximately half way across the channel in a wide and shallow riffle. The diversion weir at the headgate extends across the entire side channel and is made of channel materials with a few boulders. There are two metal headgates in a wooden housing that was recently replaced. The headgate is housed in a large floodplain berm that extends downstream to an area with barbs and riprap.

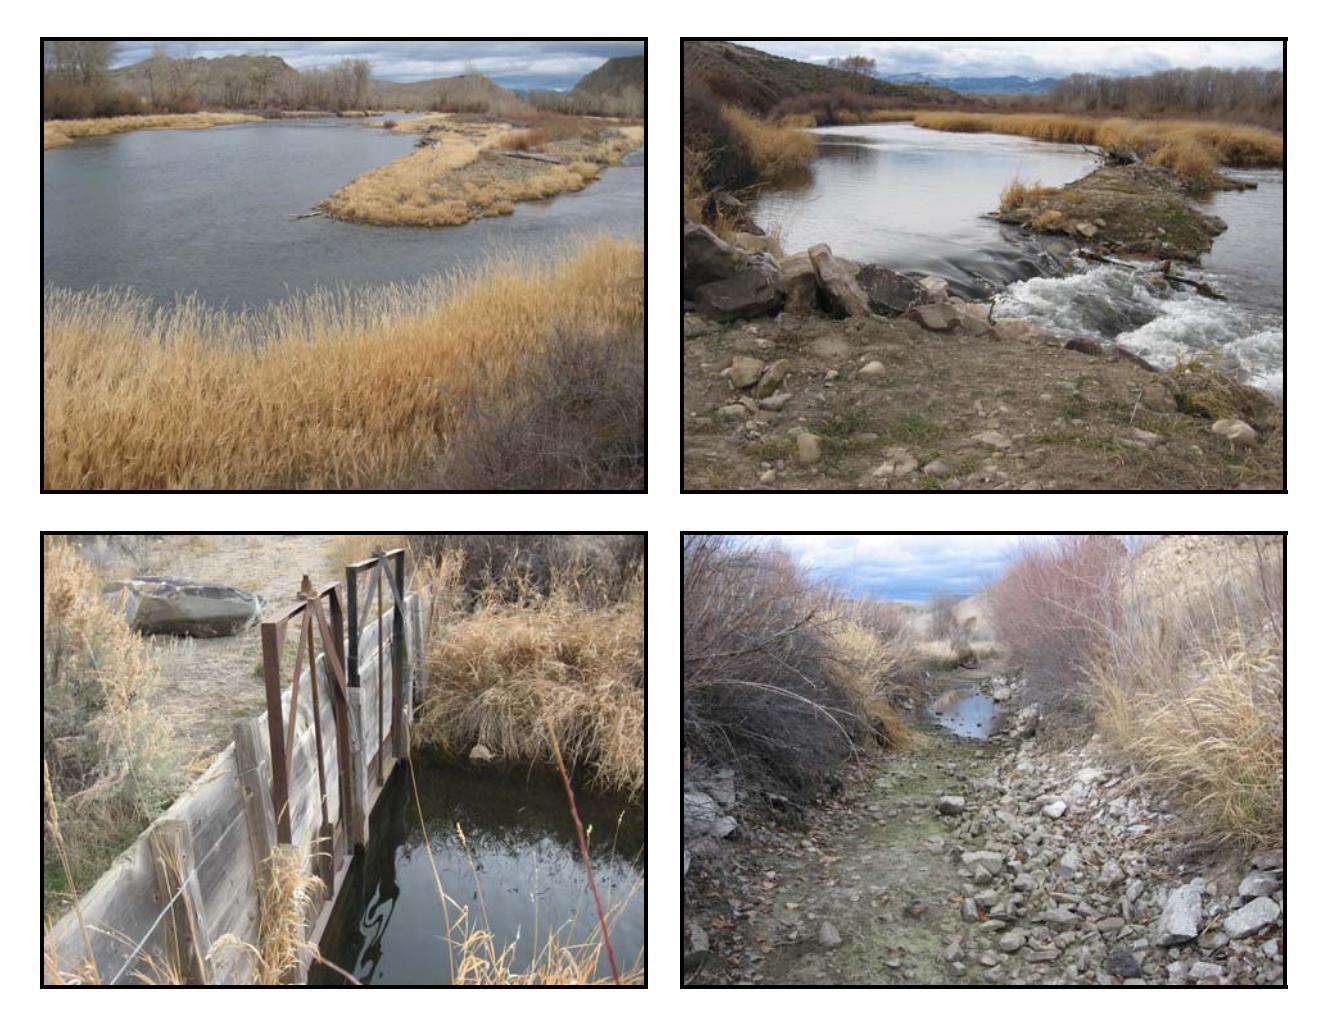
Diversion 27 – Rafferty's "Upper South Side" Ditch

Diversion 27 is located along the river right bank in a side channel to the river right. The original inlet to this diversion has been abandoned and the river eroded away part of the original ditch. The existing point of diversion looks like a natural gravel bar. At the headgate, there is a diversion dam extending across the entire channel. This diversion dam is made primarily of channel materials, with some smaller angular boulders. There are two metal "screw gates" in a wooden housing that were situated parallel ("askew") to the flow. The cobble bottom ditch flows along the base of the foothill and through the Notch, irrigating an area downstream of the Notch.

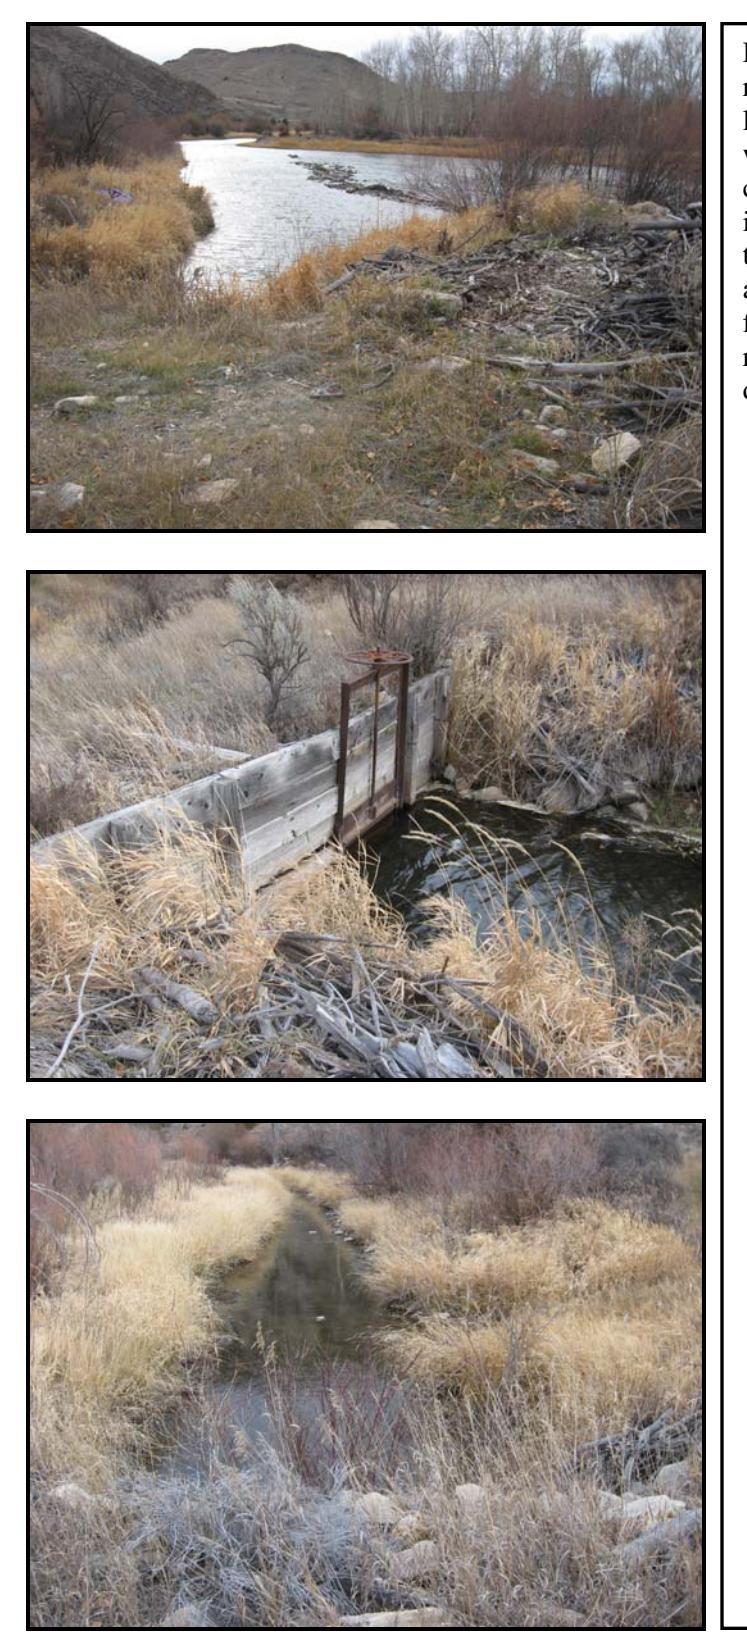
Diversion 28 – Rafferty's "Lower South Side" Ditch

Diversion 28 is located along the river right bank in the main channel. There is a large cobble and boulder weir extending well upstream and across most of the channel. The single metal "screw gate" is in a wooden housing. The ditch parallels the "Upper South Side" ditch and runs along the river. This ditch carries floodwater during high flows and is regulated by a second headgate where it departs from the river.

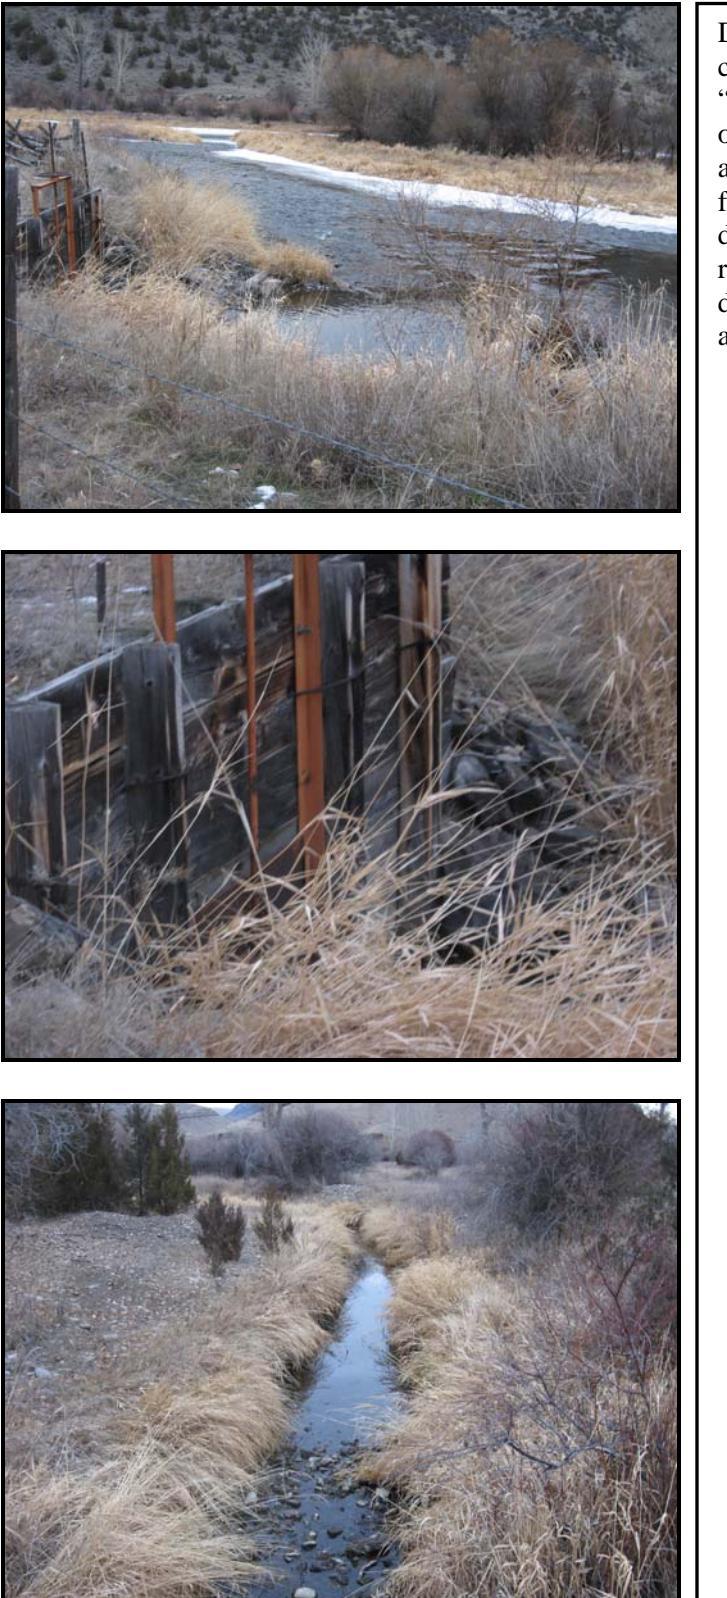
Diversion 37 – Bryan Ditch

Diversion 37 comes off a river left side channel across from where Rafferty's "Lower South Side" ditch (D27) comes off on river right. There are two headgates in a row, with a created "spring creek" flowing in-between. The ditch then leads down into a ponded area that also has return flow water from Garrison's diversion (D17a). This ditch irrigates an area downstream of the Notch.

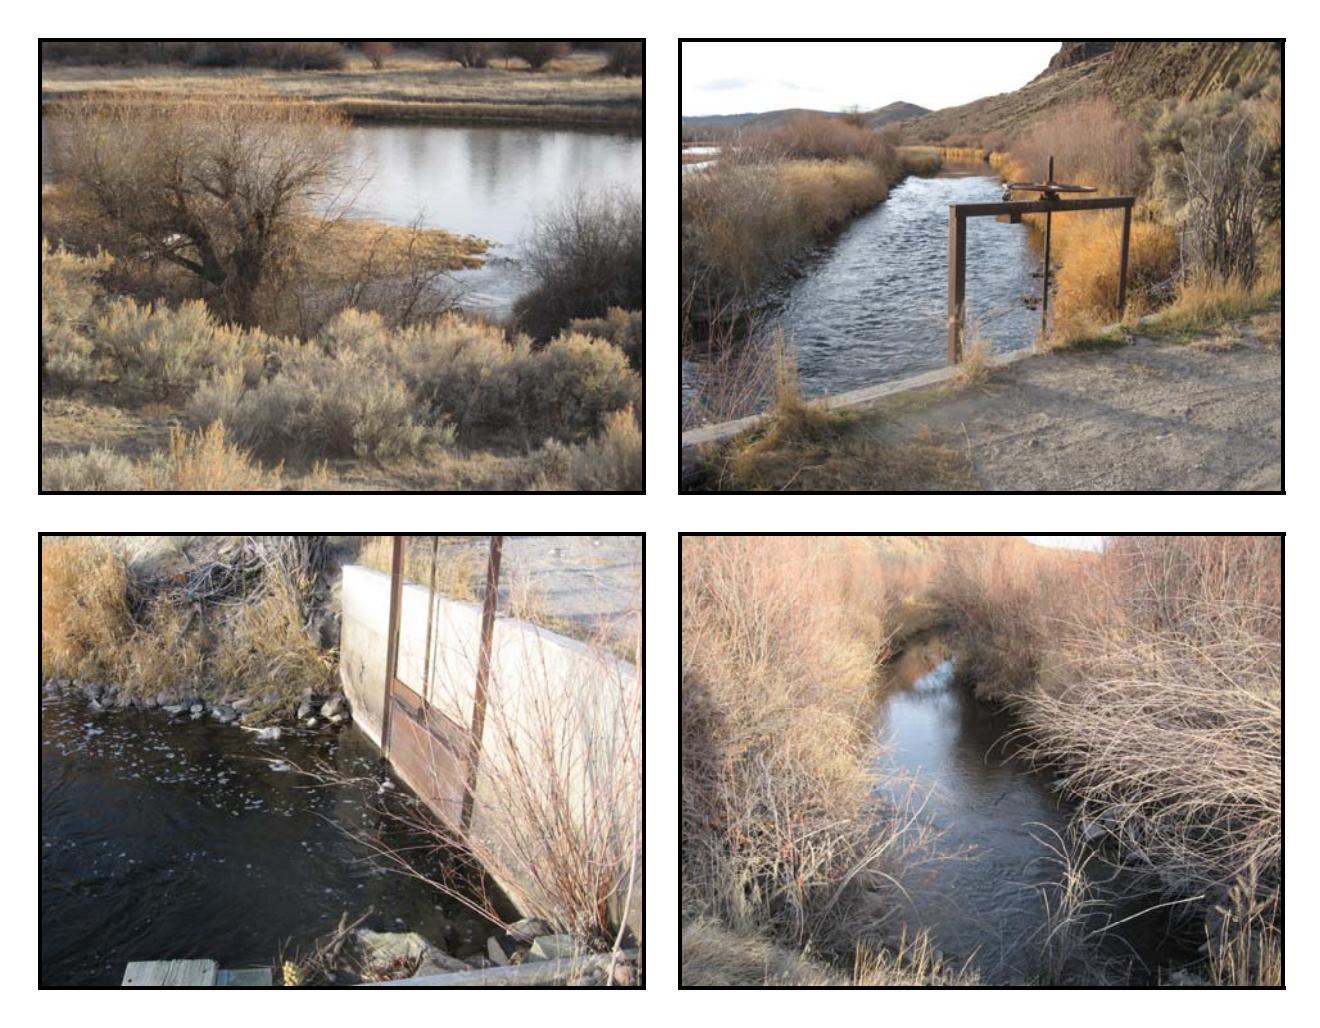
Diversion 4 – JS Ranch (Larson-Naranchich Ditch)

Diversion 4 is located along the river left bank downstream of Notch Bottom. A diversion channel has been created on river left to direct water toward the headgate. The diversion channel consists of a large vegetated berm with a natural looking gravel bar directing flow from the main channel. The headgate is a metal "screw gate" in a concrete housing and is located approximately 1,500 feet downstream of the initial point of diversion. There is a "collapsible jack" to increase the elevation of the water at the headgate. This ditch irrigates fields to the north of the Big Hole River.

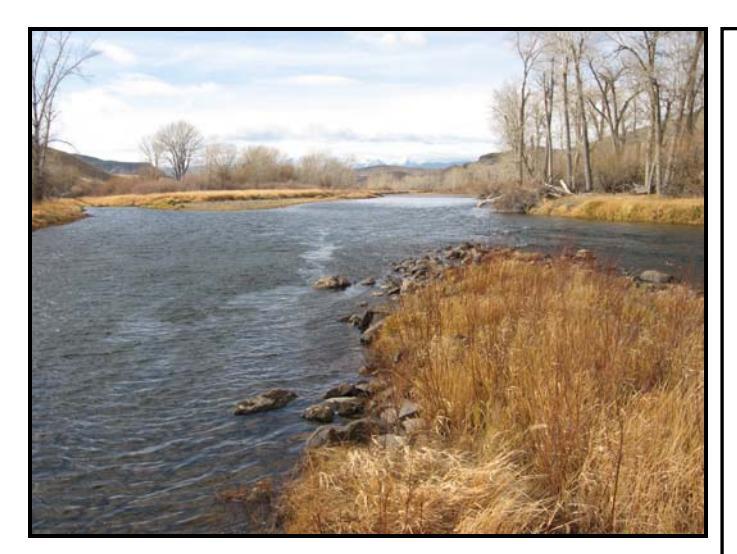
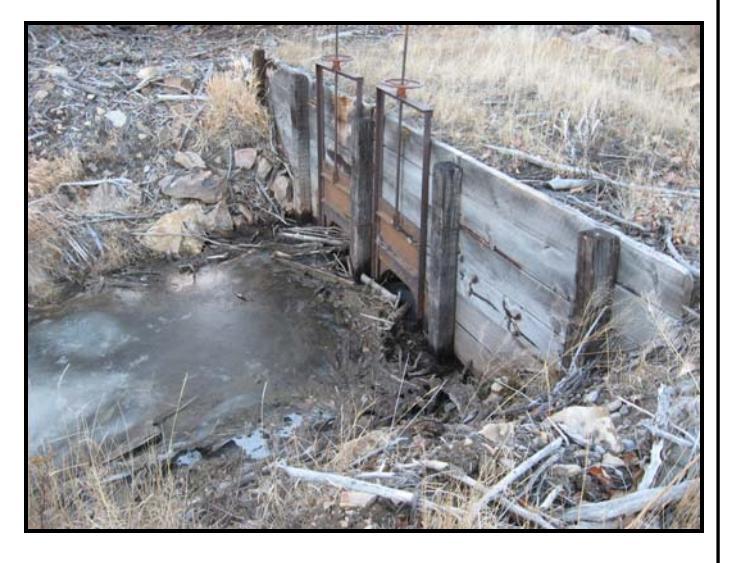
Diversion 1 – Cooper's (Whitney Ditch)

Diversion 1 is located at the outside of a meander bend along the river right bank. There is a vegetated cobble and boulder weir that extends approximately half way across the channel. The weir is vegetated with willows and has captured woody debris. There are two metal "screw gates" in a wooden structure that were fully opened at the time of the site visit.

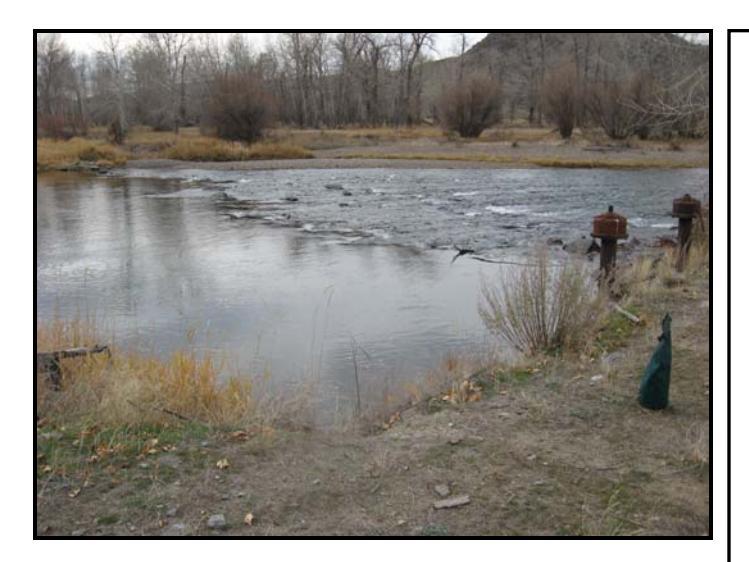
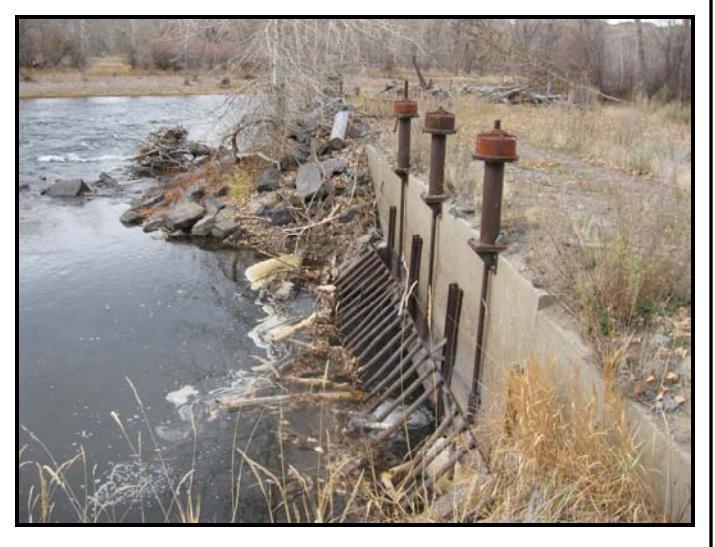
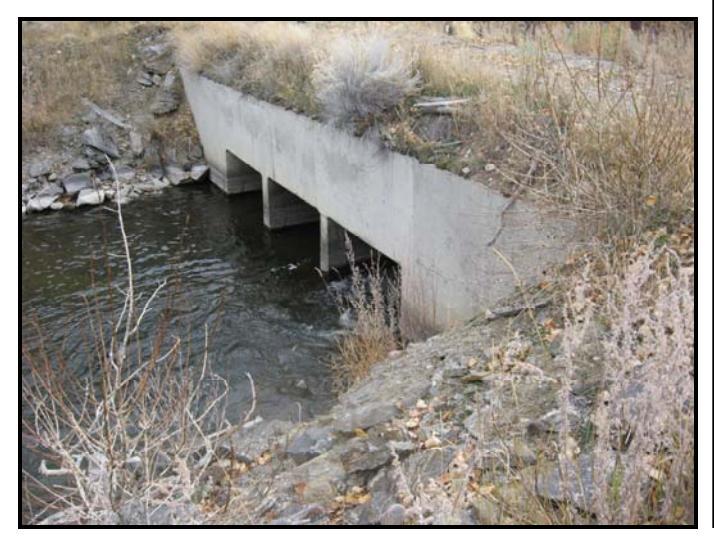
Diversion 3 – Pageville Canal

Diversion 3 is located at the outside of a bend on the river right bank. The ditch appears to utilize what was historically a side channel and is associated with a geologic nick-point that naturally confines the left side of the channel. The diversion dam is comprised of large boulders that were used to fill a deep hole. Since the placement of these boulders, the channel bed has aggraded and the diversion structure now appears assimilated into the streambed. There are 3 metal "screw gates" in a single concrete structure at the initial point of diversion, though the ditch reportedly fills with 2 of the headgates. This ditch splits into 3 ditches at a second diversion (D32) slightly less than a mile downstream of the initial diversion, with the most westerly of the ditches continuing on as the Pageville Canal. The main split (D32) is a concrete structure with metal headgates that sends the majority of the flow to the north through the main ditch, off which the Redfield ditch splits shortly thereafter at Diversion 33.

There is riprap downstream of the headgate along the river right bank. The ditch has a staff gages at the initial point of diversion (D3) as well as at the first split (D32). **Diversion 32 – Pageville Canal splits into 3 ditches**

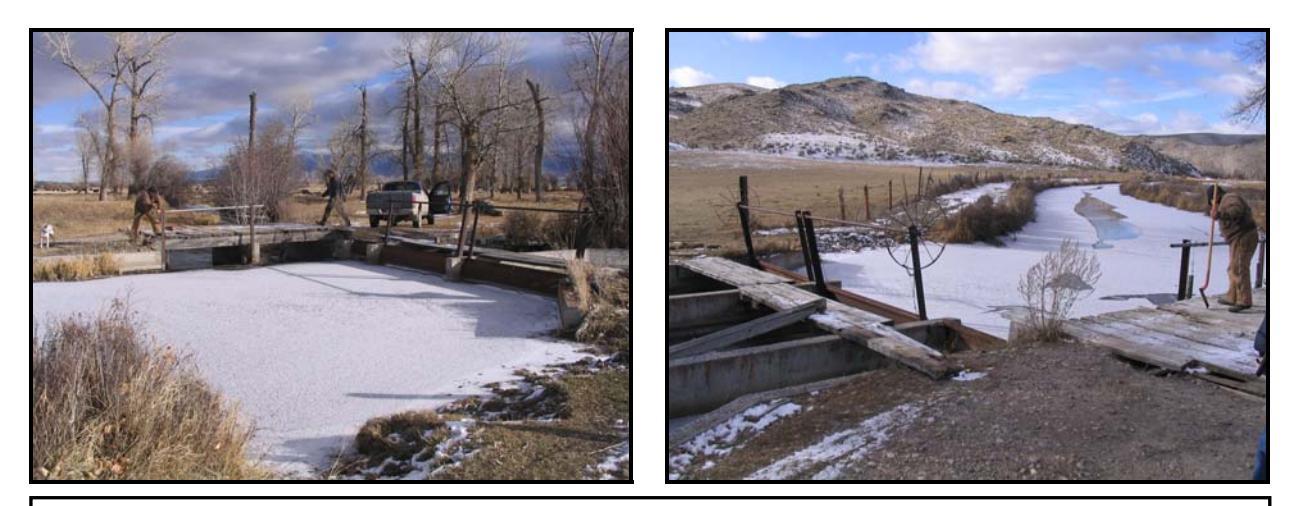
The Pageville Canal (D3) splits into 3 ditches at a second diversion (D32) slightly less than a mile downstream of the initial diversion and headgate, with the most westerly of the ditches continuing on as the Pageville Canal. The main split (D32) is a concrete structure with metal headgates that sends the majority of the flow to the north through the main ditch, off which the Redfield ditch splits shortly thereafter at Diversion 33.

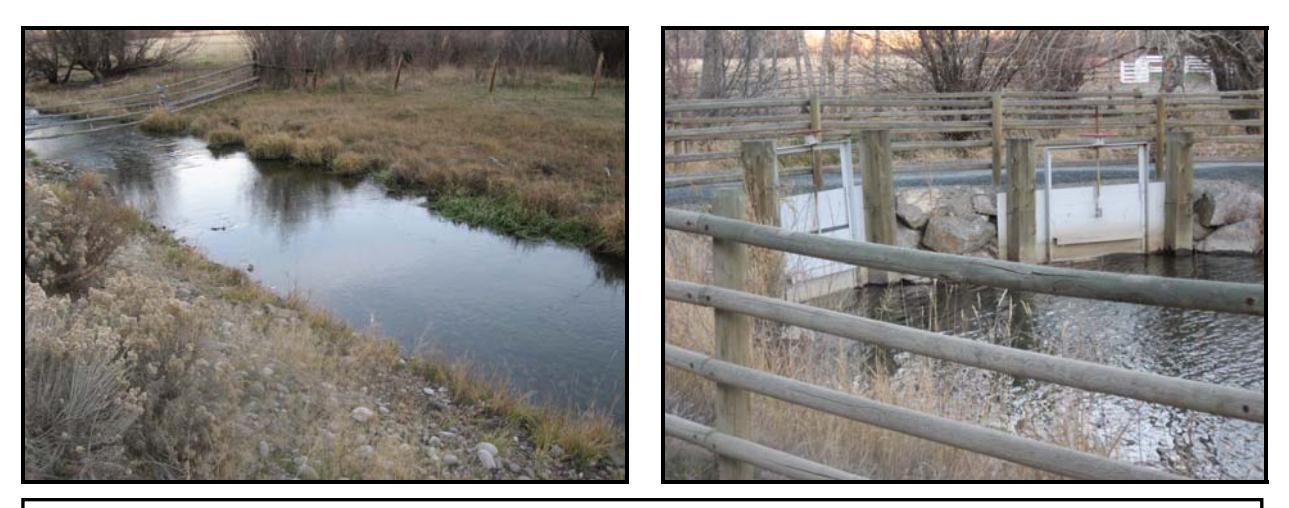
Diversion 5 – Naranchich

The initial point of diversion consisted of a natural looking gravel bar that diverts flow into a diversion channel to the left of the mainstem slightly downstream of where the Pageville Canal (D3) comes off of river right. The diversion dam in the diversion channel leading to this ditch was not observed in the field and the two "Diversion 5" headgates recorded here are located within the ditch network. There are two metal "screw gates" in a rock and wood housing that supports a driveway and fence and creates a small pond upstream. This ditch runs along Burma Road, irrigating land between the river and road.

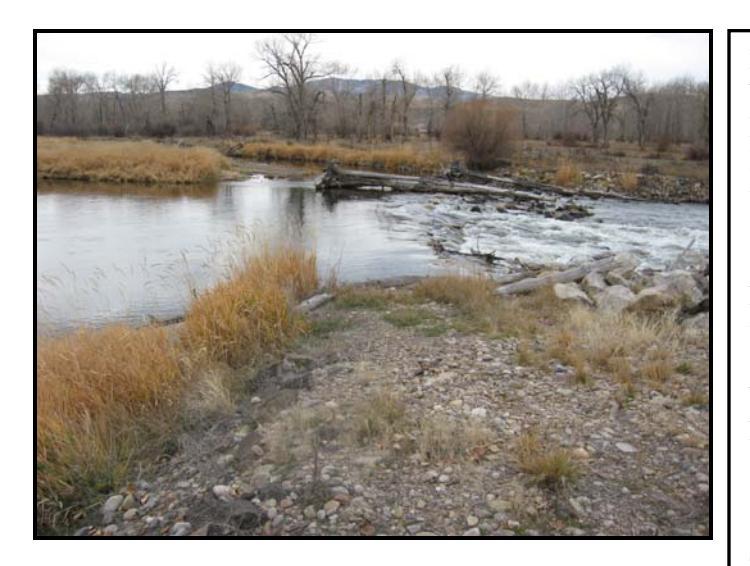
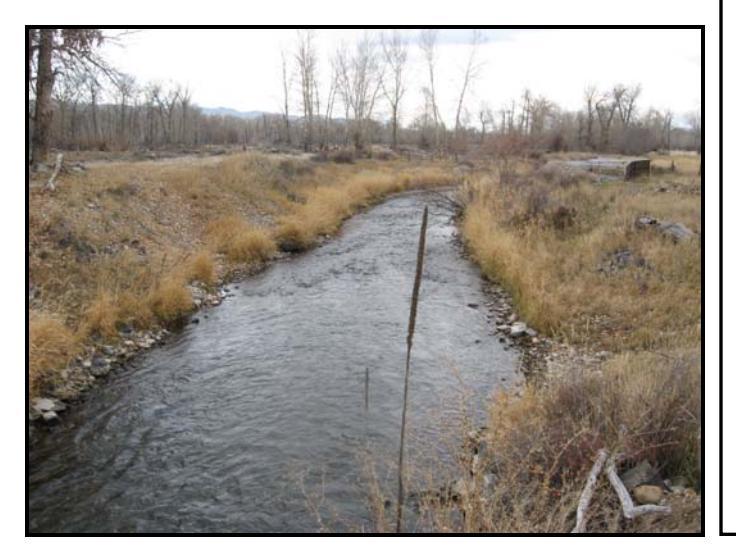
Diversion 6 – Big Hole Co-op Ditch

Diversion 6 is located along the river right bank downstream of the more southerly Pennington Bridge crossing. This is a very large diversion structure utilizing boulders that extend across the entire channel with a chute in the center for floater passage over an approximately 3-foot drop. The headgate is a single mechanism metal unit that is housed in a metal and rock structure. While it opens manually, a backhoe is currently required to "push" the headgate closed. Due to this issue, it is currently difficult to regulate during critical low flow periods.

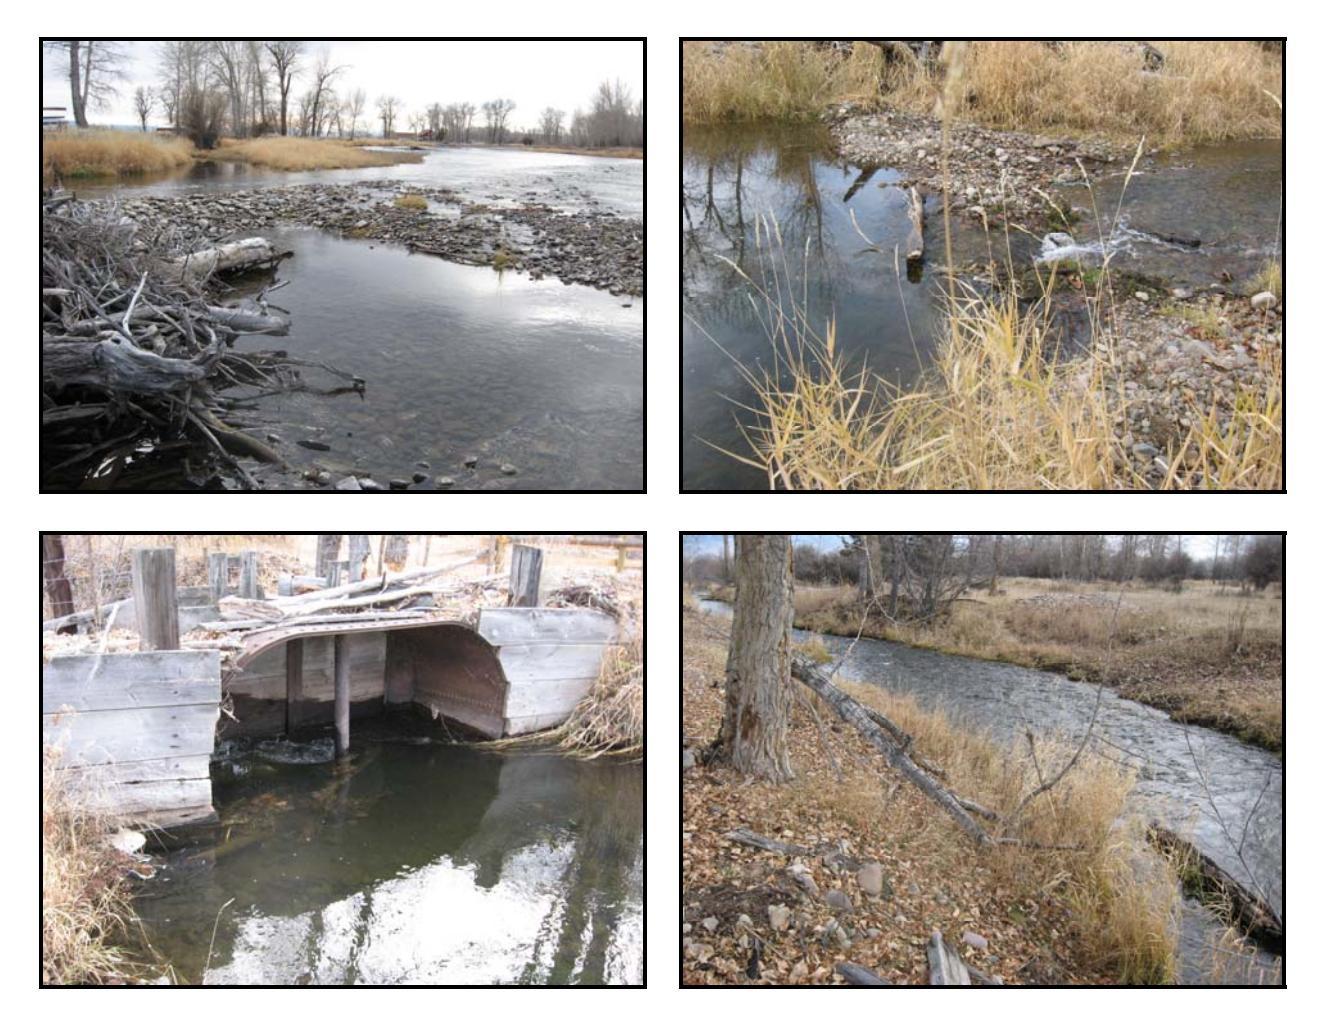
Diversion 8 – Orphan Home

Diversion 8 is located on the river right bank in a relatively straight section of river downstream of a bend where riprap protects a low spot in the floodplain. The initial point of diversion is located in a relatively flat floodplain area and the headgate is located approximately 600 feet down the diversion channel. The initial diversion consists of a gravel berm extend well into the channel in this overwidened and shallow riffle. At the headgate, a small gravel berm has been built up to divert water toward the headgate, which is situated parallel to the flow. The headgate is comprised of wooden boards in a metal structure constructed from an old boiler pipe. There is a floodplain berm along the diversion channel that extends downstream of the headgate.

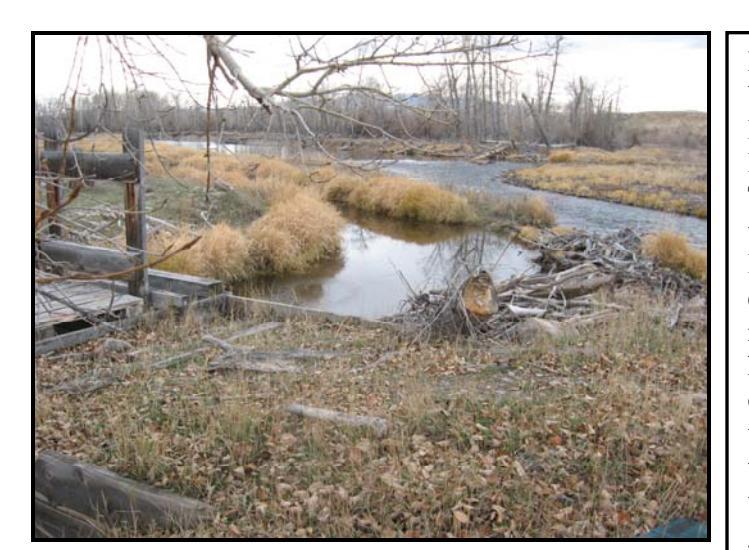
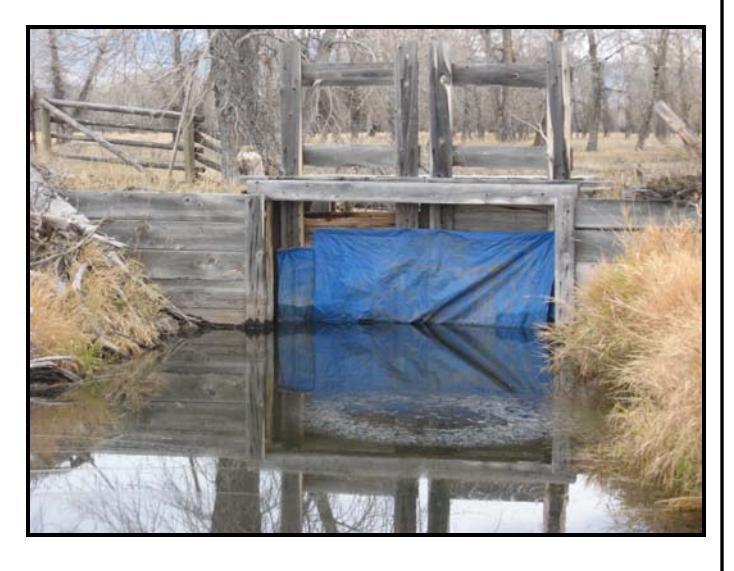
Diversion 9 – Hamilton Ranch Lott-Harvey Ditch

Diversion 10 is located on the river right bank in the right channel upstream of a large floodplain berm. The diversion is located in a relatively flat floodplain area. The diversion structure includes boulders that create a vegetated peninsula, which leads to a small barb with cobbles extending into the channel. The channel reportedly used to lead directly to the headgate, but now only a slough leads down to it and the channel has migrated to the left. The short diversion channel leads to a wooden "pin and plank" headgate with two openings, while the ditch has a gravel/cobble substrate. The headgate is situated parallel to the flow.

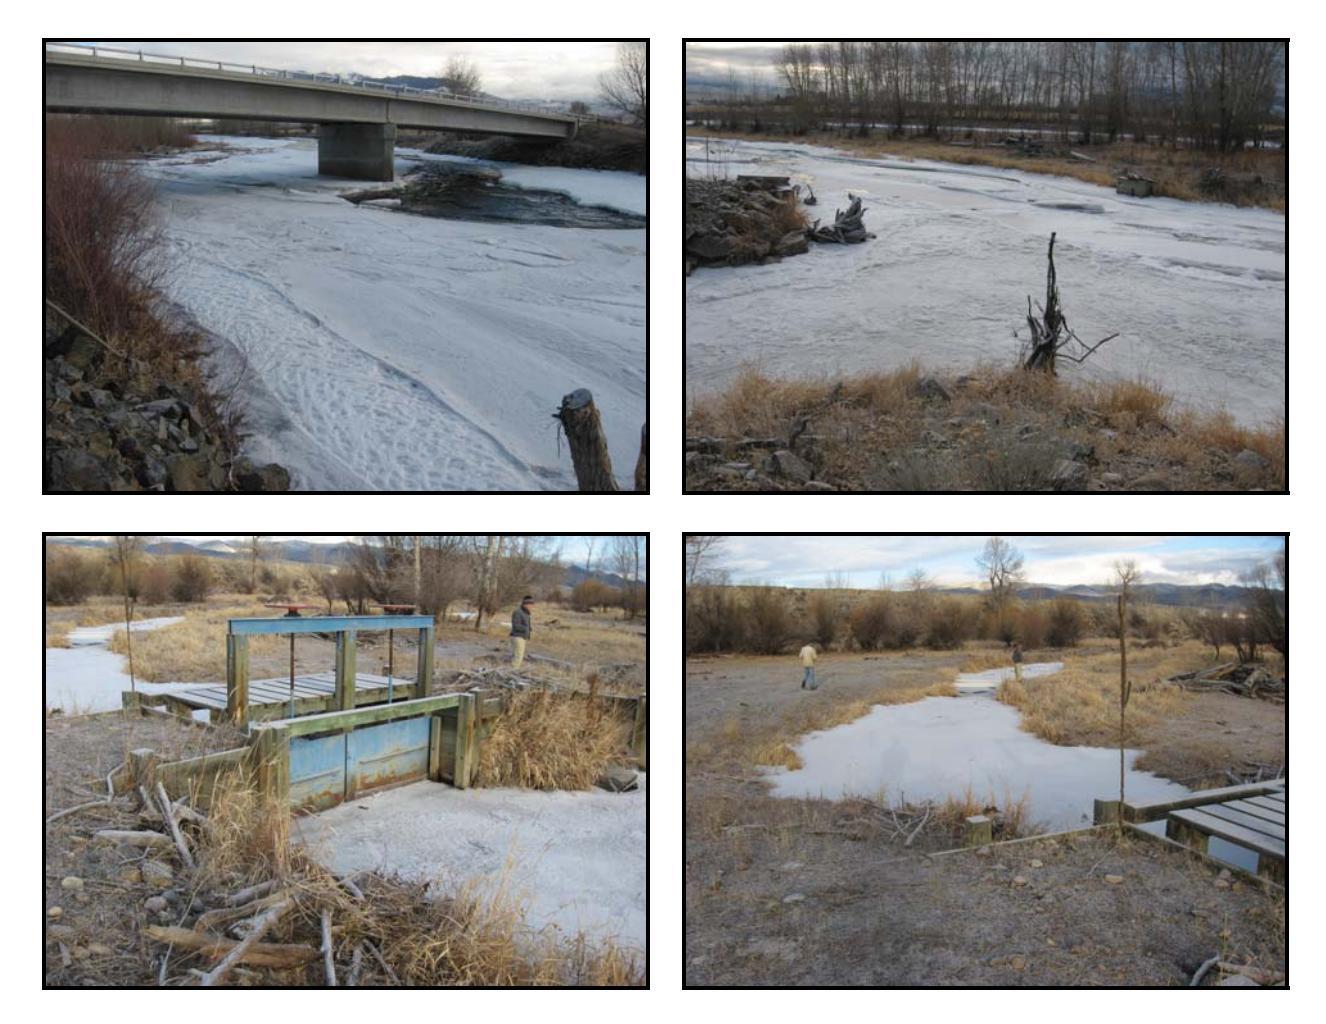
Diversion 36 – Hamilton "Ranch" Ditch, also known as "Hamilton" Ditch

The initial diversion dam serves both Diversions 35 and 36. This diversion dam extends out from the river left bank just upstream of the High Road Bridge. The diversion dam is situated just upstream of the bridge pylon and an eroding bank upstream reportedly deposits sediment at the inlet of the diversion channel. Annual maintenance is reportedly required to keep the inlet of the diversion channel free from grave. Diversion 35 is located upstream of Diversion 36 and serves a pump.
