Calling all Volunteers - We Need YOU!

(To help restore a precious wetland area in the Mount Haggin Wildlife Management Area.)

We will be installing simple, low-tech, hand-built rock "Zeedyk" structures to kickstart the processes in order to heal this ephemeral stream. The emphasis will be on stabilizing shallow headcuts and counteracting channel incision. Be ready for some good old fashion manual labor-moving and placing rocks and digging in the dirt.

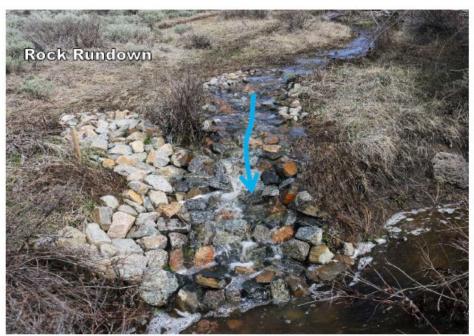
Figure 10. The center of a rock rundown should be the lowest so water runs down the middle and not around the structure. Photo by: Nathan Seward

The rock rundown structure is used in low energy headcuts (< 1.5 ft tall) in small catchments and offchannel return sites to stabilize them and prevent upstream erosion (Fig. 10). Typically, the headcut is first laid back by shaping it to a stable angle (3:1 slope), and then the slope is armored with rock. In some small headcuts, shaping is not required. See Appendix B for construction specifications.

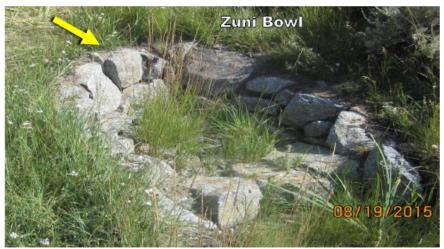
Figure 7. It is critical to ensure the top rocks of the Zuni bowl wall match the existing elevation of the headcut pour-over (denoted by yellow arrow). This helps irrigate vegetation at the lip, allowing it to become the most vigorous instead of the weakest point subject to erosion. If rocks are too high, they divert water around structure, concentrate flow, and potentially cause new gullies. If rocks are too low, soils and roots are exposed and vegetation dies. Photo by: Nathan Seward

The Zuni bowl is a rock-lined, step falls with plunge pools used to dissipate the energy of falling water and stabilize a headcut (Fig. 7, 8, 9). These structures stabilize the progression of a headcut by both stepping down the water in a way that minimizes the erosive and scour potential of falling water, and by protecting and maintaining moisture and vegetation at the pour-over. Hand-built Zuni bowls are typically applied to treat in-channel headcuts (1.5-3 ft tall). See Appendix A for construction specifications.

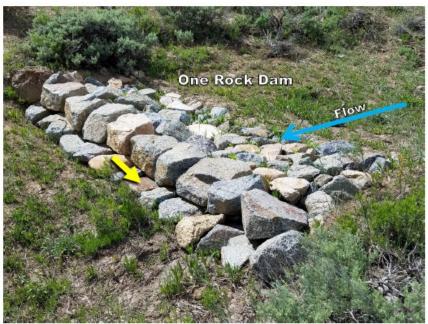
Figure 14. One rock dams should have a footer for splash apron on the downstream end that extends far enough to intercept water pouring over the structure in a high flow event (denoted by yellow arrow). Photo by: Nathan Seward

The one rock dam (ORD) is one of the most commonly used Zeedyk structures for channel recovery (Fig. 14). It effectively slows the flow of water, increases bank infiltration, captures sediment and helps recruit vegetation which can raise the channel bed elevation in gradual increments over time. An ORD is made of many rocks fit tightly together, but gets its name from being only one rock high (generally no more than a third the height of the bankfull channel).
